**THOMASVILLE ROAD (HERMITAGE BOULEVARD TO LIVE OAK PLANTATION ROAD)
ROADWAY SAFETY AUDIT**

SR 61 / Thomasville Road Road Safety Study

Hermitage Blvd./Sandhurst Dr. to Live Oak Plantation Rd.

*Sponsored by FDOT District Three Safety Office
May 15, 2018*

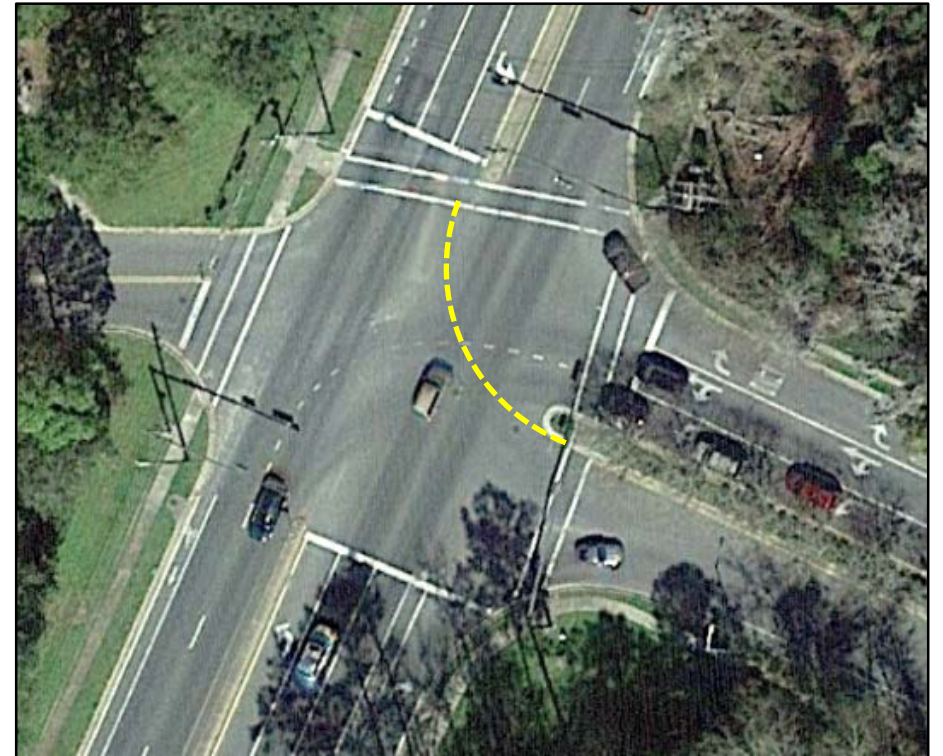
Thomasville Road at Hermitage Boulevard/Sandhurst Road

- > Issue
 - Lack of pavement marking guidelines (short-term)
- > Description of Safety Issue
 - Residents have observed motorists turning left (southbound) into wrong way of divided Hermitage Boulevard
- > Suggestion
 - Consider adding 2'-4' skip 6-inch yellow stripe pavement markings for this movement to help guide the turning motorists around the raised median island.

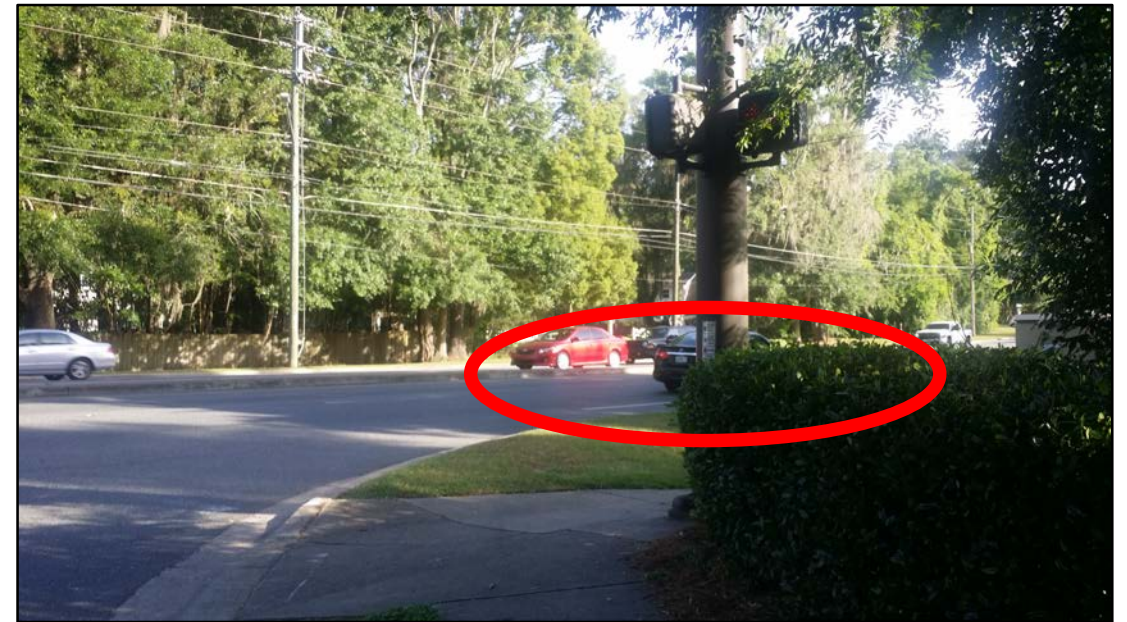
Thomasville Road at Hermitage Boulevard/Sandhurst Road

- > Issue
 - Limited sight distance (short-term)
- > Description of Safety Issue
 - The northeast quadrant has trees/landscaping impacting views
- > Suggestion
 - Consider trimming the trees and landscaping for better views of surrounding traffic and pedestrians

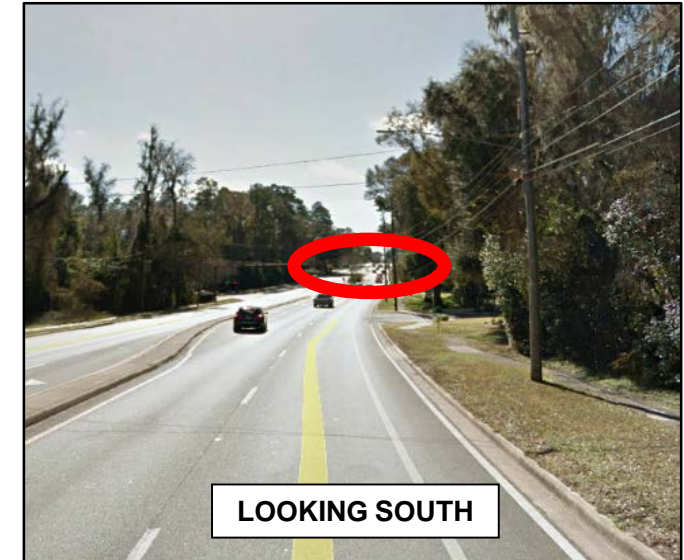
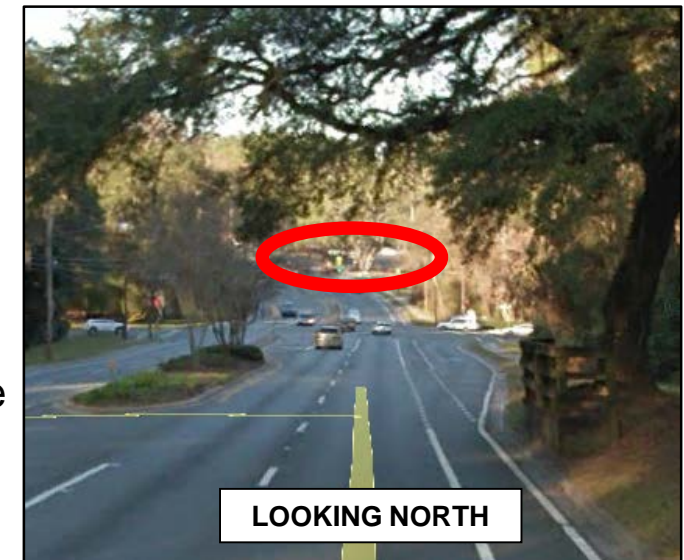
Thomasville Road at Hermitage Boulevard/Sandhurst Road

- Visibility of traffic signals for Thomasville Road approaching traffic (short- and mid-term)

- Crash history - 52 crashes with 17 northbound rear ends, 6 southbound rear ends, 6 northbound angle and 10 southbound angle crashes.
- Southbound signal head visibility impacted by the slight curvature of the roadway to the right.
- Northbound signal head visibility impacted by the downhill grade of the approach along with the trees that need trimming.

- Northbound and southbound
 - If possible, add signal head, one for each through lane and a flashing yellow arrow (FYA) signal for the left-turn lane to improve the signal head visibility
- Northbound
 - Trim tree branches to improve visibility of the signal heads as motorists travel through Woodgate Way signal
 - Install SIGNAL AHEAD sign just north of Woodgate Way to notify motorists of the signal.

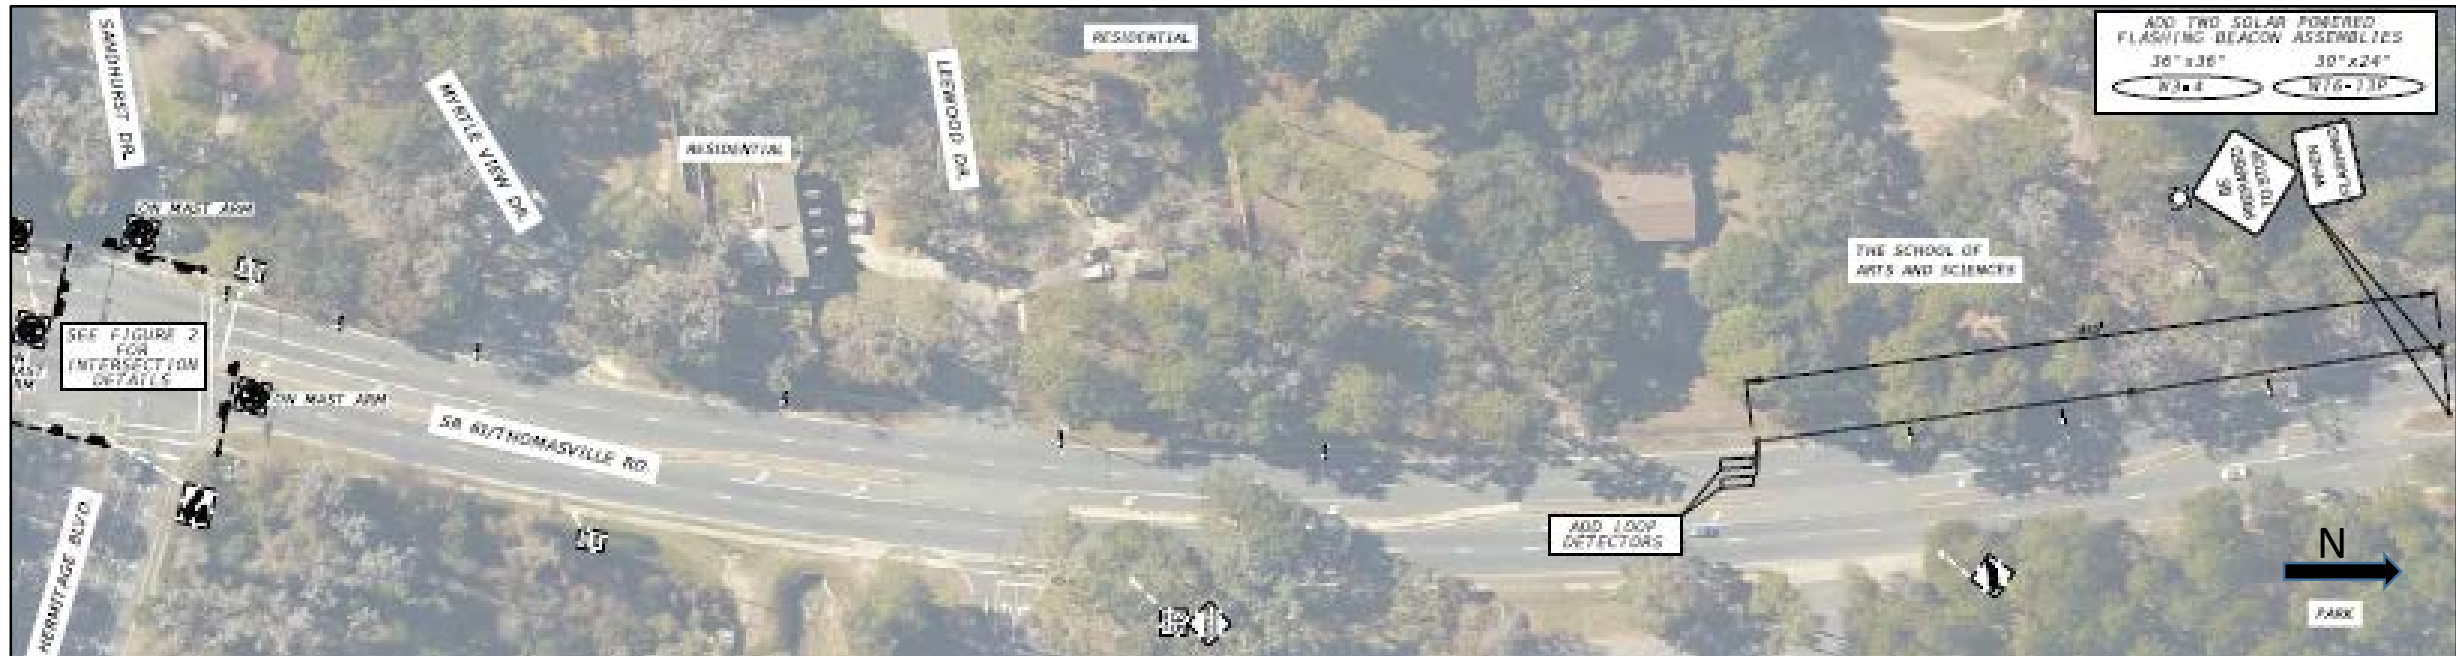
Thomasville Road at Hermitage Boulevard/Sandhurst Road

- Install flashing warning beacons in advance of the curve to provide notification of the need to slow down and stop due to standing queues on the approach.
- Flashing beacons mounted to a BE PREPARED TO STOP warning sign (W3-4) with a WHEN FLASHING warning plaque (W16-13) on roadside and in median.
- Flashing beacon activated when the standing queue is backed up far enough that the motorists do not have time to stop when visibility is blocked by the curve.

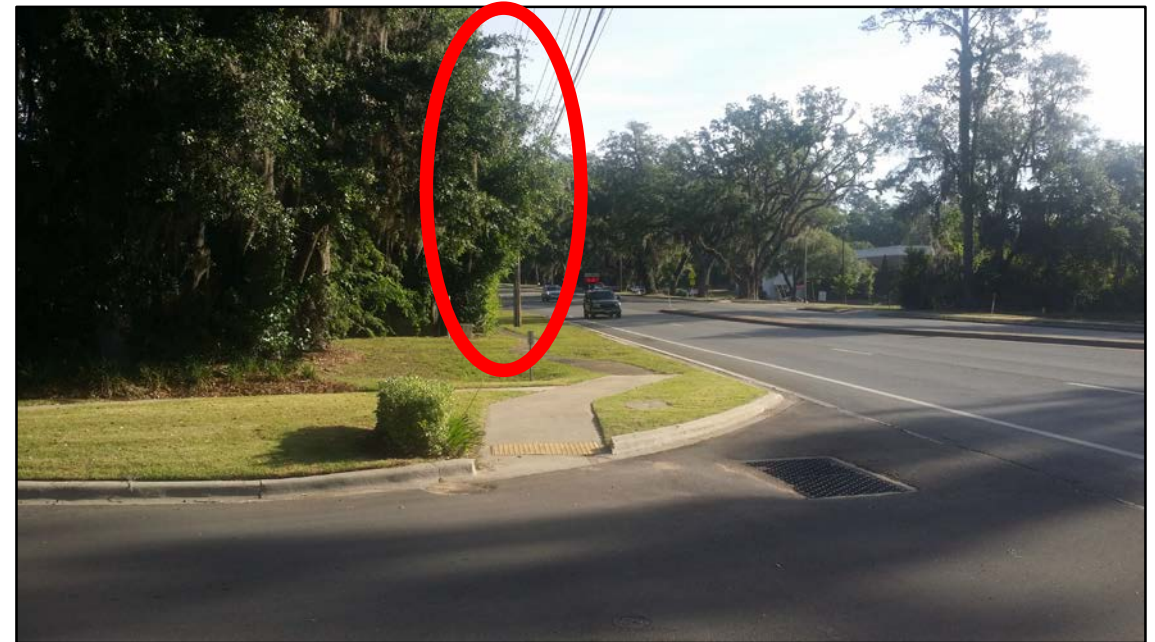
Thomasville Road at Myrtle View Drive

- > Issue
 - Limited sight distance (short-term)
- > Description of Safety Issue
 - The northwest quadrant has trees/landscaping impacting views
- > Suggestion
 - Consider trimming the trees and landscaping for better views of surrounding traffic and pedestrians

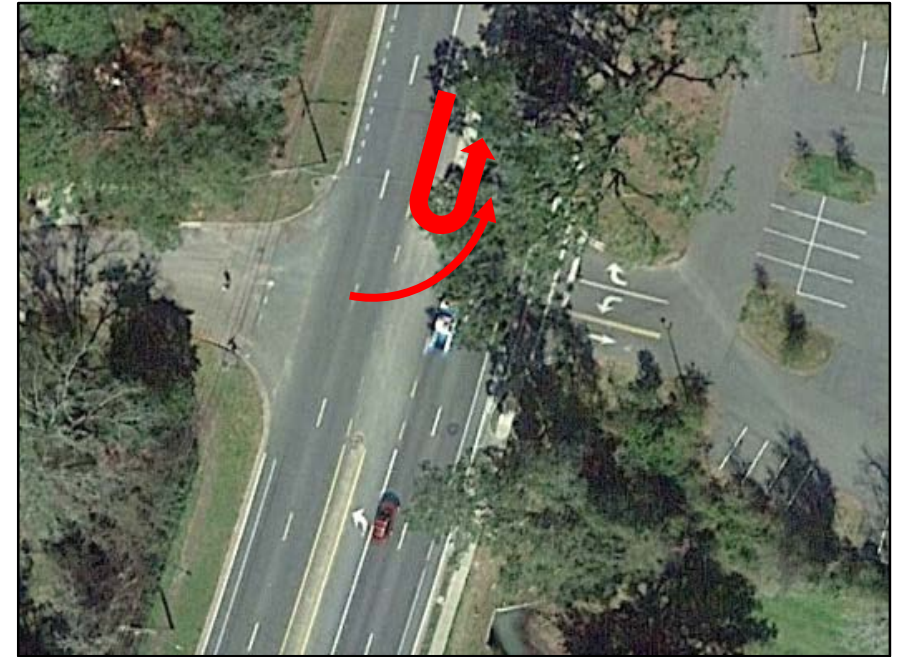
Thomasville Road at Leewood Drive/Thomasville Road Baptist Church South Driveway

- > Issue
 - Difficulty in making left-turns from Leewood Drive (short-term)
- > Description of Safety Issue
 - Eastbound to northbound left-turns from Leewood Drive difficult when southbound U-turns are sitting in the median opening. Worse during school times.
- > Suggestion
 - With low eastbound left-turn volume, consider permitting U-turns at the Hermitage Boulevard/Sandhurst Road signal and replacing the NO U-TURN sign with a U-TURN YIELD TO RIGHT TURN regulatory sign during the westbound right-turn overlap signal phase.
 - Provide residents option to avoid the median opening during heavier traffic conditions.
 - Further signal analysis at the signal is required prior to implementing.

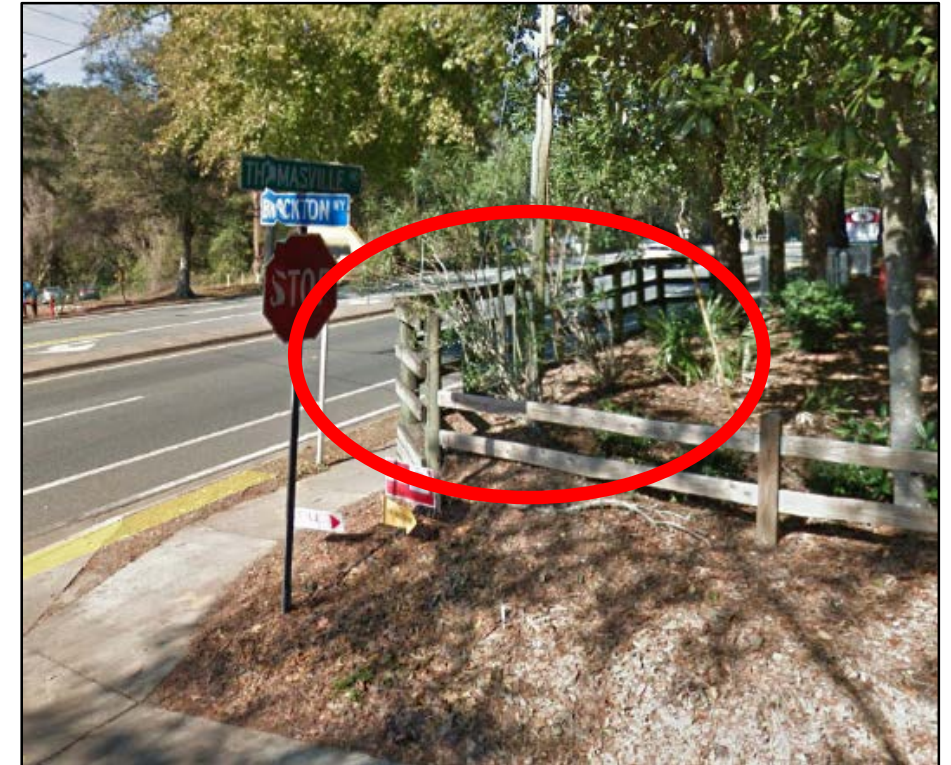
Thomasville Road at Brockton Way

- > Issue
 - Limited sight distance
- > Description of Safety Issue
 - Northeast quadrant has trees and a wooden fence atop a wood retaining wall impacting view of traffic/pedestrians from the north.
- > Suggestion
 - Install a marked pedestrian crosswalk across Brockton Way to remind motorists of the potential for pedestrian/bicycle crossings (short-term)
 - Consider removing the trees in this area
 - Consider re-grading the corner and shifting the retaining wall and wood fence back to the right-of-way (mid-term)

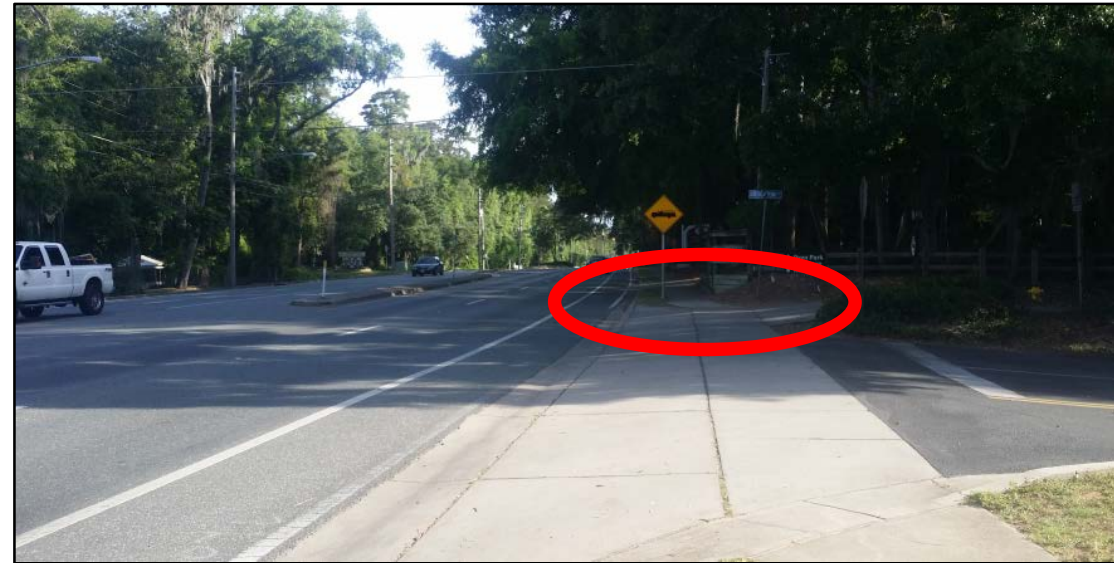
Thomasville Road at Thomasville Road Baptist Church North Driveway/Brockton Way

- > Issue
 - Church driveway/Brockton Way exiting traffic conflicts (short-term)
- > Description of Safety Issue
 - Exiting traffic from church driveway and from Brockton Way have conflicts due to close proximity
 - Also conflicts with southbound U-turn and left-turn traffic
- > Suggestion
 - Consider restricting westbound left turns from Brockton Way to minimize conflict points
 - Restricted left turns can U-turn at the median opening to the north

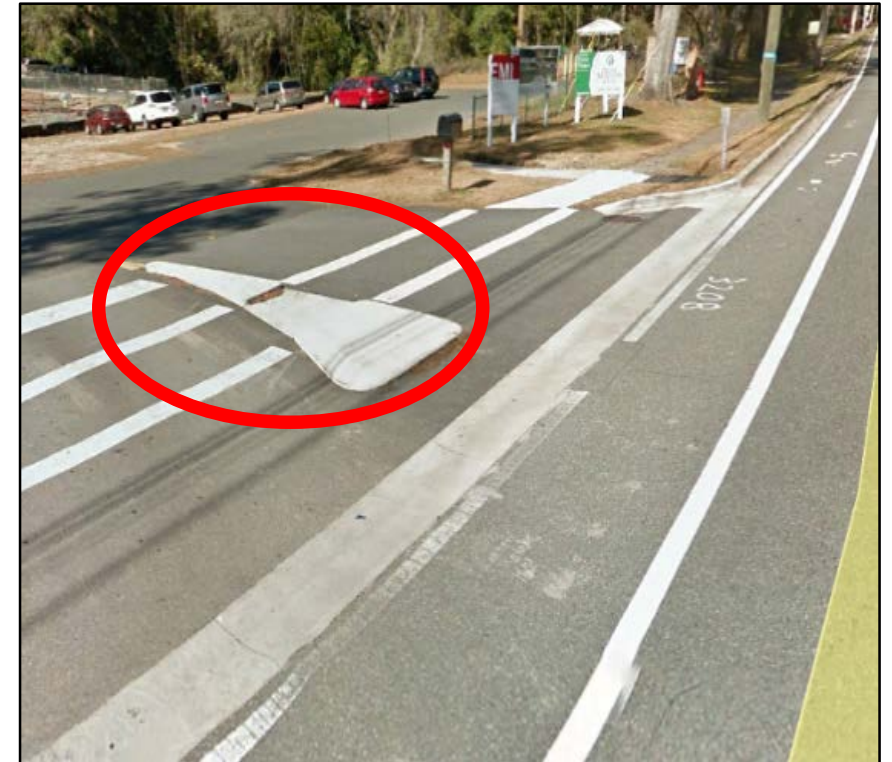
Thomasville Road at School of Arts and Sciences

- > Issue
 - Left-turn traffic from school driveway (short- and mid-term)
- > Description of Safety Issue:
 - Left-turns exiting driveway despite NO LEFT TURN sign
- > Suggestion:
 - (Short-term) Install flexible delineator posts around the concrete island to discourage movement
 - Use enforcement to ticket the drivers that are not in compliance
 - (Mid-term) Revise the existing island to be more restrictive for left-turns

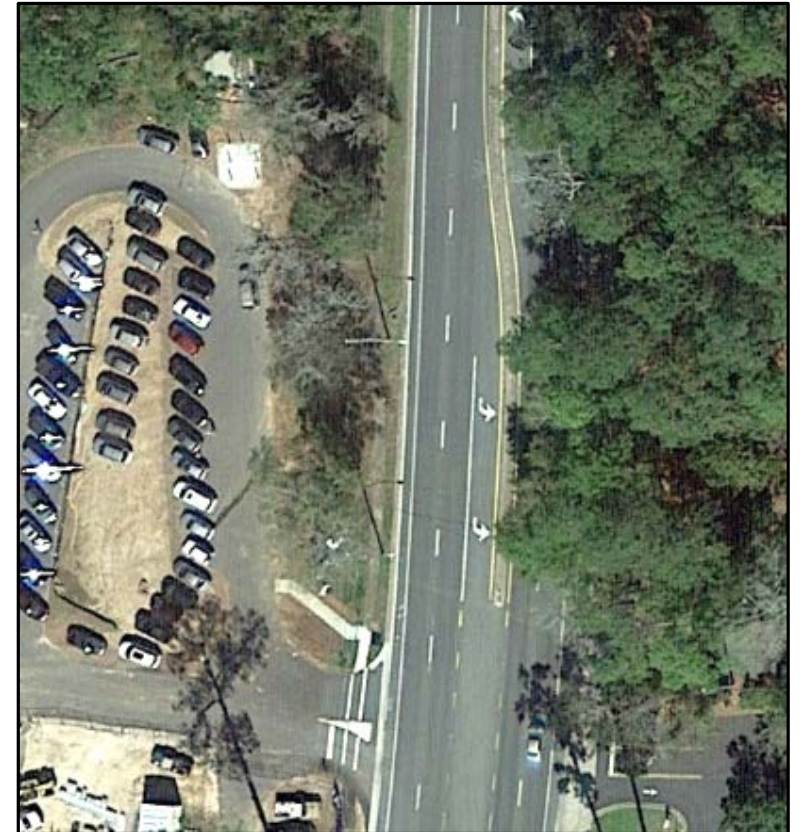
Thomasville Road at School of Arts

- > Issue
 - No Right-turn Lane at School Driveway (Short- and Long-term)
- > Description of Safety Issue
 - Southbound Thomasville Road traffic must slow for traffic entering the school
 - At times the school traffic queued on-site backed onto Thomasville Road
- > Suggestion
 - (Short-term) Work with the school and nearby property owners for a shuttle bus to minimize impacts to Thomasville Road traffic flow
 - (Long-term) Require future developments with significant right-turn volumes to install a dedicated right-turn lane on Thomasville Road

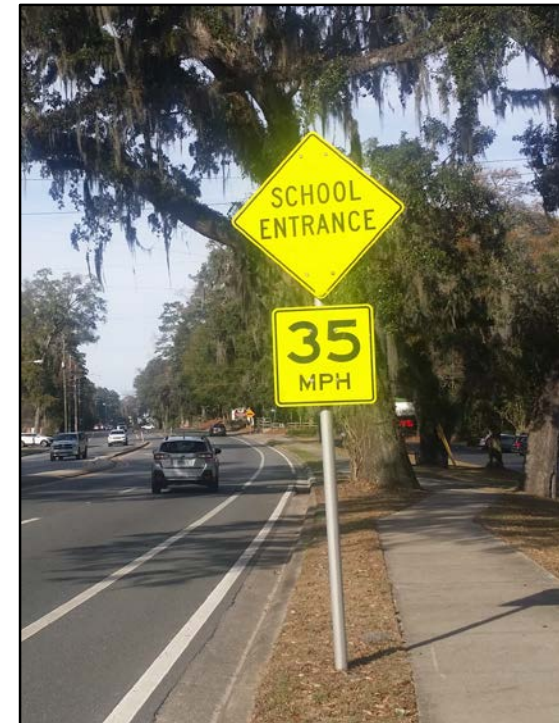
Thomasville Road at School of Arts

- > Issue
 - Speeds during school day begin/end
- > Description of Safety Issue
 - Concerns with Thomasville Road traffic speeds when buses/parents are dropping off/picking up students
- > Suggestion
 - Retain 35 MPH SCHOOL ENTRANCE signs

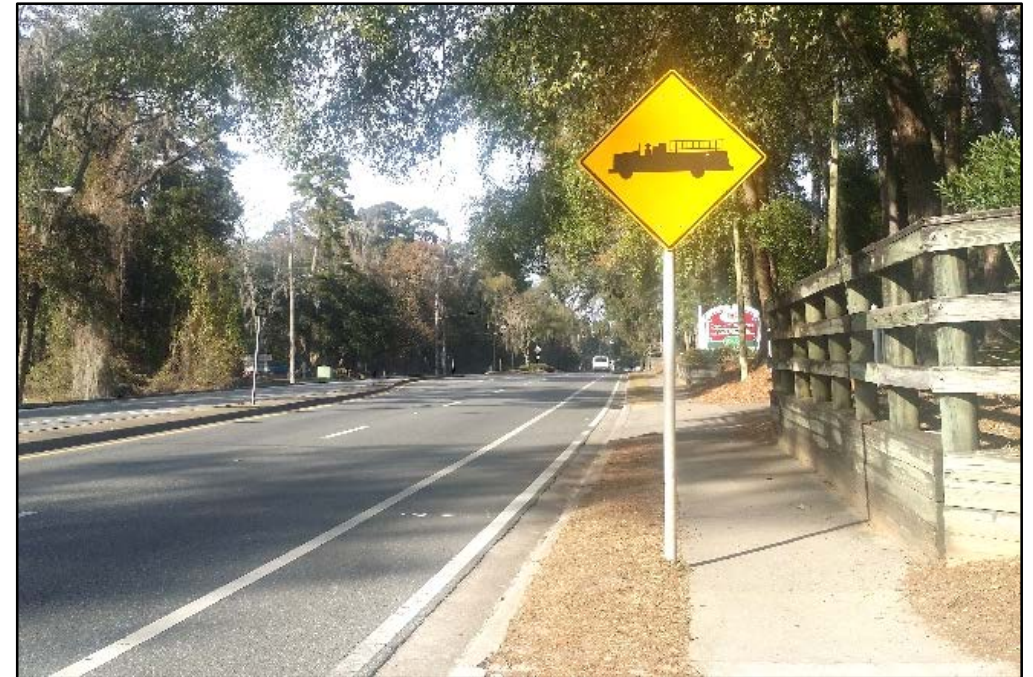
Thomasville Road at Oven Park Entrance

- > Issue
 - Lack of signing at driveway (short-term)
- > Description of Safety Issue
 - This is a driveway entrance only but has a ONE WAY sign in the median for the non-existent exiting traffic.
- > Suggestion
 - Consider adding ONE WAY signing for entering Oven Park from the right-in only driveway and removing the ONE WAY sign in the median.

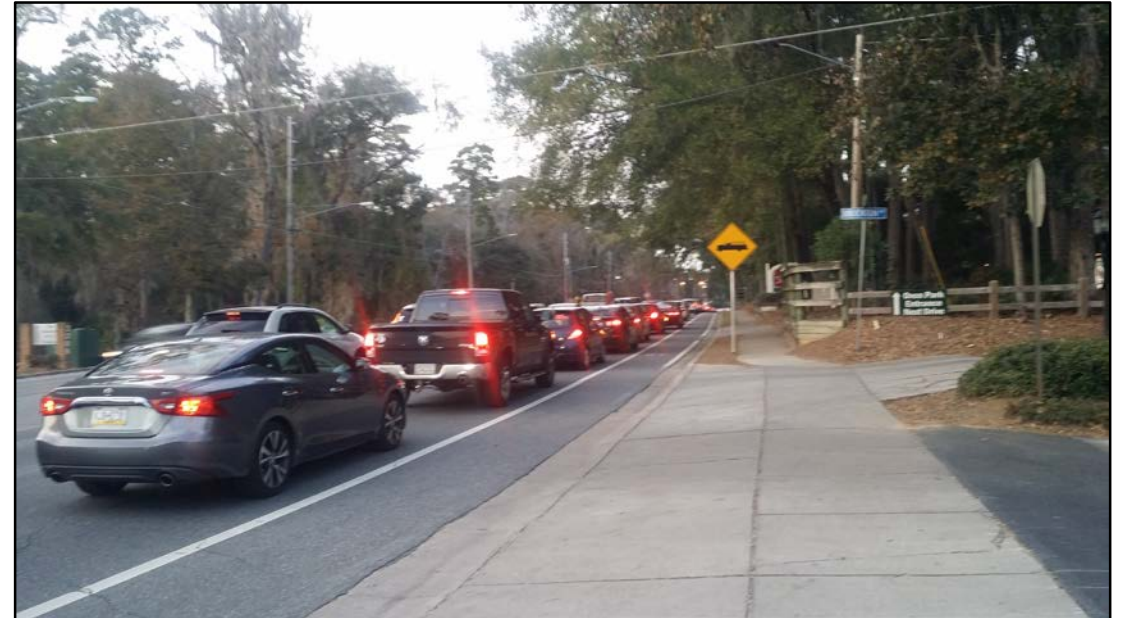
Thomasville Road at Fire Station Entrance

- > Issue
 - Traffic blocking fire station access/driveway (Short-term)
- > Description of Safety Issue
 - Northbound queued traffic blocked the fire station driveway during the PM peak hour
- > Suggestion
 - Consider adding a DO NOT BLOCK INTERSECTION regulatory sign for northbound traffic to ensure timely exit of emergency vehicles

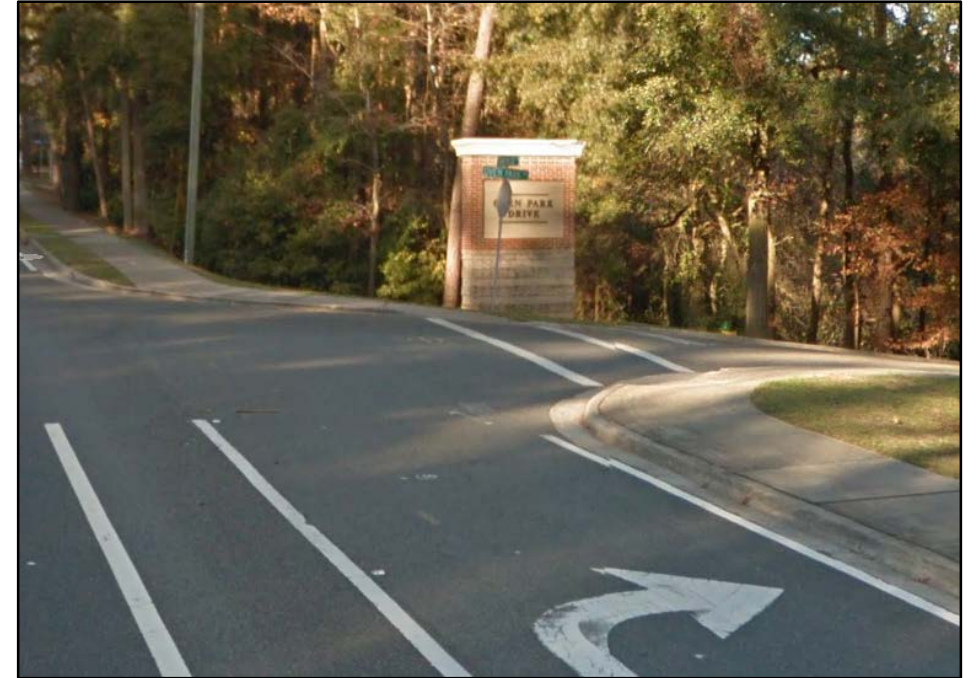
Thomasville Road at Oven Park Drive

- > Issue
- > Location of STOP sign and stop bar (short-term)
- > Description of Safety Issue
 - STOP sign and stop bar for westbound traffic were noted as located too far back to see approaching northbound Thomasville Road traffic
 - Both are properly placed at the back of the curb radius for a side street
 - Motorists are required to stop safely for pedestrians and then move up as necessary to see traffic on the mainline
- > Suggestion
 - No change is required

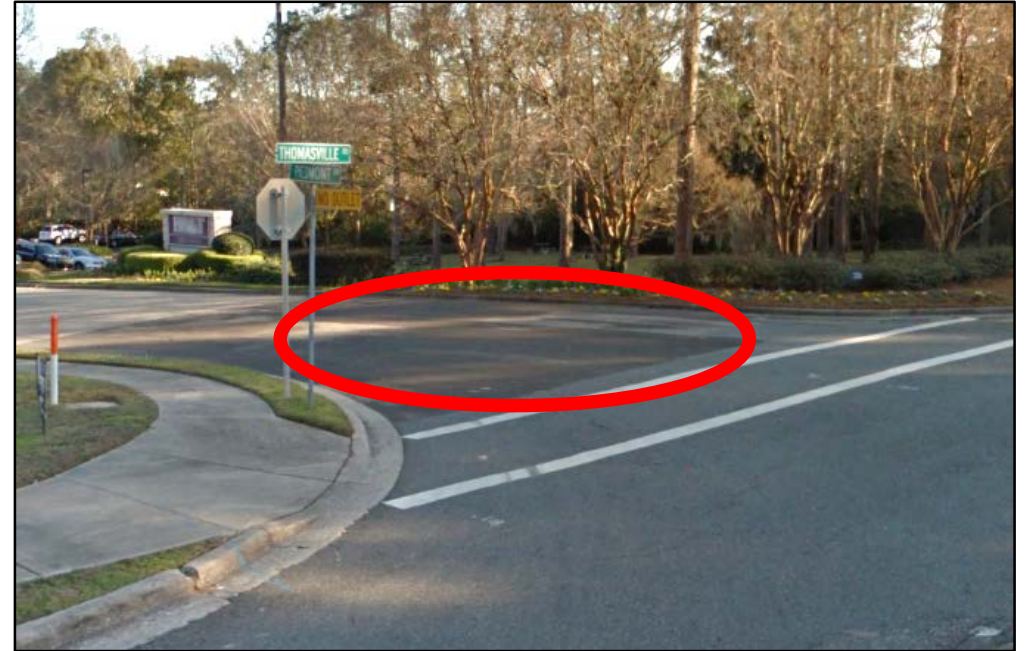
Thomasville Road at Piedmont Drive

- > Issue
 - Lack of pavement markings (short-term)
- > Description of Safety Issue:
 - Piedmont Drive is lacking pavement markings
- > Suggestion
 - Install a stop bar and 6-inch solid double yellow stripes to separate the opposing movements on Piedmont Drive

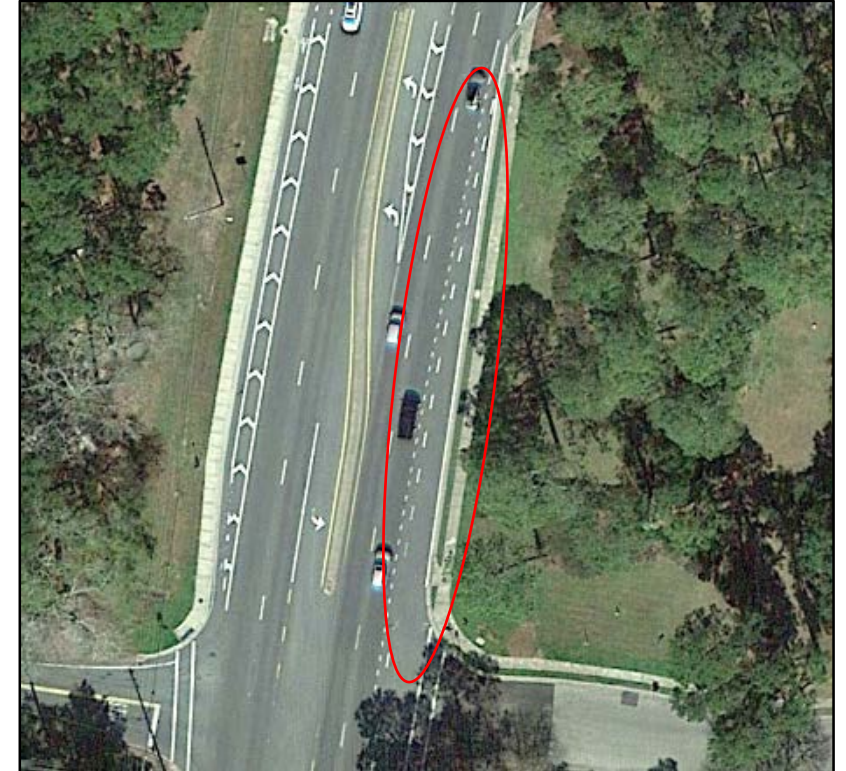
Thomasville Road at Piedmont Drive

- > Issue
 - Pavement Markings on northeast corner are confusing (short-term)
- > Description of Safety Issue
 - Acceleration lane pavement markings are confusing.
 - not wide or long enough for an acceleration lane to merge into northbound traffic
- > Suggestion
 - Remove and replace with 18-inch white gore striping
 - Striping would be similar to west side of Thomasville Road

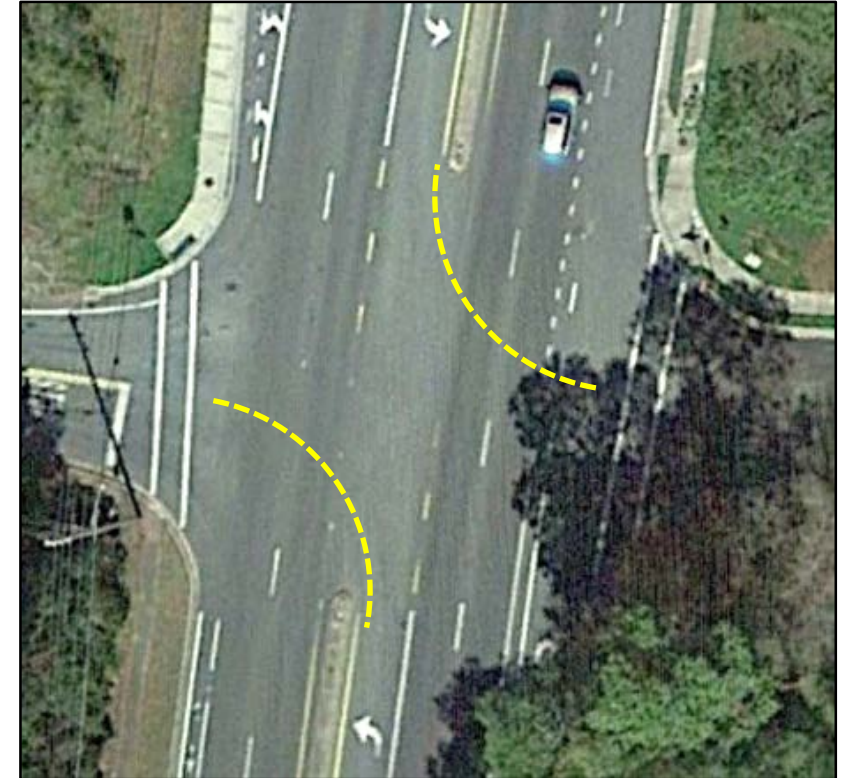
Thomasville Road at Piedmont Drive

- > Issue
 - Lack of pavement marking guidelines (short-term)
- > Description of Safety Issue:
 - Northbound and southbound left turns lacking pavement guidelines
- > Suggestion
 - Consider adding 2'-4' skip 6-inch yellow stripe pavement markings to help guide motorists

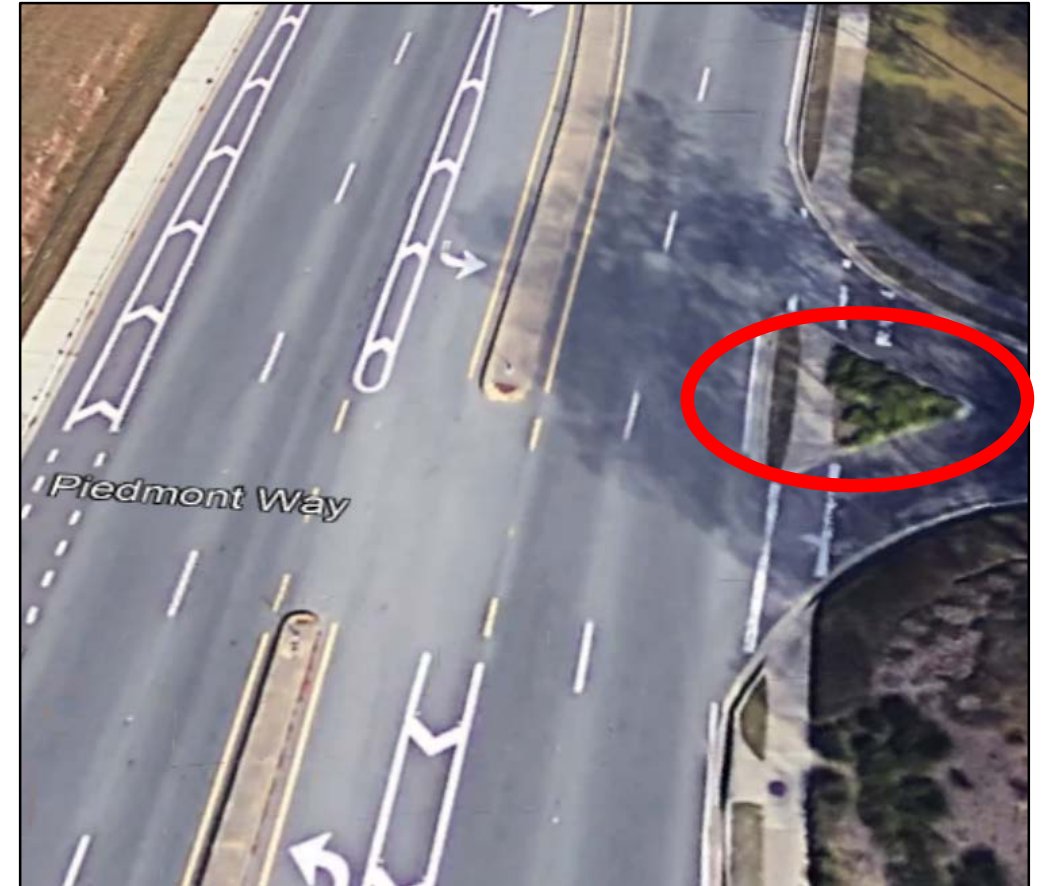
Thomasville Road at Piedmont Way

- > Issue
 - Restricted turning movement (short-term)
- > Description of Safety Issue
 - The “pork chop” island designed to restrict traffic to right-turn-in and right-turn-out only
 - The southbound left-turn lane provided to allow turns
- > Suggestion
 - Consider modifying the island to allow the southbound left-turn movement from Thomasville Road onto Piedmont Way

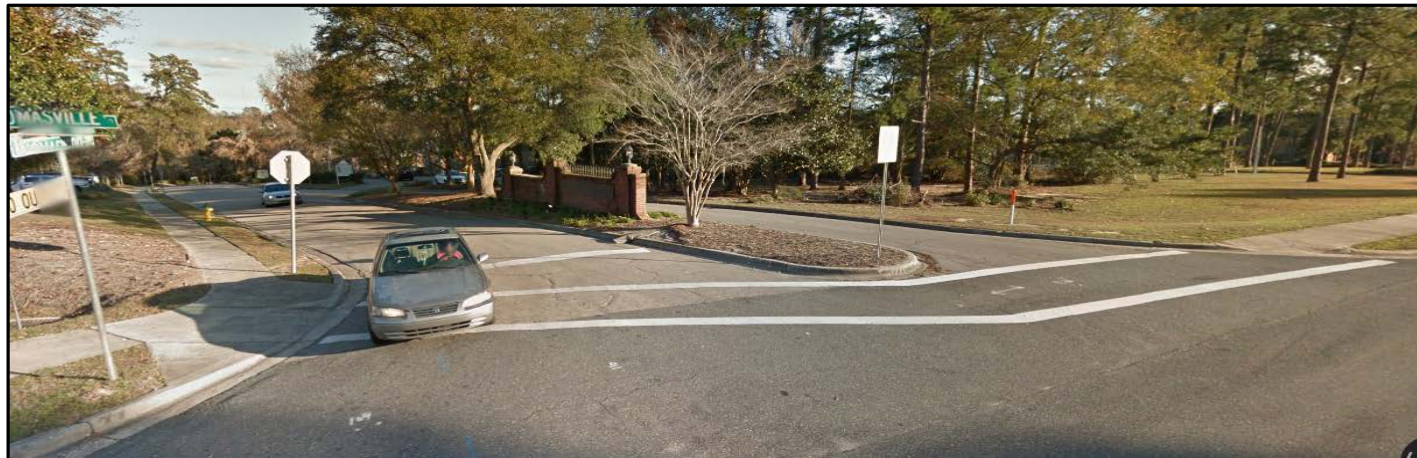
Thomasville Road at Thomaswood Drive

- > Issue
 - Poor crosswalk alignment (short-term)
- > Description of Safety Issue
 - The east leg crosswalk has a 'kink' in it as it crosses Thomaswood Drive
- > Suggestion
 - Consider revising the location of the crosswalk or median to allow a straight movement across the driveway

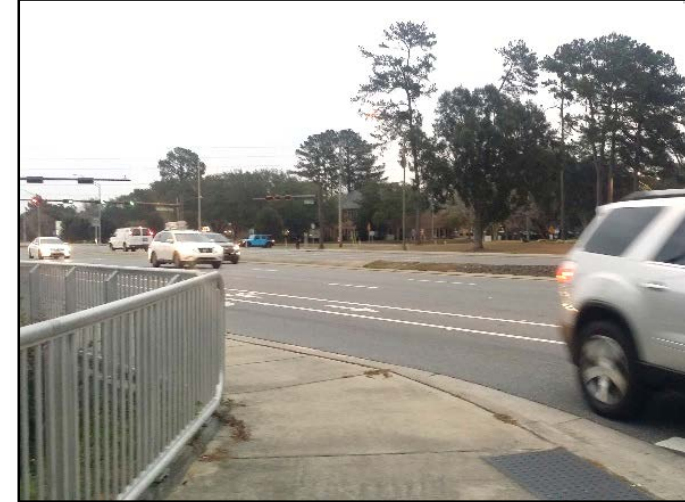
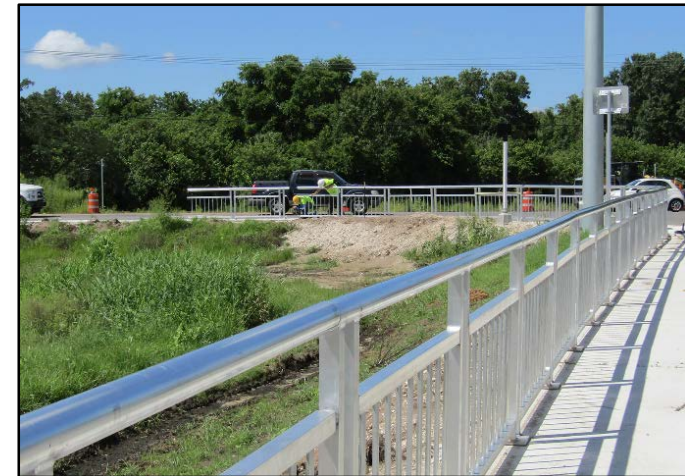
Thomasville Road at Live Oak Plantation Road

- > Issue
 - Limited sight distance (short-term)
- > Description of Safety Issue
 - Pedestrian rail in the northwest corner obstructs view of southbound approaching traffic.
- > Suggestion
 - Consider replacing the railing with the FDOT design that includes a window for improved visibility

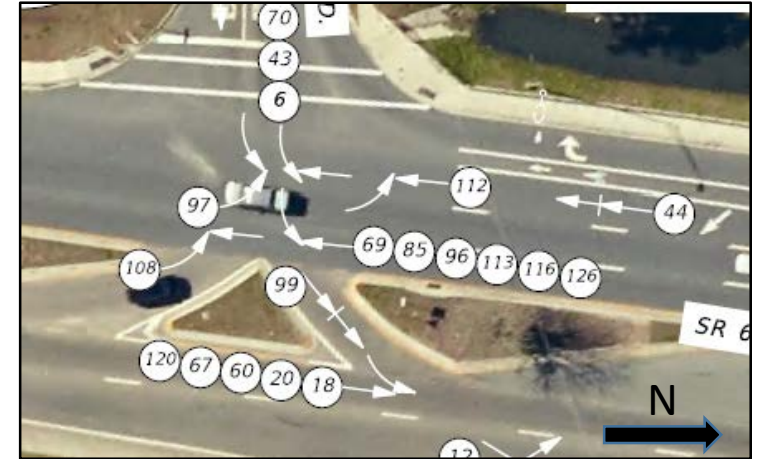
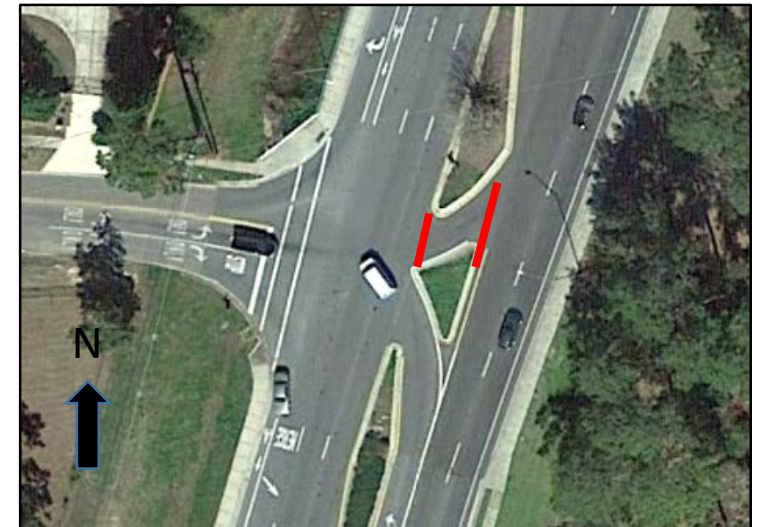
Thomasville Road at Live Oak Plantation Road

- > Issue
 - Number of crashes involving eastbound left turns (mid-term)
- > Description of Safety Issue
 - 15 angle crashes at this intersection
- > Suggestion
 - Consider eliminating the eastbound left-turn movement at this location.
 - Modify median opening to a directional northbound opening
 - Eastbound left turns required to make a right-turn followed by a U-turn
 - Access management study required along the segment to determine the effects of U-turn traffic

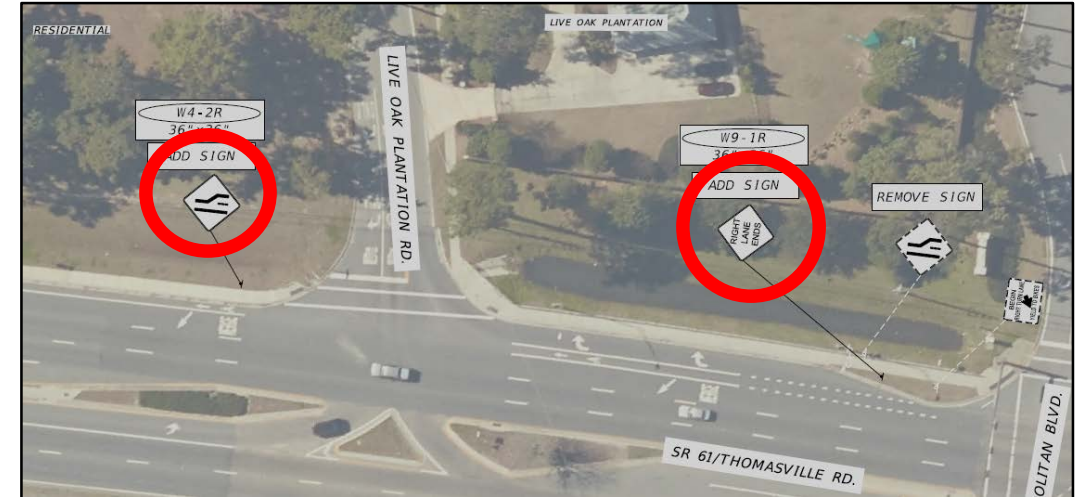
Thomasville Road at Live Oak Plantation Road

- > Issue
 - Lack of roadside warning sign (short- and mid-term)
- > Description of Safety Issue
 - Within the southbound lane merge area there is only one roadside warning sign, a LANE ENDS symbol sign, which is not easily understood by some motorists

- > Suggestion
 - (Short-term) Consider removing the existing LANE ENDS warning sign and adding a new LANE ENDS sign south of Live Oak Plantation Road. Add a RIGHT LANE ENDS warning sign just south of Metropolitan Boulevard in a more visible location.

- (Mid-term) Many of the southbound right-turns onto Live Oak Plantation Road are turning right from the merge lane. Consider eliminating right-turn lane and using the merge lane for the right-turns

- Will help reduce sight restrictions for eastbound motorists on Live Oak Plantation when a right-turn vehicle is located in the southbound turn lane
 - Further analysis is needed for this lane change

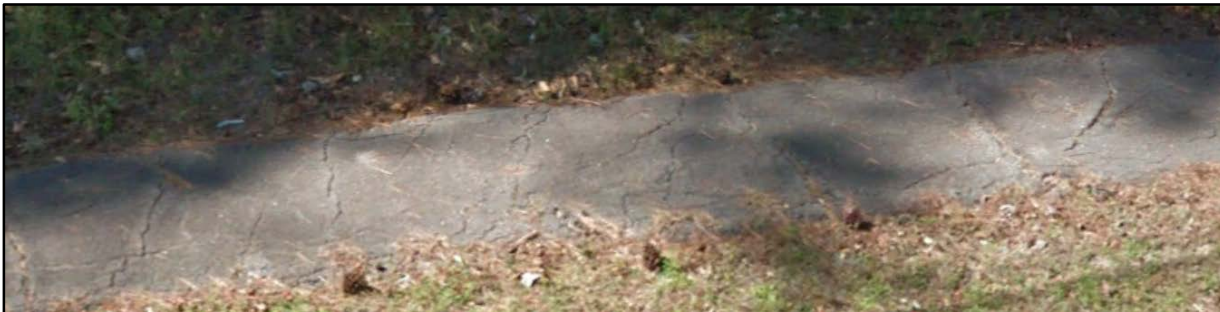
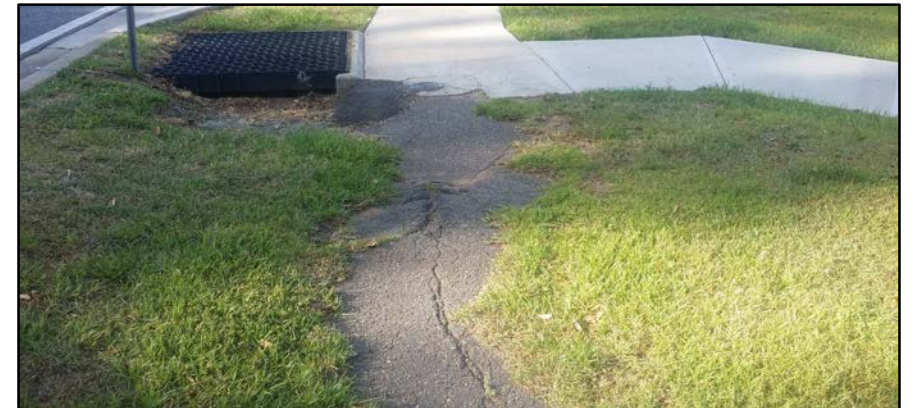
General Corridor Observations

- > Issue
 - Cracked and uneven sidewalk (long-term)
- > Description of Safety Issue
 - Areas of cracked and uneven sidewalk throughout the corridor
 - Most of the west side sidewalk is in poor condition due to tree roots
- > Suggestion
 - Consider replacing deficient sidewalk during the next resurfacing project
