North Monroe Street Design & Safety Study

Florida State University
Department of Urban & Regional Planning
Summer Studio 2010
Prepared for the CRTPA

| 2 Road Safety Audit Report..... | 7 |

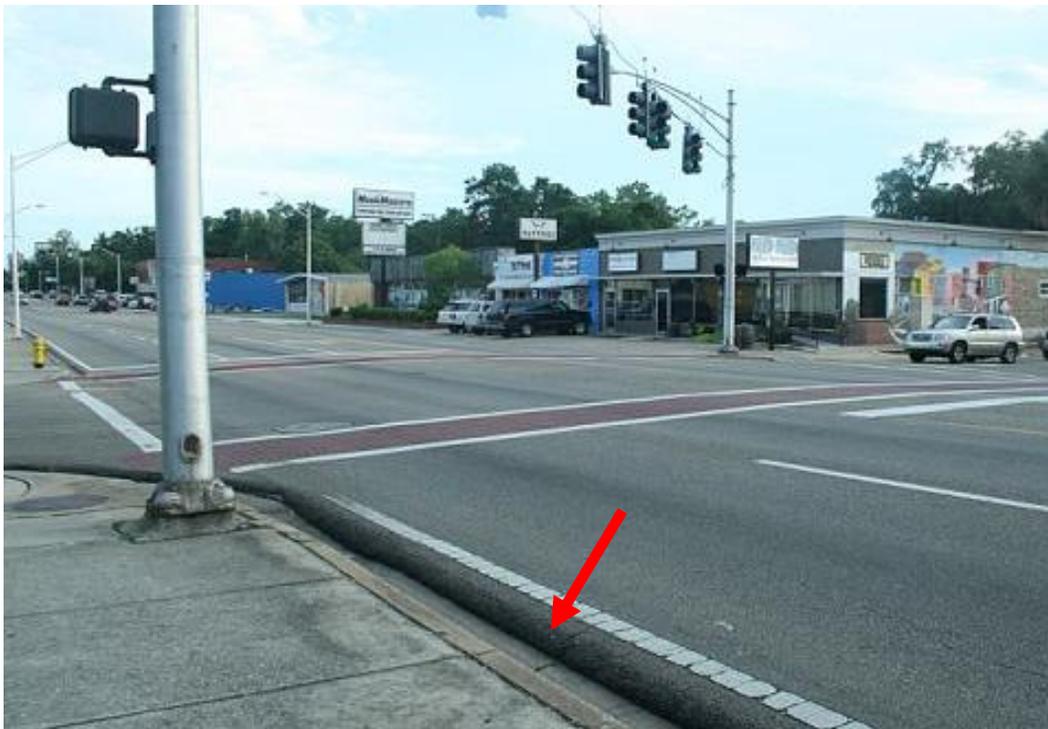
Much of the corridor has a very steep drop-off (in some cases up to 4 inches) between the asphalt of the right edge of the traffic lanes and the curb apron. This is hazardous to bicyclists and other facility users.

Mill roadway and repave traffic lanes to smooth out transition from roadway to curb. Insufficient road right-of-way space prohibits a bicycle lane to exist; bicyclists should be diverted to a safer roadway route. Further analysis on bicycle accommodations along this corridor is highly recommended.

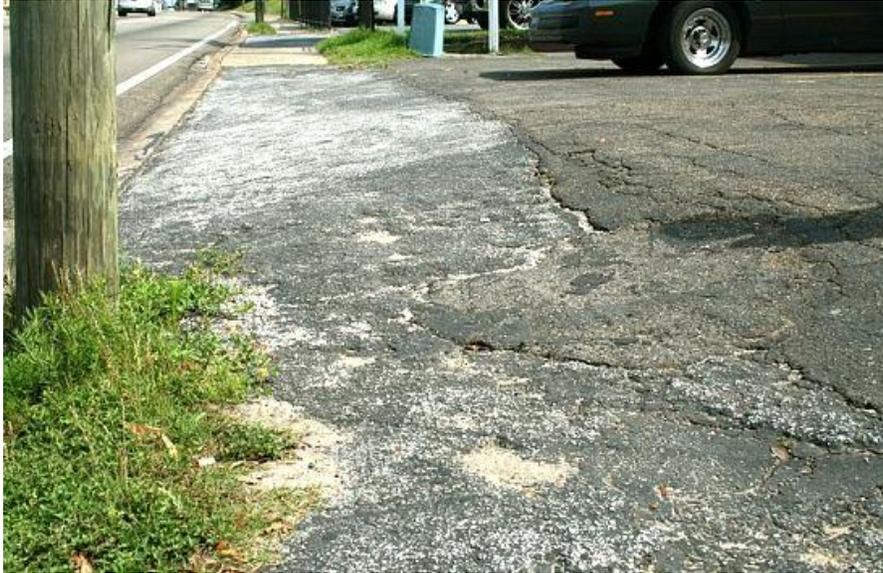
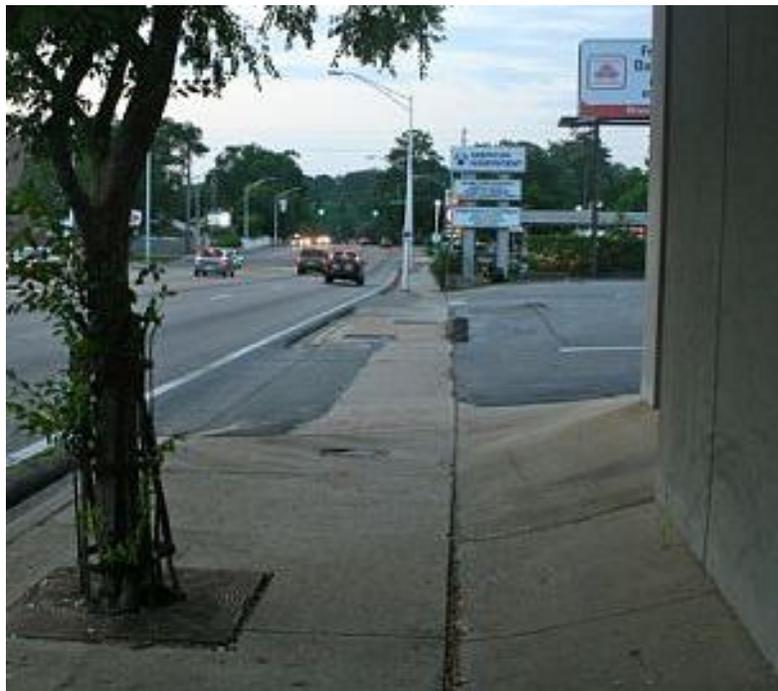
Many driveways are not built according to current design standards that allow sidewalk construction to be built behind turnout.

Update and reconstruct driveways on properties with design issues to allow for the development of a continuous sidewalk.

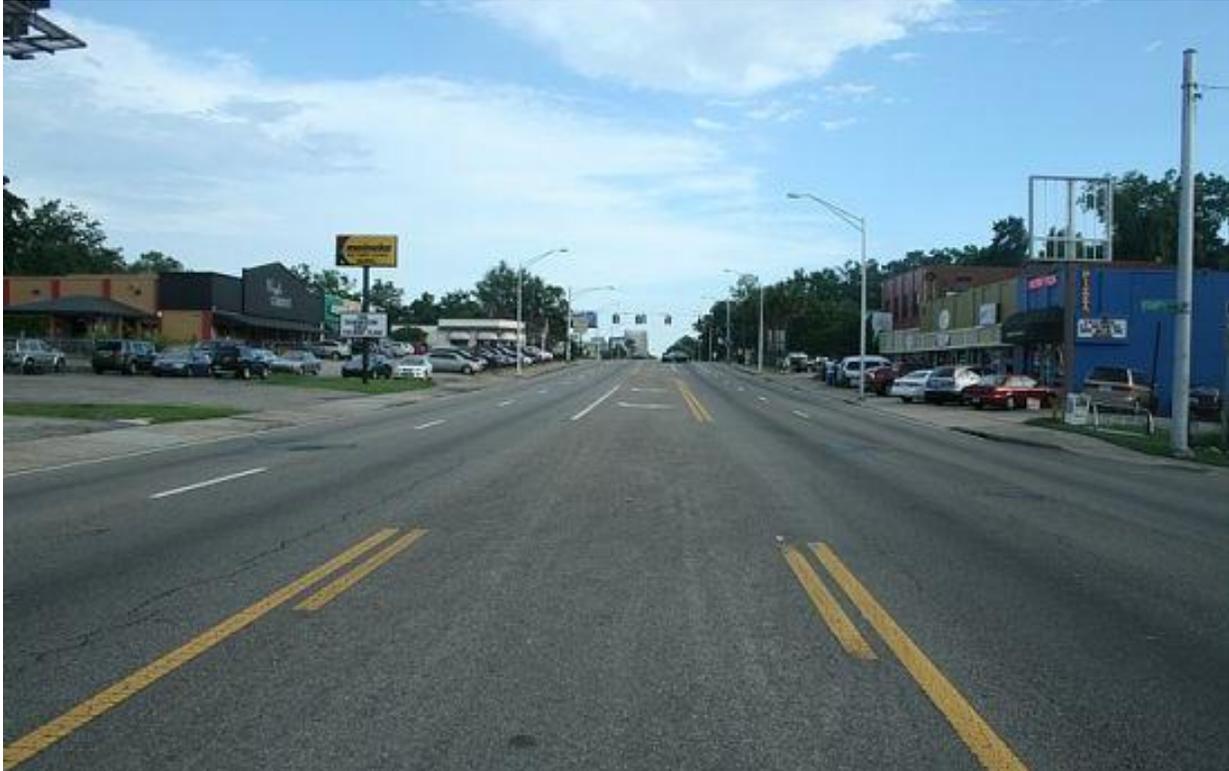
Dual left turning lanes into driveways can cause hazards for pedestrians as drivers may not see them. This can also be an issue for drivers not knowing what driveway the other vehicle is trying to turn into.

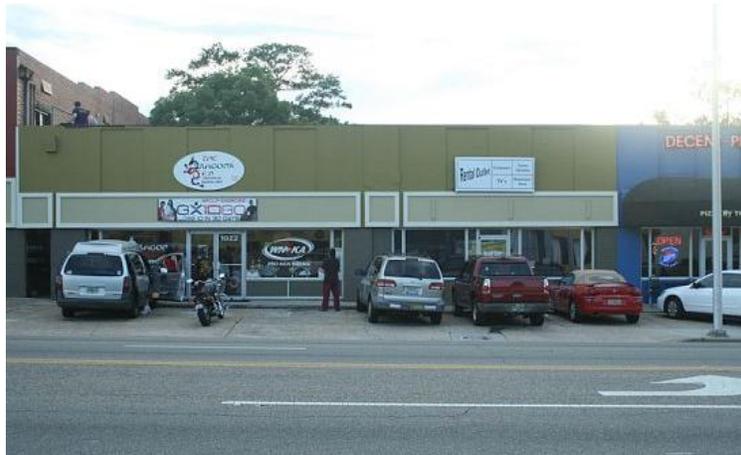
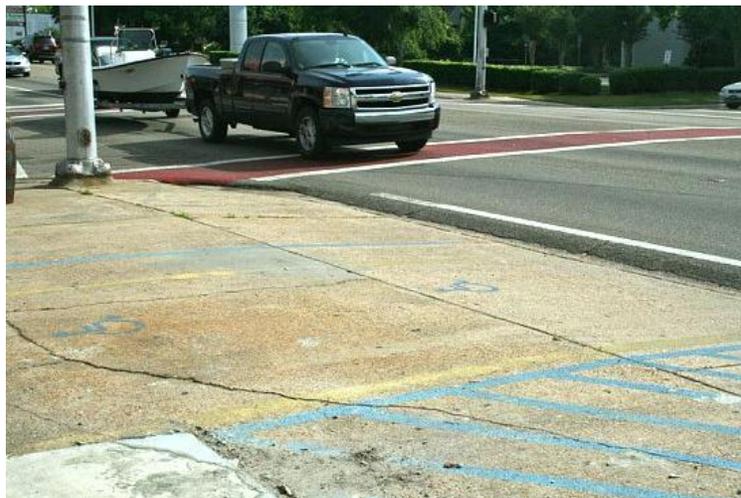
Front-in parking causes issues with pedestrians, forcing them to walk between parked vehicles and the outside travel lane. These spaces also cause issues when the vehicles are backing out over sidewalks into oncoming traffic, presenting a high risk for pedestrians and cyclists as well.

Immediate recommendations include signage to warn drivers to look for pedestrians when backing up. Intermediately, businesses should be deterred from using the limited space for parking and rather use the area for landscaping, outdoor seating or some other pedestrian friendly use. Parking spaces will have to be relocated to other areas more suitable for parking. Over time, the amount of open access to Monroe Street should be reduced. A proactive approach should be to require new buildings to be constructed closer to the street.

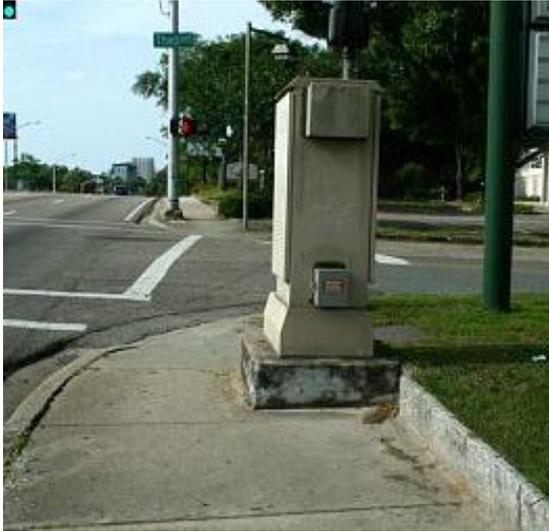
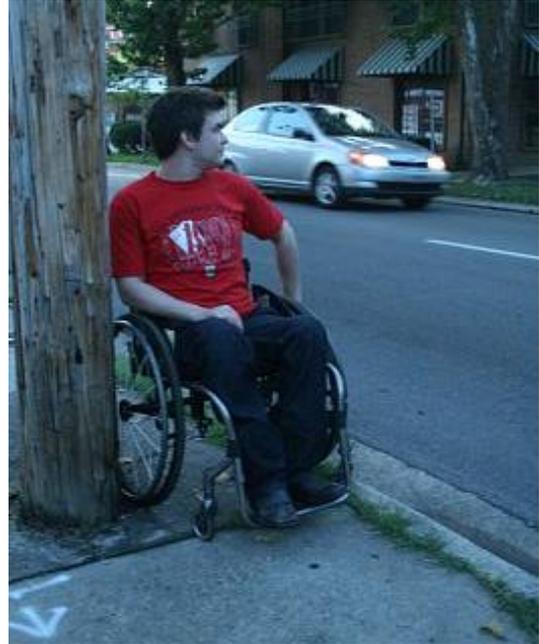
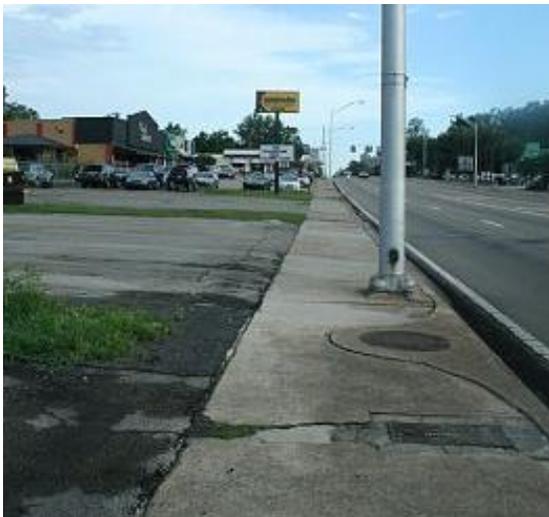
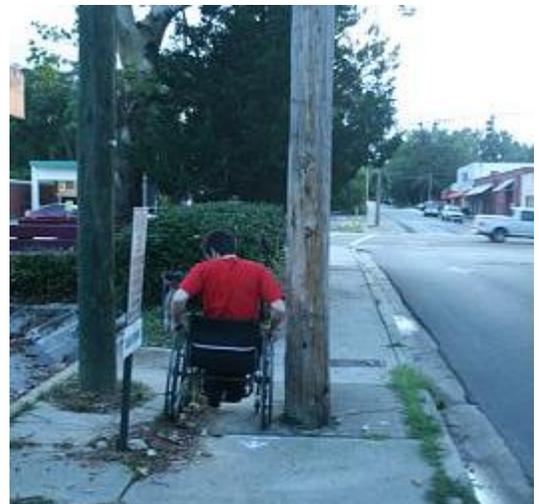
Obstacles in the sidewalks, such as signal boxes, light/utility poles, drainage grates and manholes make it difficult to navigate some portions of the sidewalk, especially for people in wheelchairs.

Obstacles should be relocated or redesigned to better accommodate pedestrians. Utilities could be converted to an underground system, light poles could be relocated to less intrusive locations, and drainage gates/manholes can be updated to safer designs.

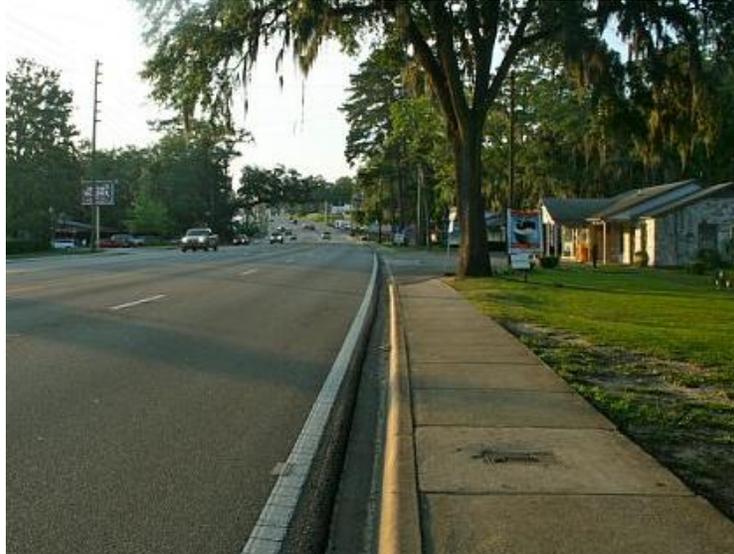
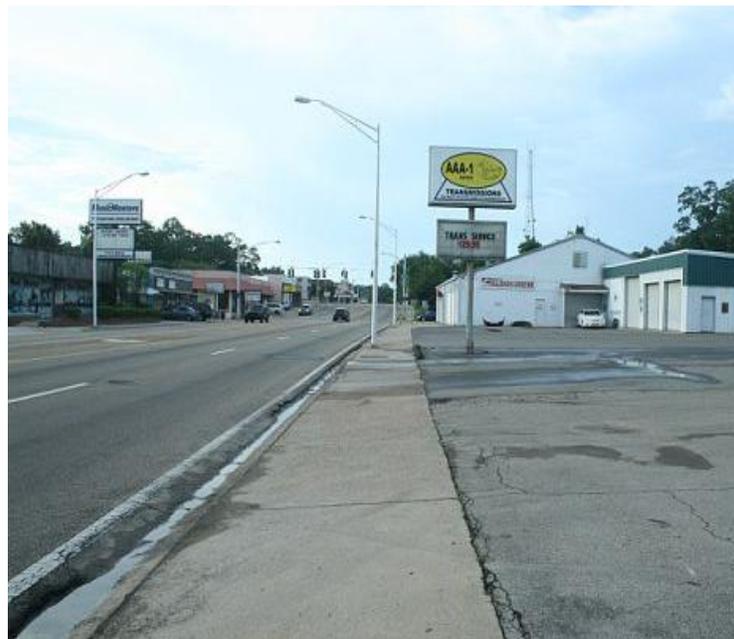
Narrow sidewalks create dangerous situations for pedestrians and other facility users.

If widening sidewalks is not feasible due to right-of-way constraints, some sort of buffer between traffic lanes and the sidewalks should be created to better divide auto and pedestrian traffic.

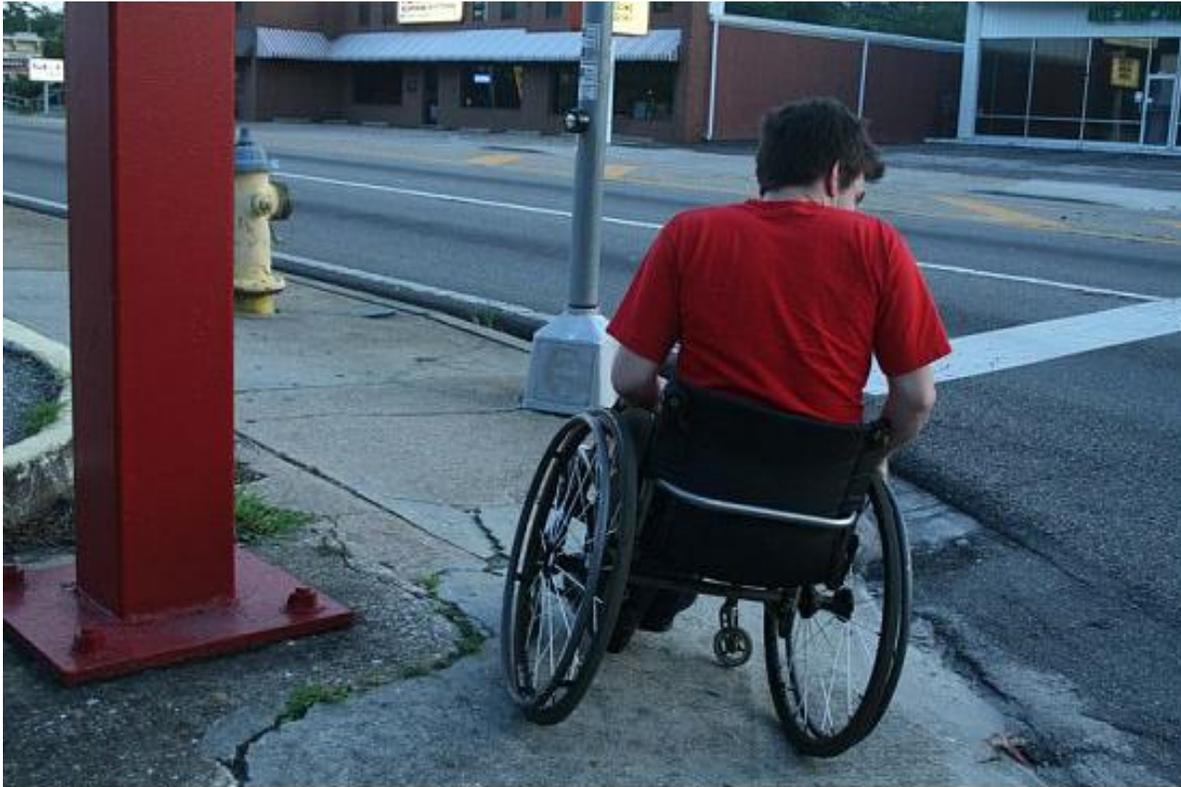
Some sections of sidewalk have too much cross-slope to meet ADA requirements and ADA ramps are missing in many locations. This poses an issue for people in wheelchairs or other type of mobile device that are trying to cross streets or simply travel the sidewalk.

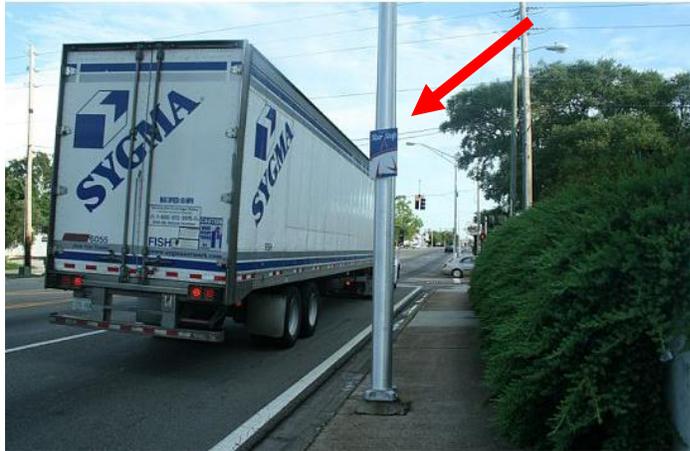
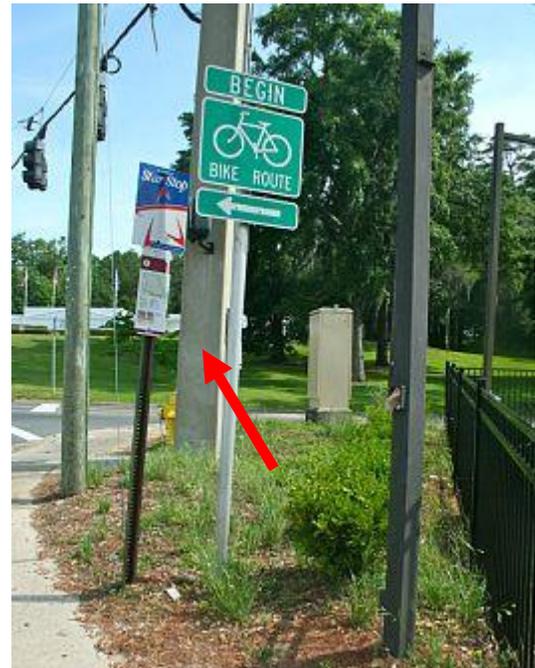
Every bus stop on the corridor lacks shelter to protect riders from sun or rain and bus stop locations are not very noticeable. This is an issue for drivers as they may not notice pedestrians standing at bus stops and for pedestrians who may not notice the bus stops.

Coordinate with StarMetro to improve the bus stop facilities, including shelters, to make the stops more visible and comfortable for bus riders.

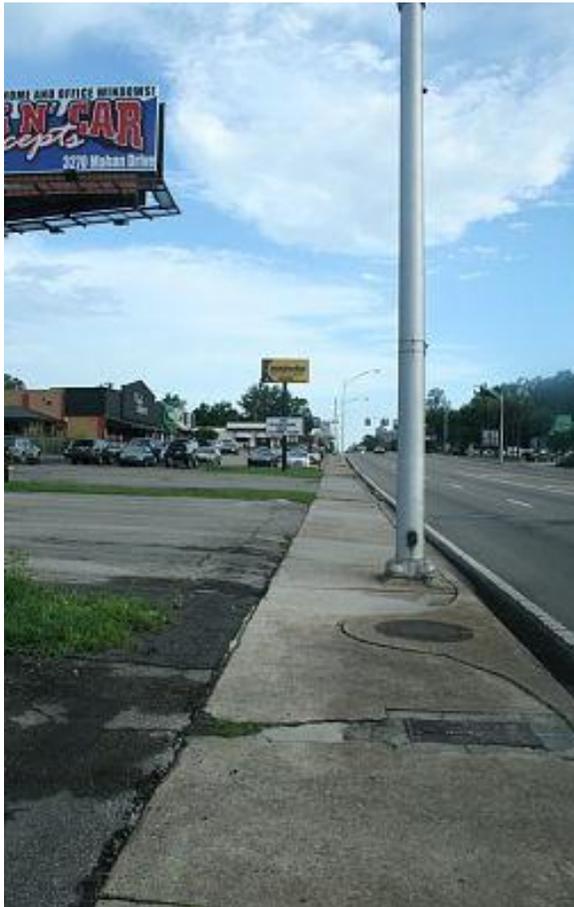
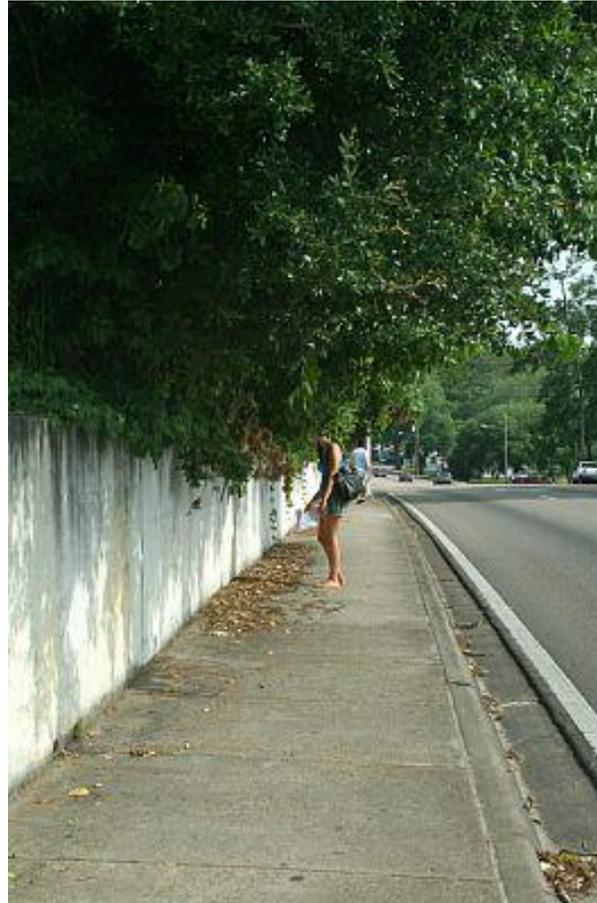
The lack of shade throughout the corridor can be dangerous during hot summer months as there is no protection for pedestrians. The poor maintenance of existing landscaping can limit the visibility of autos/pedestrians, increasing the opportunity for accidents.

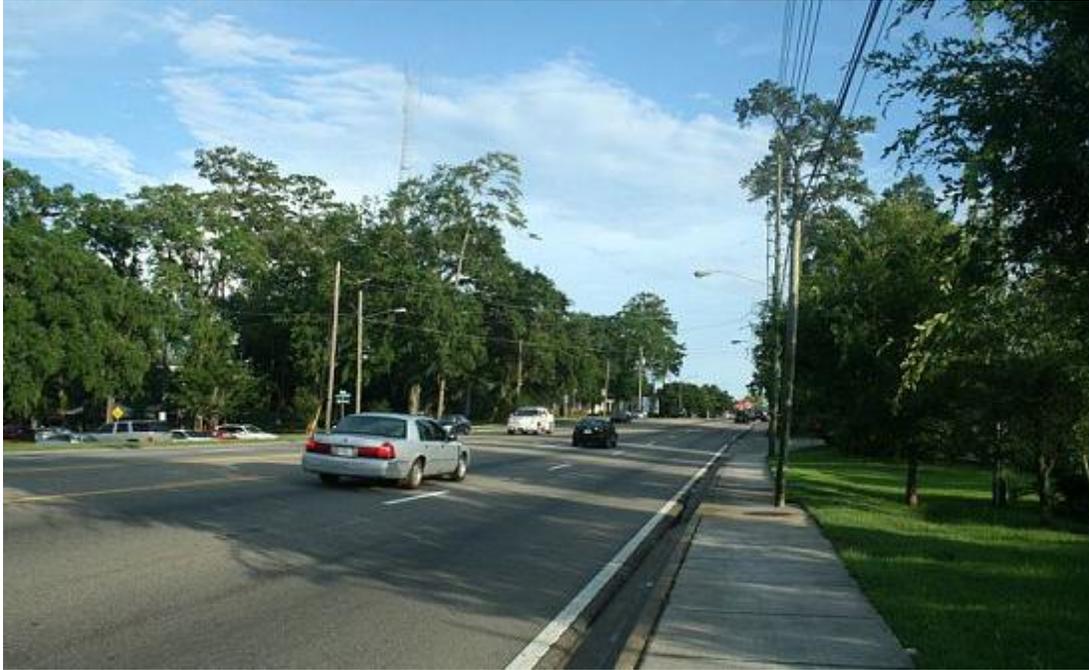
The distance between some intersections makes it difficult for pedestrians to cross Monroe Street and increases the possibility of pedestrians dangerously crossing in the middle of a block.

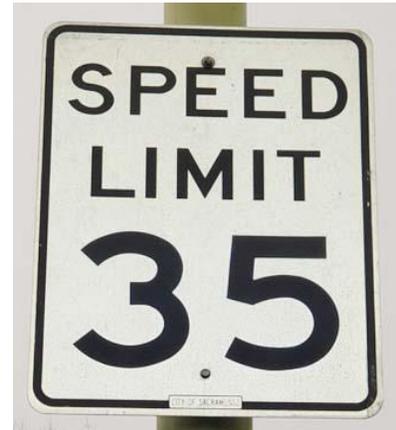
The general speed of vehicles travel along the corridor is well over 35 mph, which increases the risk of auto accidents as well as potential incidents with pedestrians. Vehicles traveling over the speed that has been designed for the roadway creates an issue with stop-and-go traffic in the area during rush hour, with many accidents being reported as rear-end collisions.

This section of North Monroe St needs speed enforcement on a regular basis.

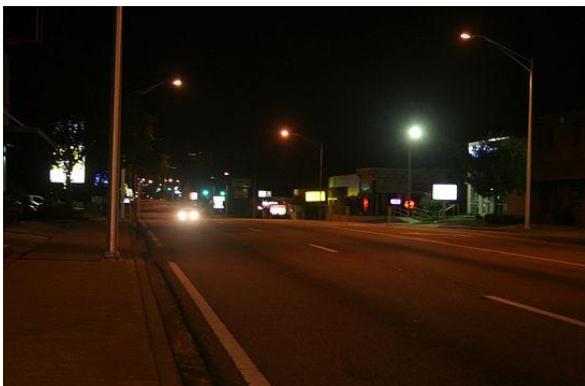
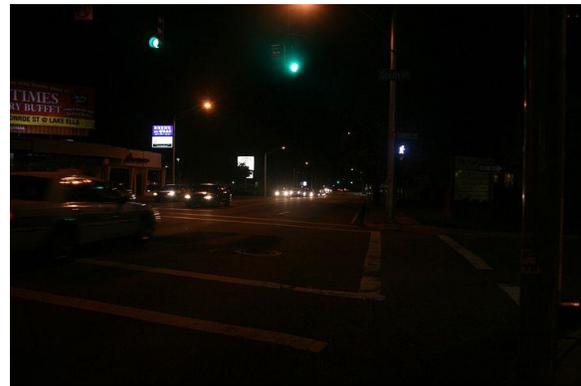
6th Ave crosswalk at night headed north

Other than the outdoor lighting from night-operated businesses, there is a lack of lighting at the human level along the entire corridor, which is a safety issue for any pedestrians walking on the sidewalks at night. This also increases the risk of vehicles not seeing pedestrians crossing the street at night.

Lighting other than the standard street lamps present should be added at the human scale to increase the safety and visibility of pedestrians at night. A well-lit road is safer for drivers traveling along the corridor.

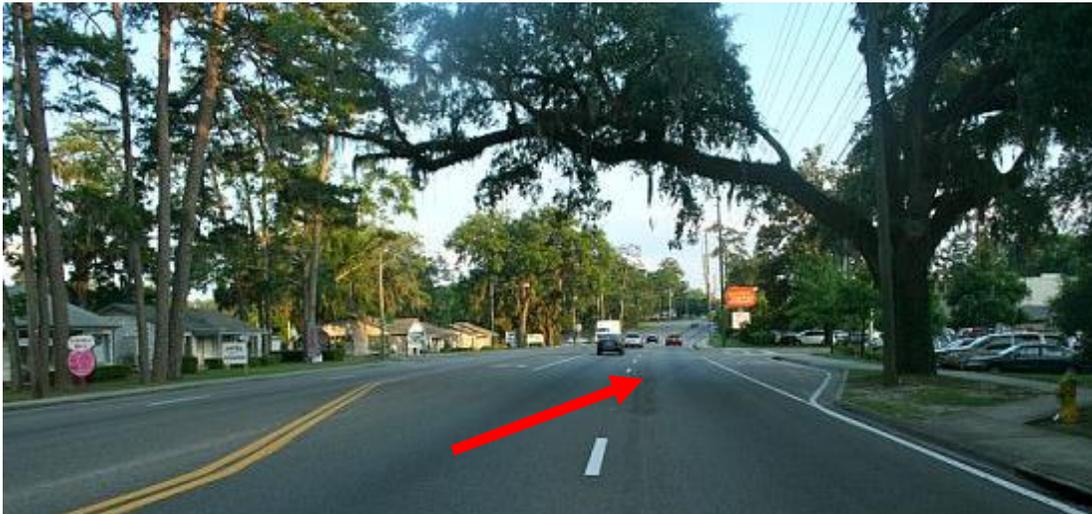
The right-turn-only lanes, such as at the Publix Shopping Center and the On the Border/Golden Corral restaurants, can lead to high speed turns, increasing the risk of auto and pedestrian accidents.

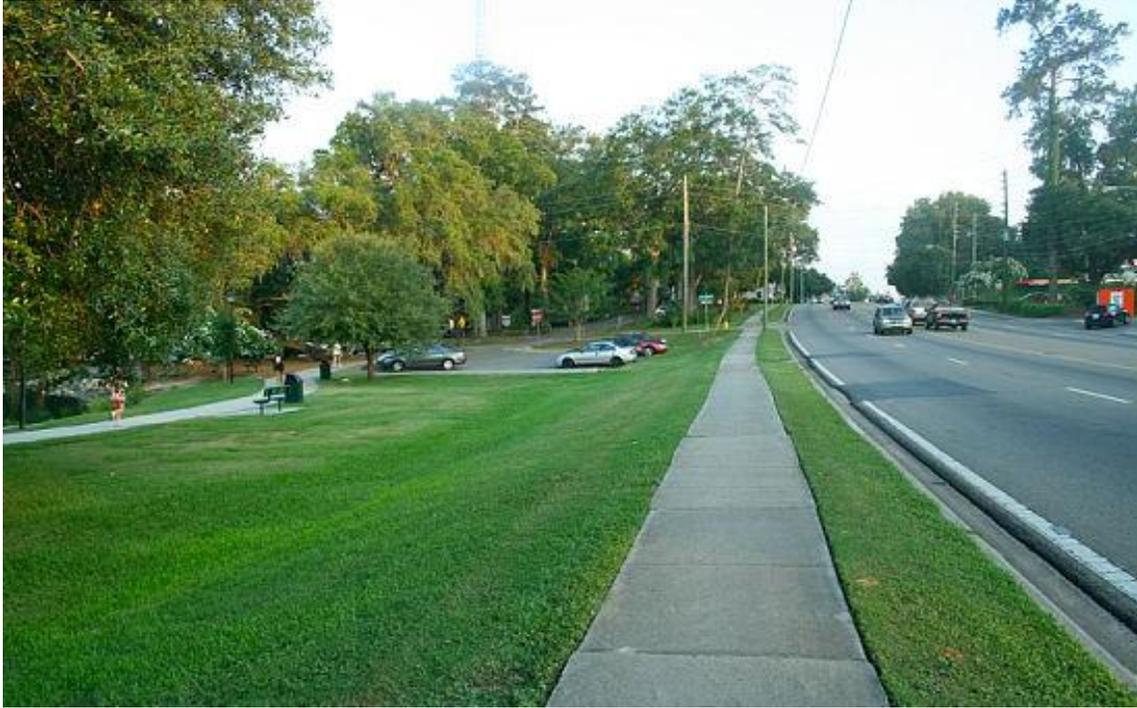
The sidewalk on the southeast side of Monroe St near Lake Ella is very narrow, making it difficult for two people to walk next to each other, much less cross paths with another person. If bicyclists happen to be riding on the sidewalk, this could also cause a passage issue.

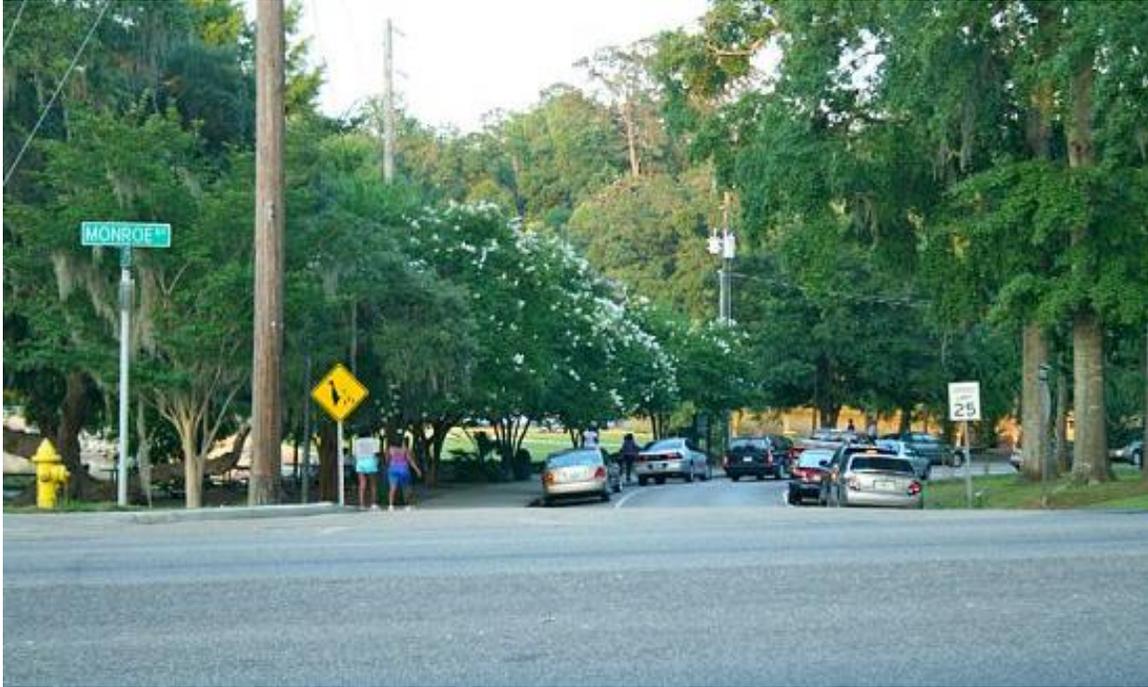
The lack of crosswalks at almost every side street in the area, including the Lake Ella entrance, reduces connectivity for pedestrians and can cause issues with drivers seeing pedestrians crossing.

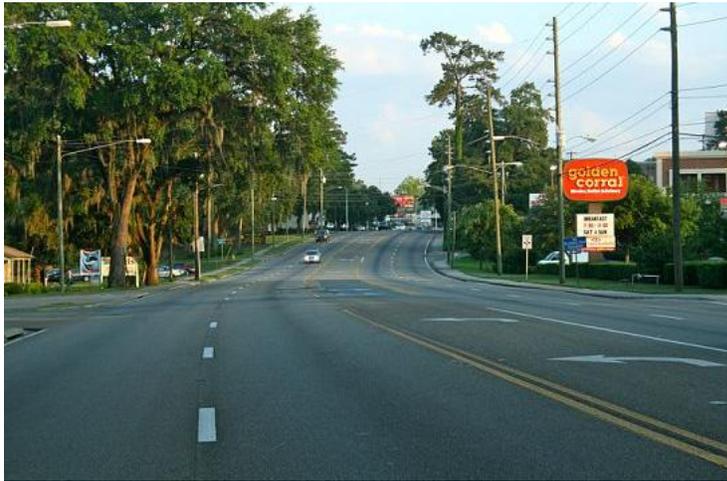
North Monroe St looking South

There is not any type of mid-block crossing between 7th Avenue and Tharpe Street, which increases the possibility of pedestrians dangerously crossing Monroe Street to access Lake Ella, as well as the other existing businesses in the area.

The pedestrian crossing experience from 7th Ave to Tharpe St could be improved with a raised protected median and crosswalks. A mid-block crossing could be installed near North and South Lake Ella, as well as Legion Street.

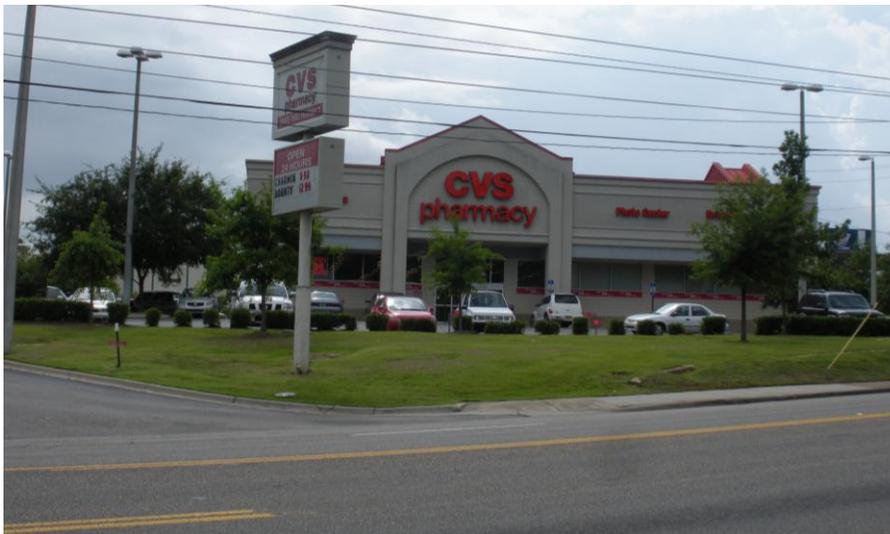
There is a lack of connectivity between the sidewalk and the CVS, as there is no direct pedestrian access from the crosswalks at Tharpe and Monroe Street. Pedestrians are forced to walk through the grass or in the driveway, which can be dangerous, especially with cars turning into the CVS at high speeds due to the right-turn lane.

Implement sidewalk infill to improve connectivity to CVS. The crosswalk should be marked and the turning radii should be reduced at the entrance of the CVS to decrease the turning speed into the driveway.

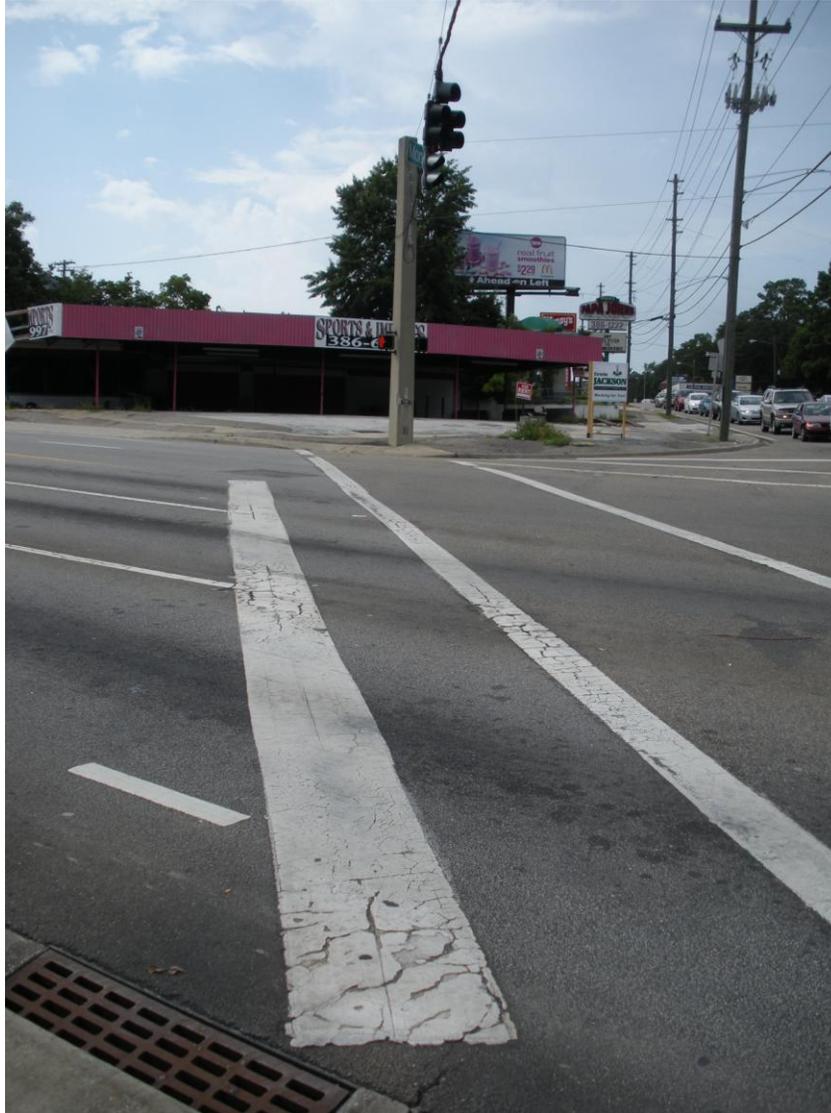
18. **Issue: Poor crosswalk condition**

The crosswalk on the west side of Tharpe Street is skewed, increasing the crossing distance and amount of time people are in the roadway. Pedestrian buttons are located too high on the signal pole at the crosswalk and this poses a problem for people in wheelchairs.

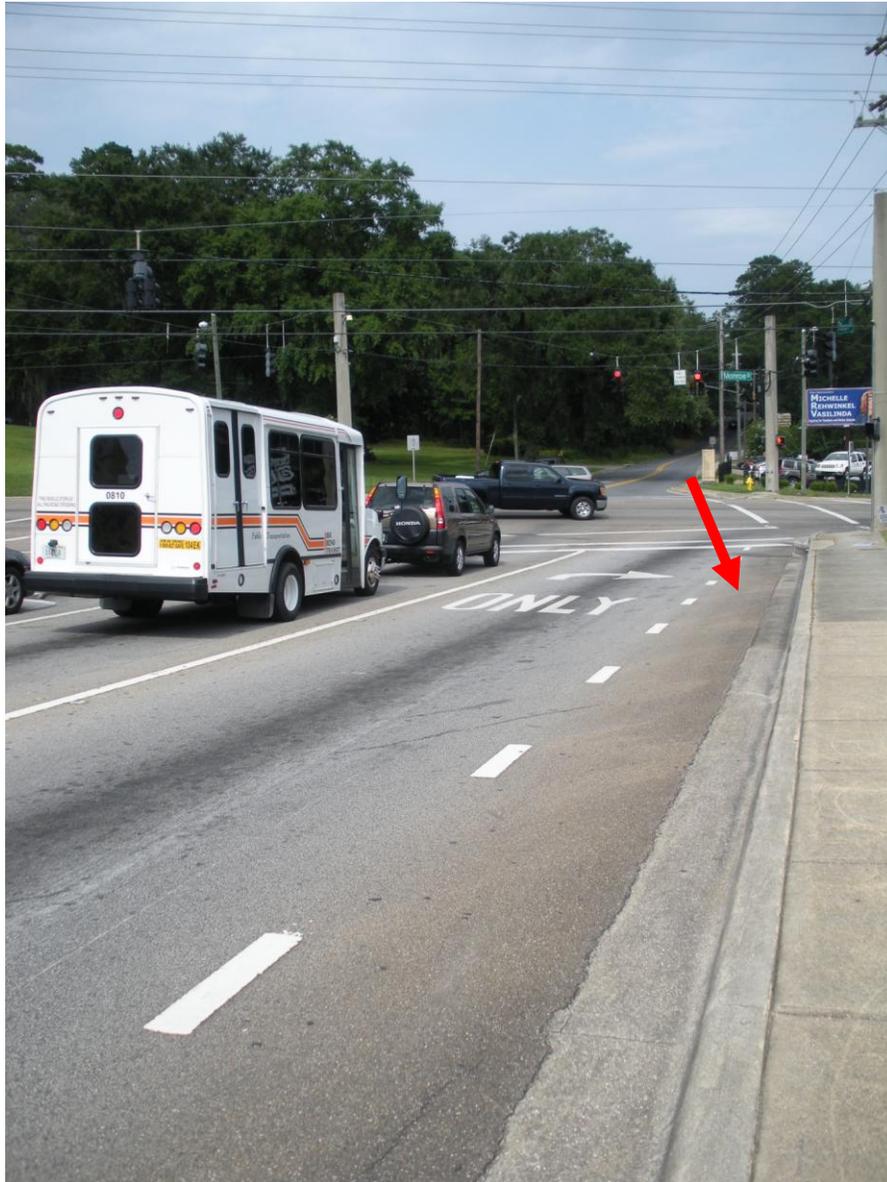
The bicycle lane on eastbound Tharpe St is to the right of the right-turn-only lane, which can lead to collisions between cyclists and vehicles.

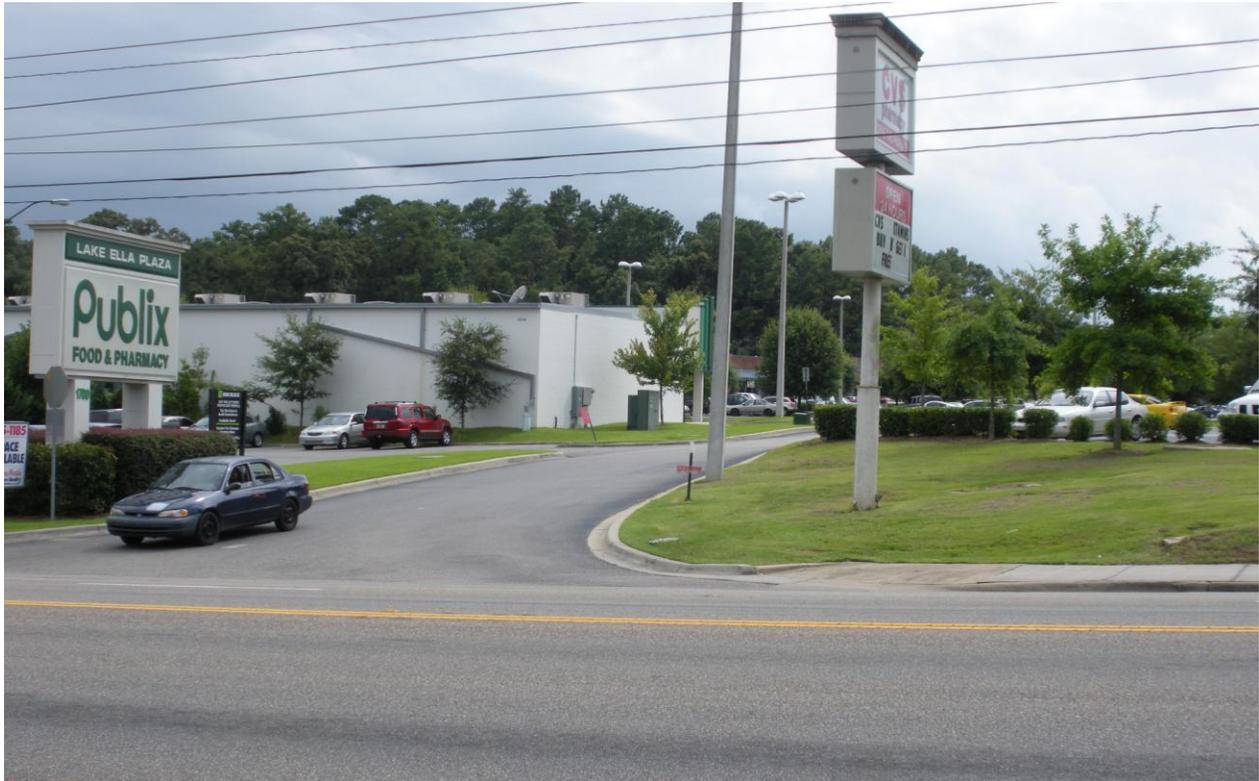
The outbound turn radii from the Publix Shopping Center onto Monroe St are very large which increases the exposure of pedestrians walking along Monroe, as well as the crossing distance. Moreover, the inbound radii are too large, allowing high speed turns into the Publix shopping center driveway.

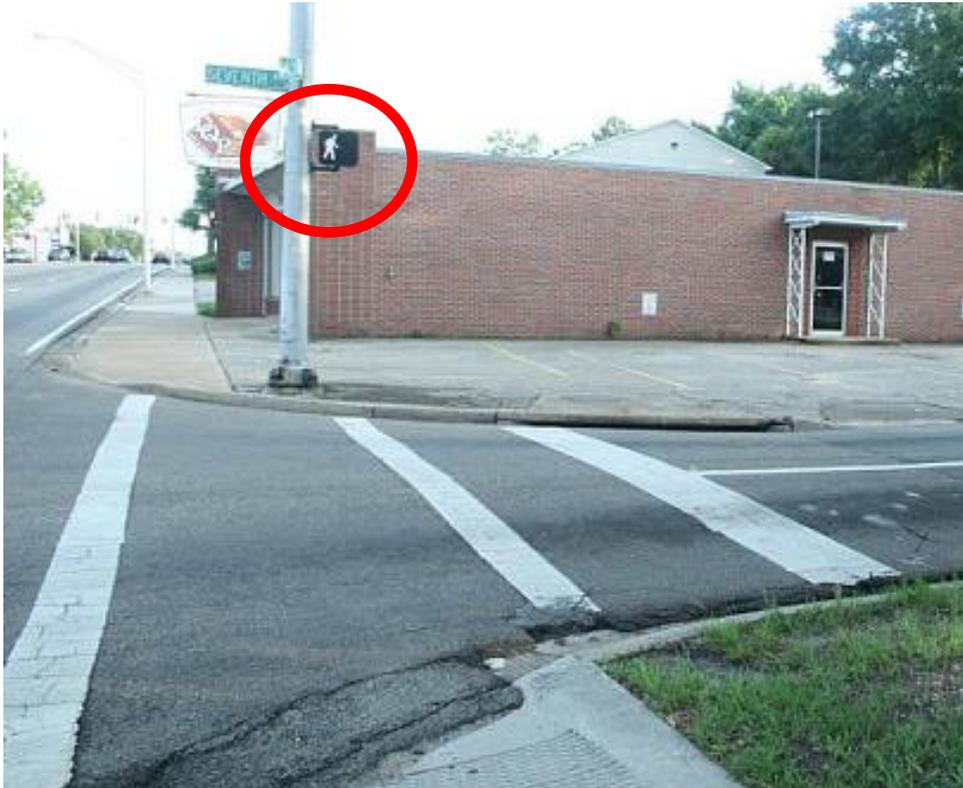
The crosswalk signal time across both North Monroe and 7th Avenue is short, which forces pedestrians to hurry when crossing, especially when vehicles are traveling faster than the posted speed.

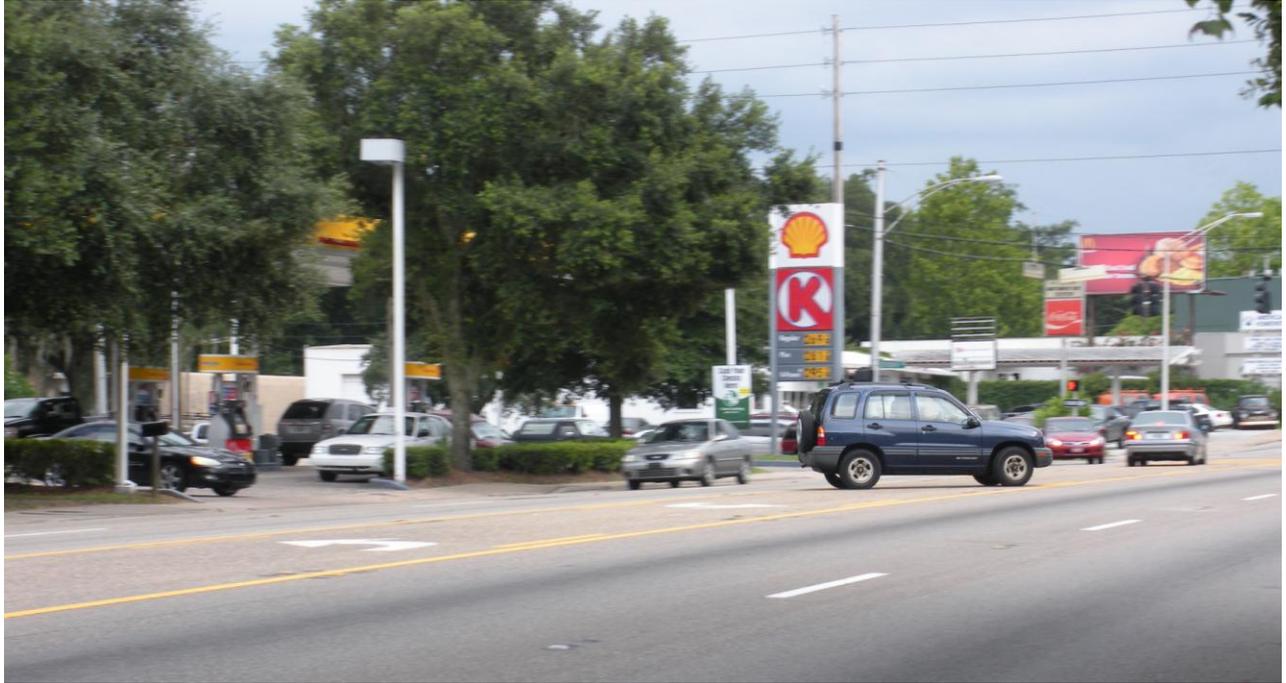
Multiple driveway entrances can increase the possibility of car crashes, especially when they are located close to intersections as they can create conflict points with traffic and vehicles leaving or accessing the Shell gas station/Circle K convenience store.

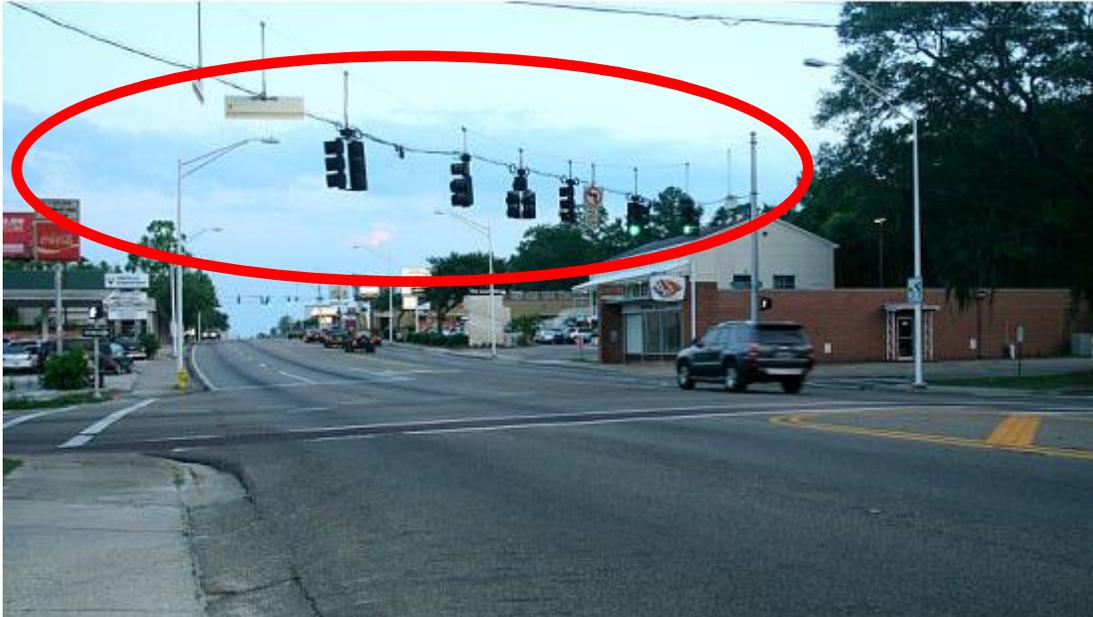
24. **Issue: Signal pole needs to be replaced**

The signal pole at 7th Ave has exceeded its expected life and is a danger to the traveling public, especially if heavy winds are present.

The signal pole should be replaced with a mast arm pole.

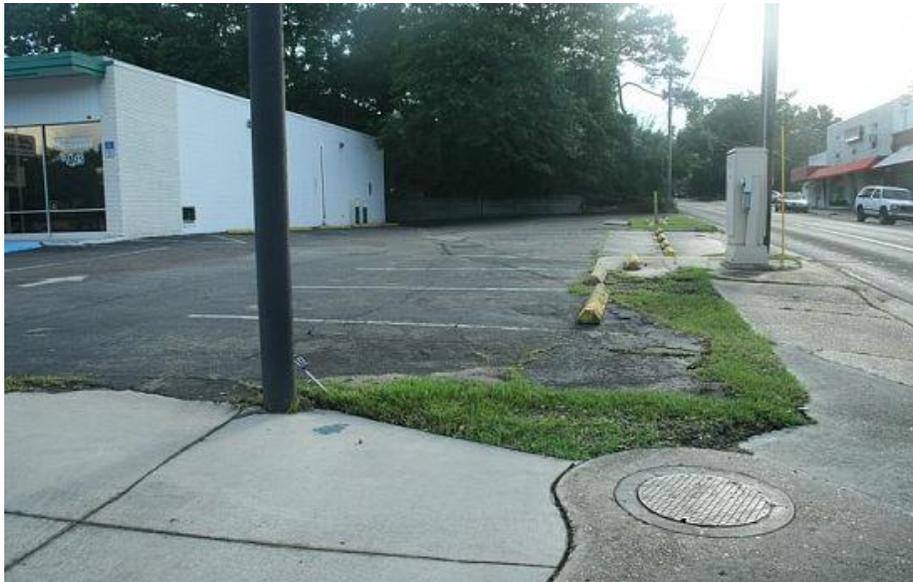
There is a lack of connectivity between the sidewalk and the businesses located on the west side of 6th Avenue, and curb ramps are missing on some of the corners.

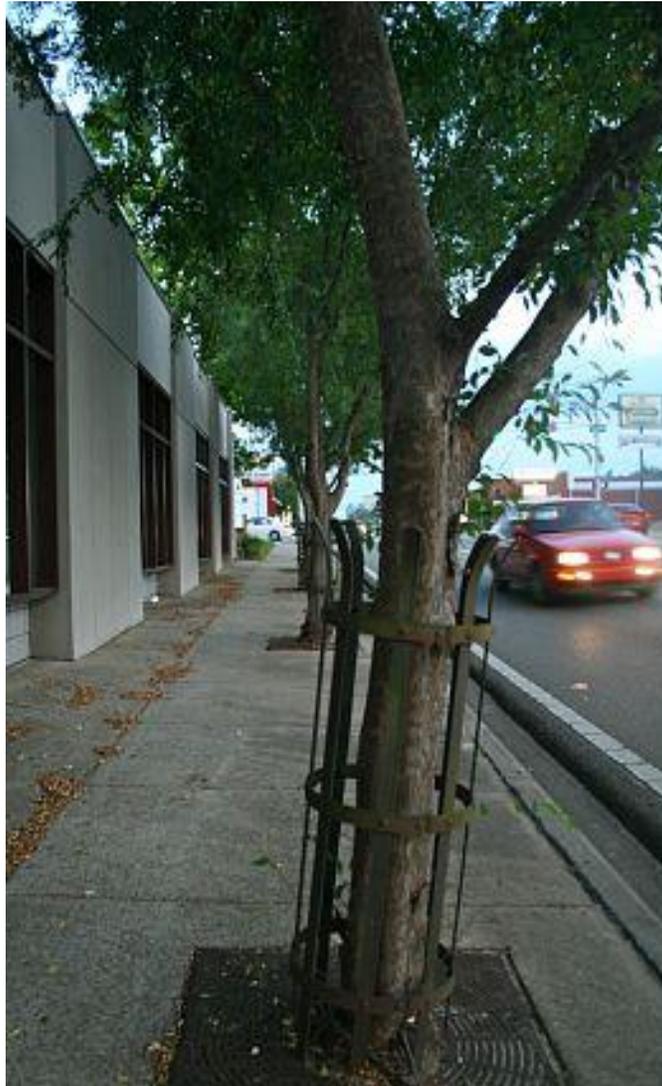
On the sidewalk in front of the Amedisys business, there are several trees that have grates around them. This is can be a problem for pedestrians who are visually impaired and can be “toe stumpers” for anyone.

If the trees are owned by the business, request that the grates be removed and possibly replaced with mulch or something less obstructive and less dangerous for pedestrians.

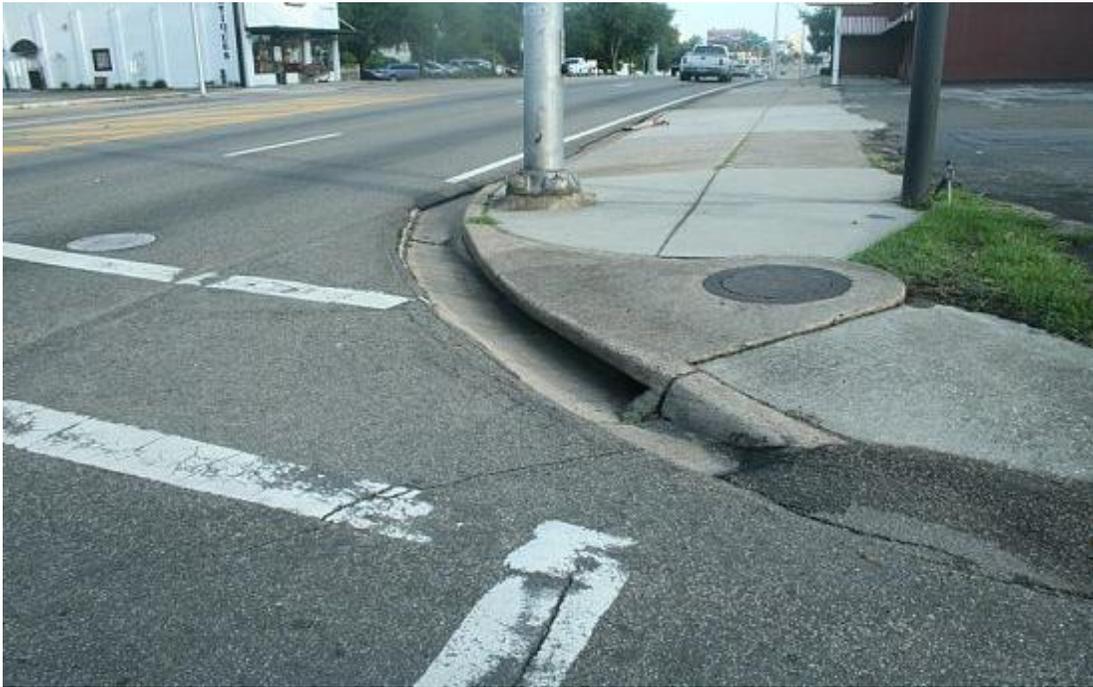
28. **Issue: Poor crosswalk conditions**

The crosswalk is skewed and does not match up to the curb ramps and on the southeast corner of 6th and Monroe Street the ramp faces the wrong way. The push button for pedestrians is too high on the signal pole and it is unclear which crossing will be activated.

The crosswalk should be repaved and appropriately oriented to improve its current poor condition and its connectivity. The push button for the pedestrian crossing should be placed adequately using ADA standards, and the crossing signals should be examined. A LPI (Lead Pedestrian Interval) would be effective on the left turn for traffic turning left onto 6th Avenue. A raised median nose could be placed on Monroe Street at this location to enhance the pedestrian crossing experience.
