North Monroe Street Design & Safety Study

Florida State University
Department of Urban & Regional Planning
Summer Studio 2010
Prepared for the CRTPA

| 2 Road Safety Audit Report..... | 7 |

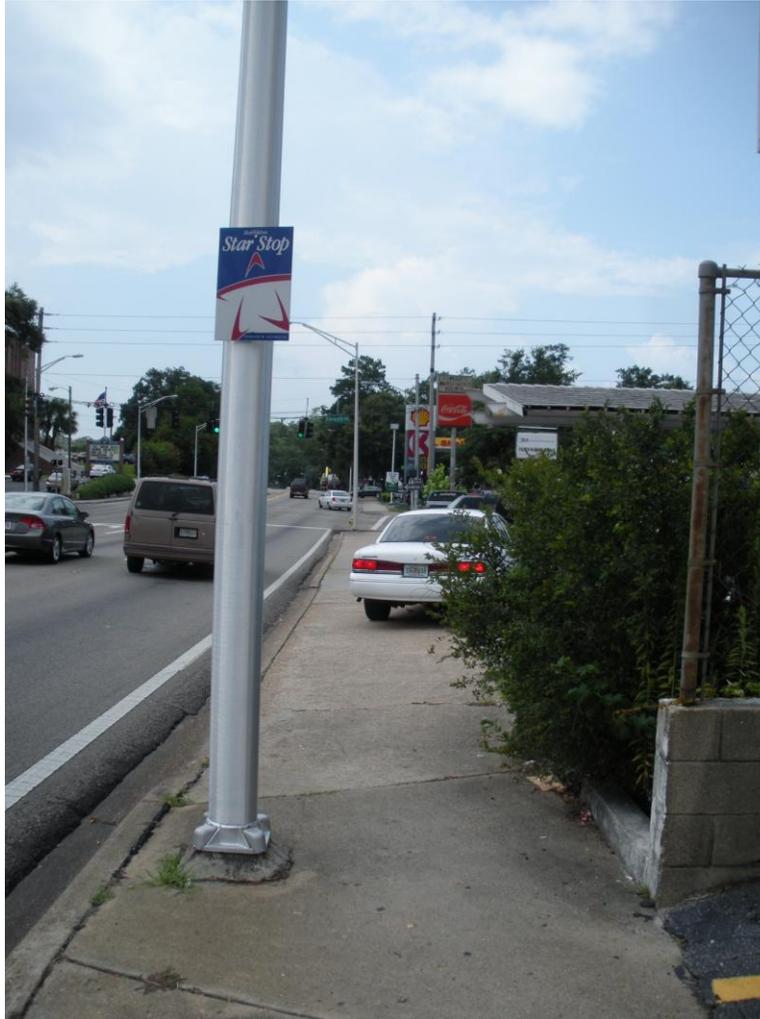
The bus stop between 6th and 7th Avenue does not have a shelter or pad to protect pedestrians from the sun or rain. This may also be an issue for drivers as they may not recognize the bus stop.

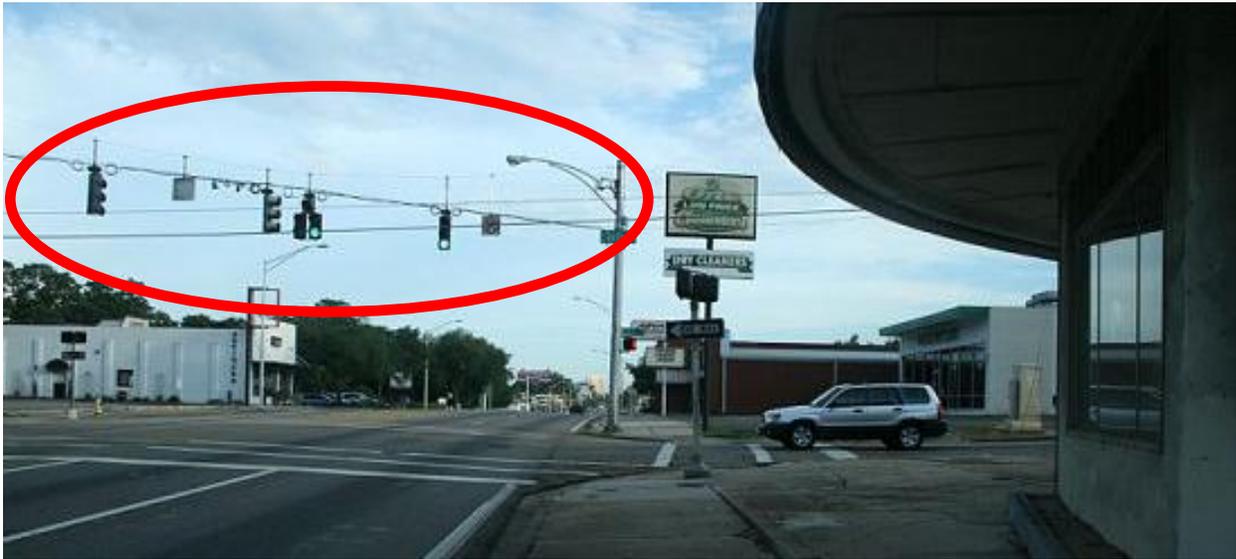
30. **Issue: Signal pole needs to be replaced**

The signal pole at 6th Ave has exceeded its expected life and is a danger to the traveling public, especially if heavy winds are present.

The signal pole should be replaced with a mast arm pole.

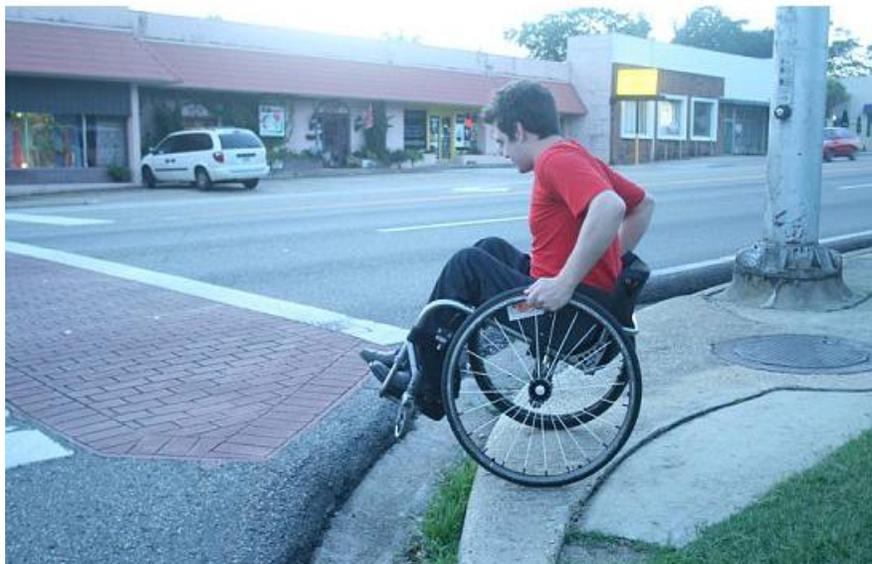
Curb ramps are missing at some quadrants, which make it unsafe for pedestrians, especially those in wheelchairs who may have some difficulty accessing the sidewalks when crossing the roadway.

Reconstruct crosswalk landings to include curb ramps that meet ADA requirements.

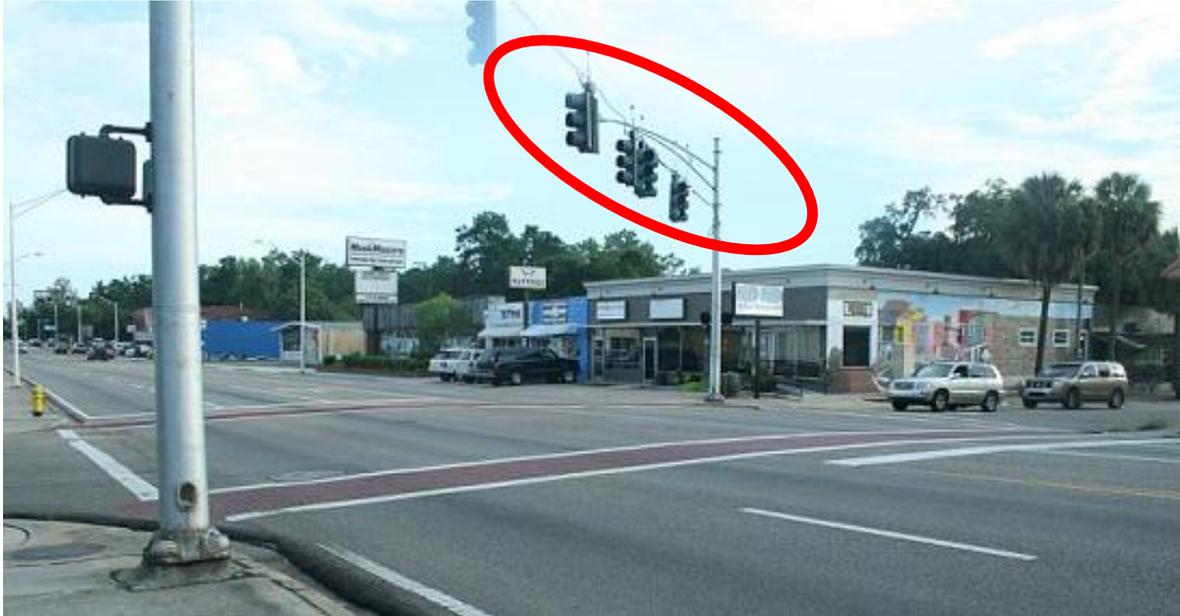
32. **Issue:** Signal pole needs to be replaced

The signal pole at 5th Ave has exceeded its expected life and is a danger to the traveling public, especially if heavy winds are present.

The signal pole should be replaced with a mast-arm pole.

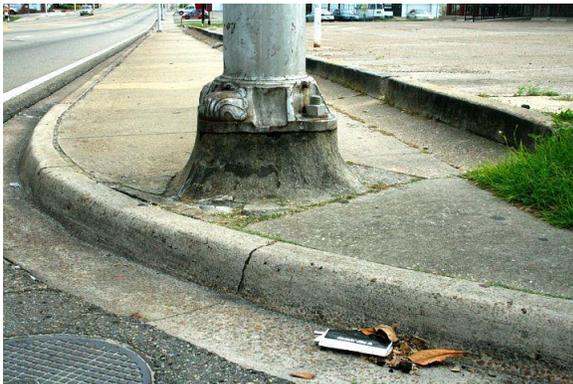
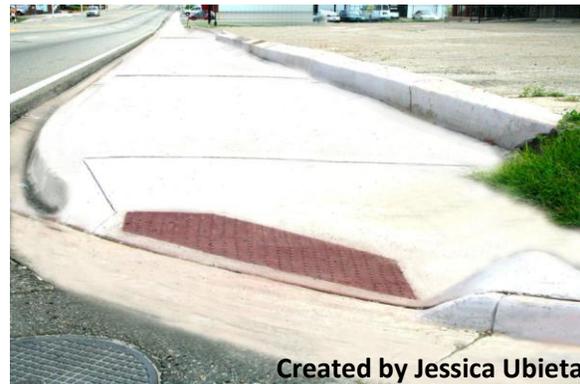
Rendering – Potential After

A lack of curb ramps at the intersection's crosswalks prevent connectivity of the sidewalks and are an issue for people in wheelchairs, on bicycles, pushing strollers, etc. who are trying to cross.

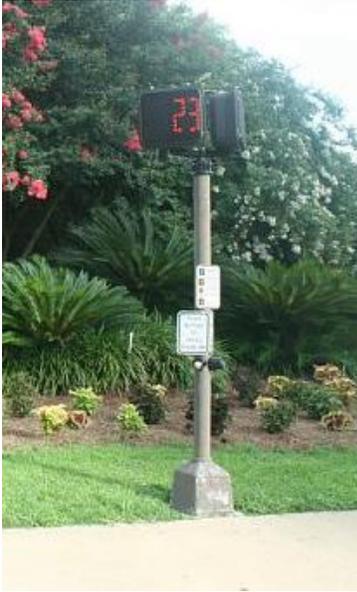
The cross signal timing when crossing 3rd Avenue is very short, forcing pedestrians to hurry across once crossing.

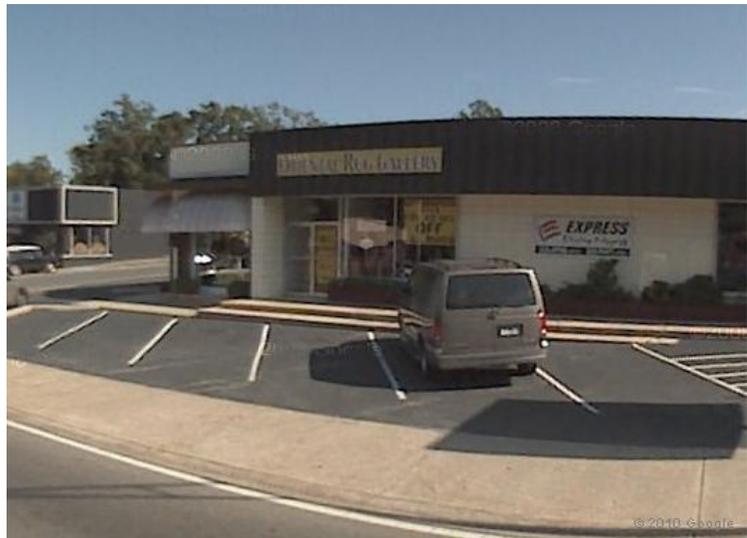
The front-in parking spaces at the Rag Junkie and Oriental Rug Gallery could be a safety issue for pedestrians or other vehicles when backing up.

Signage should be included in front of the parking spaces, warning drivers of potential pedestrians or traffic behind them when backing up.

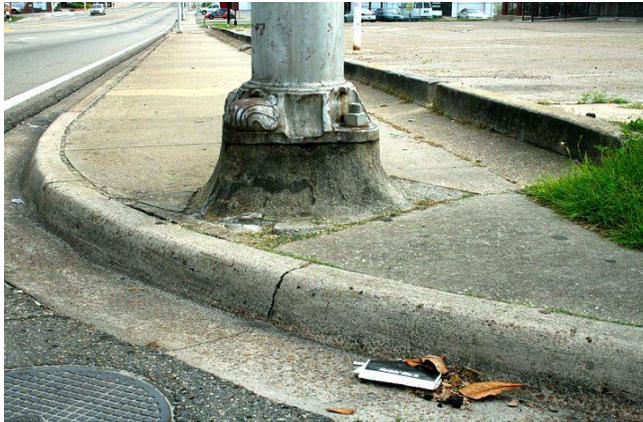
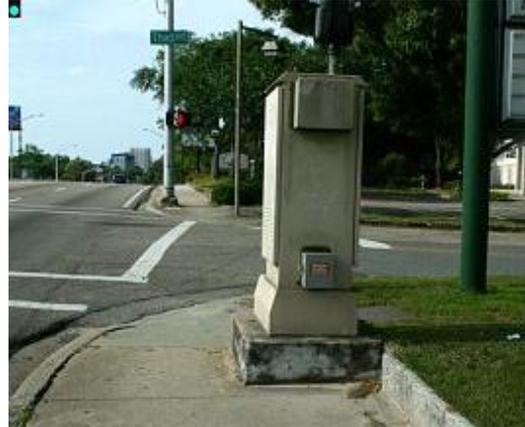
A utility pole in the sidewalk, located at the northeastern section of the intersection, makes it difficult to cross the street, much less navigate a wheelchair around. Also poorly located is a signal box in the sidewalk northwest of the intersection, presenting the same issues as the utility pole.

The utility pole and the signal box should be relocated to create a more passable sidewalk.

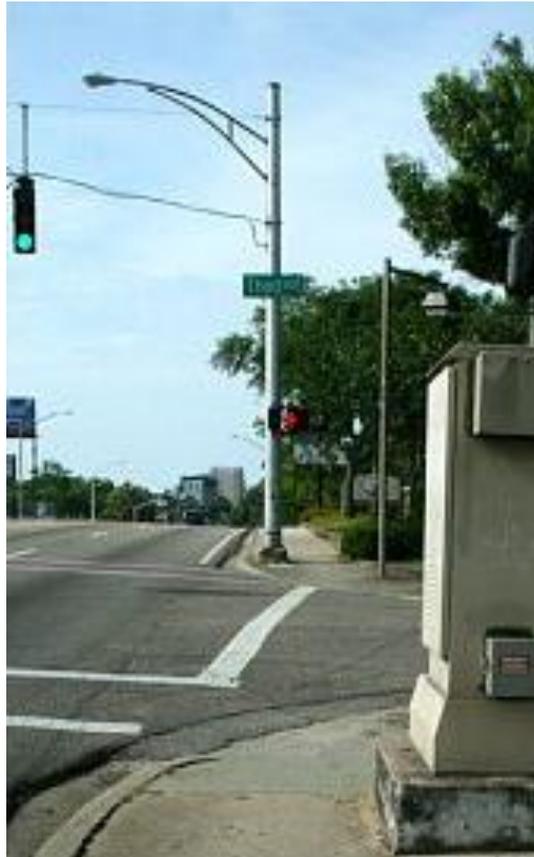
The signal pole at 3rd Ave has exceeded its expected life and is a danger to the traveling public, especially if heavy winds are present.

The signal pole should be replaced with a mast-arm pole.

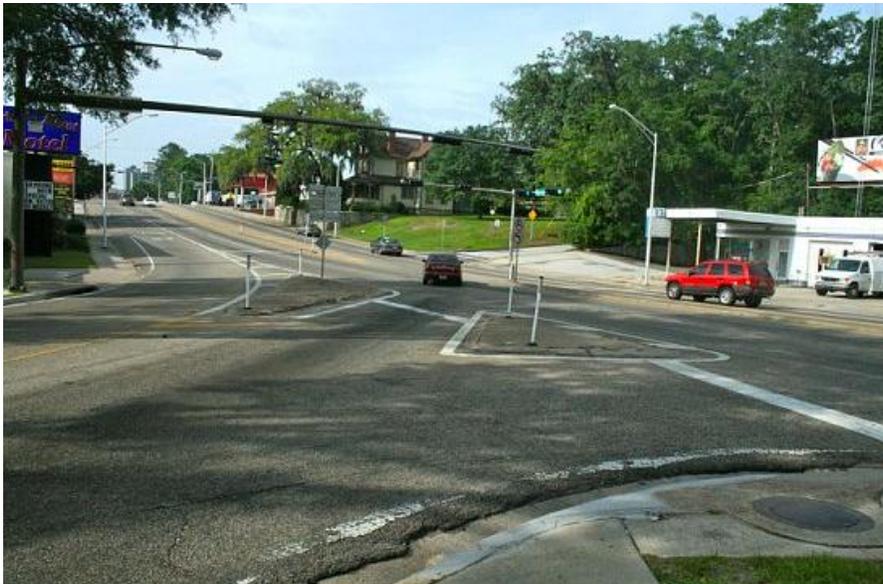
This intersection does not have any type of crosswalk or pedestrian facilities, which is dangerous for current pedestrians and the growing foot traffic entering the Midtown area.

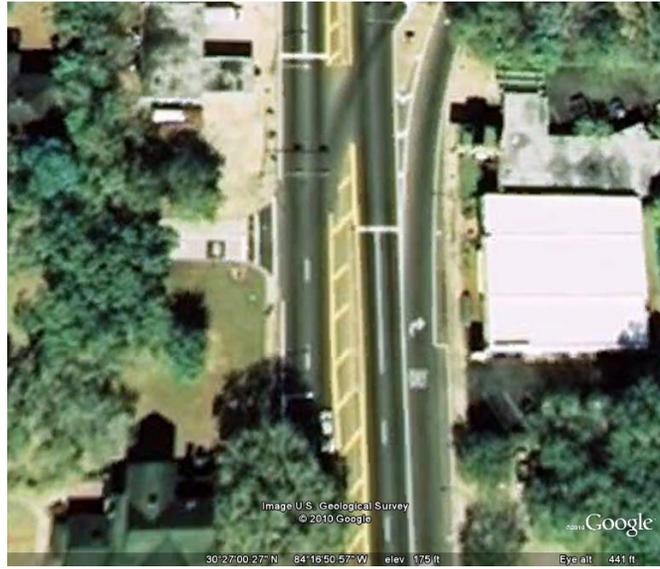
1ST AVE

Issue : No issues noted

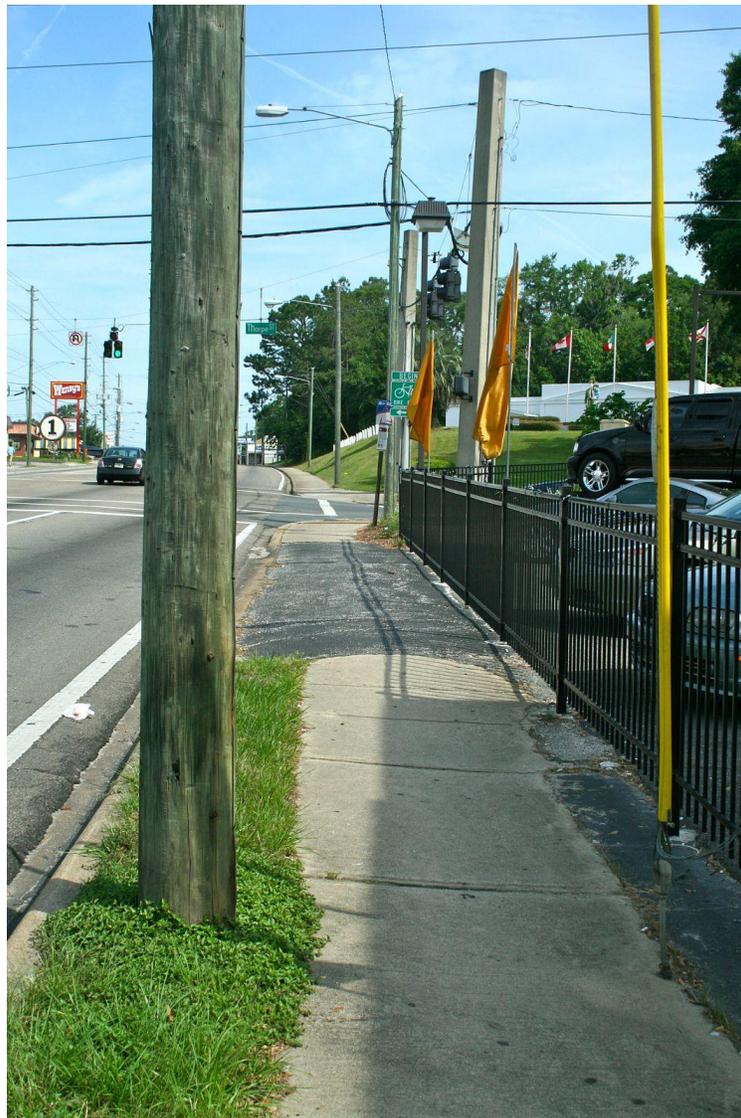
Figure 4.1: A portion of the Northwest sidewalk conditions within the Lake Ella District

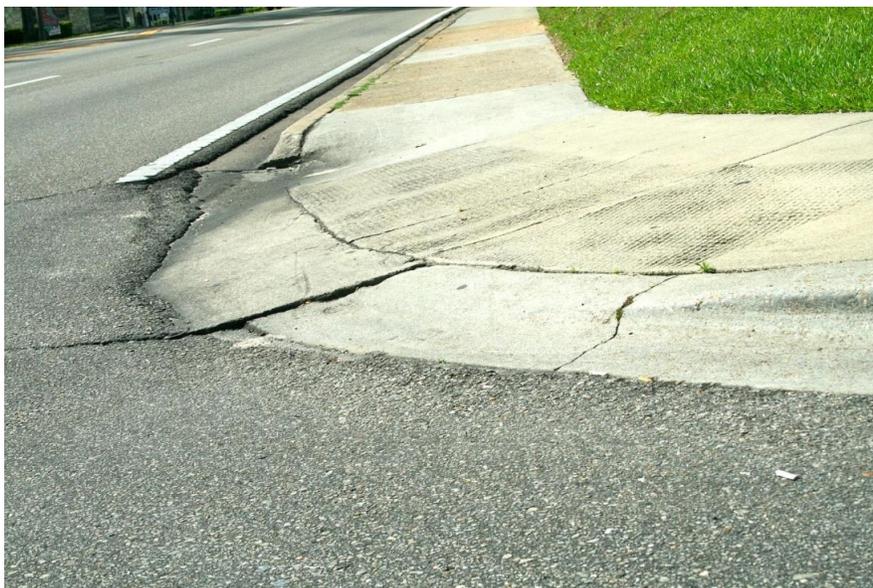
The curb ramps within the Lake Ella District on the west side of the roadway are mediocre at best. Figure 4.2 shows an example. Though some are well maintained or well marked, a great number are poorly positioned. In many cases the directional exit of the curb is into oncoming traffic, and is the only curb ramp for the bisecting intersection. Both the east and west sides have curb ramps that fail to have truncated domes to meet ADA guidelines. There are 18 curb ramps in the Lake Ella District, six of which are in poor condition for ADA accessibility as shown in Map 4.3.

Figure 4.2: Existing poor condition curb ramp within the Lake Ella District

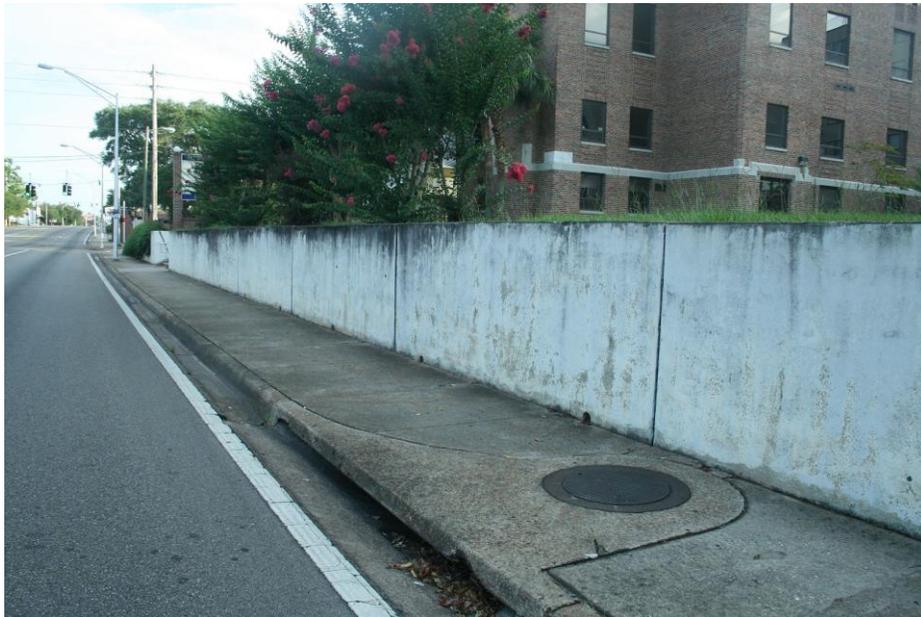
Figure 4.3: Existing wall located on North Monroe Street in front of the Senior Center

Along the front of the Tallahassee Senior Center is a concrete wall (See Figure 4.3) that is currently unattractive in both appearance and in comparison to its surroundings. Chipped and degenerated, the wall needs improvements aesthetically.

As seen in Figure 5.4, Music Masters has already taken the steps to use wall space for advertisement with their artistic musical mural on the side of their business; the wall located from 7th Avenue to 8th Avenue in front of the Senior Center is an ideal location for aesthetic enhancements.

The wall spans half a block and has great potential to bring a sense of identity and place to the corridor by enhancing it with local art. This location is in close proximity to Lake Ella, as well as Midtown, providing an opportunity to depict the transition from one district to another through the use of art. A mural depicting Lake Ella, or the signature canopy roads of Tallahassee, could serve as a transition between the Lake Ella and Midtown Connector Districts, reminding residents and visitors of the unique beauty that surrounds them. In order to involve the Tallahassee community, this alternative is suggested because it would call for recommendations for artistic ideas from local artist. This would not only cut costs of hiring outside individuals for such projects, but would also provide a sense of hometown support for local artists and their ideas. This has been a useful tool in Gainesville, Florida with such projects as the Martin Luther King, Jr. Multipurpose Center that consists of a mural done by a Gainesville local depicting several sports achievements within the city. The mural was placed in this location to encourage children, teens, and adults to look around their community and notice that “there are endless opportunities ahead” with hard work and perseverance (Division of Cultural Affairs).

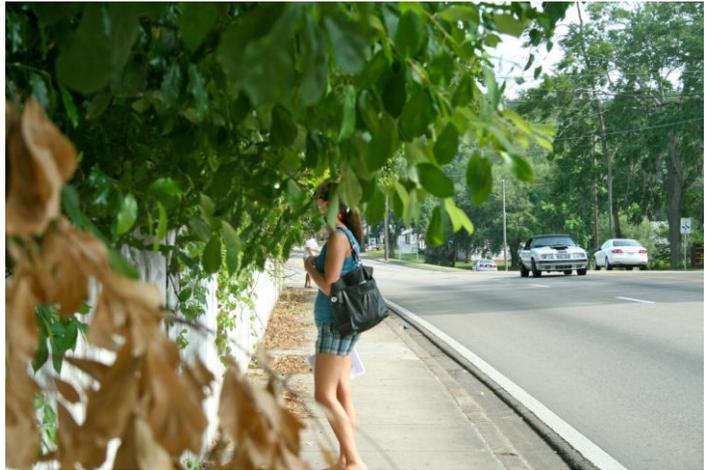
Figure 4.4: Poorly maintained landscaping

Continuing south to the Senior Recreational Center on 7th Avenue is an example of poorly maintained vegetation as shown in Figure 4.4. The trees and shrubs within this area have become overgrown, and are intruding on the walkway creating a negative experience and safety hazard for pedestrians and bicyclists. Overhanging tree branches into the roadway though are not currently a threat.

However, during severe weather the danger of the trees breaking into the road is escalated. The eastern portion of Monroe Street is well-shaded with a great deal of native vegetation. However, as was previously mentioned, the sidewalk conditions are poor along this stretch so the natural foliage cannot be enjoyed by pedestrians.

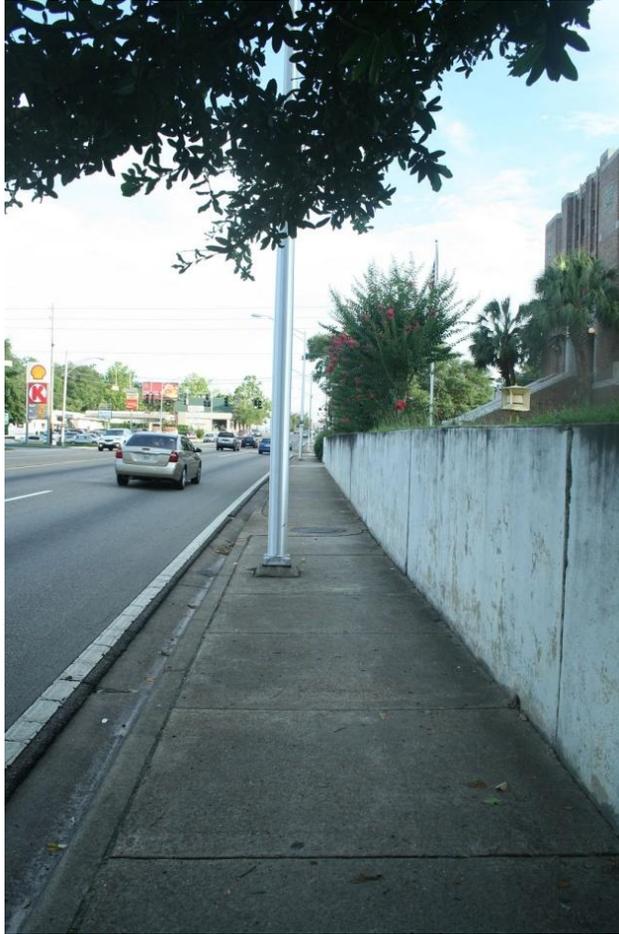
Figure 4.5: Example of poorly placed light pole impeding pedestrian traffic-flow

The current lighting within the Monroe Street corridor has been constructed to encourage vehicular traffic, and does not promote pedestrian traffic or safety. Increasing uniform lighting standards within the city that includes a combination of human scale vertical lighting as well as coinciding horizontal fixtures on businesses would improve the perspective of the area. Lower-hanging fixtures enhance the perceived safety of an area, and endorse pedestrian mobility. The current light poles also hinder the ability of bicycle and pedestrian mobility on sidewalks due to their placement in the middle or near center of walkways, Figure 4.5 shows an example of this.

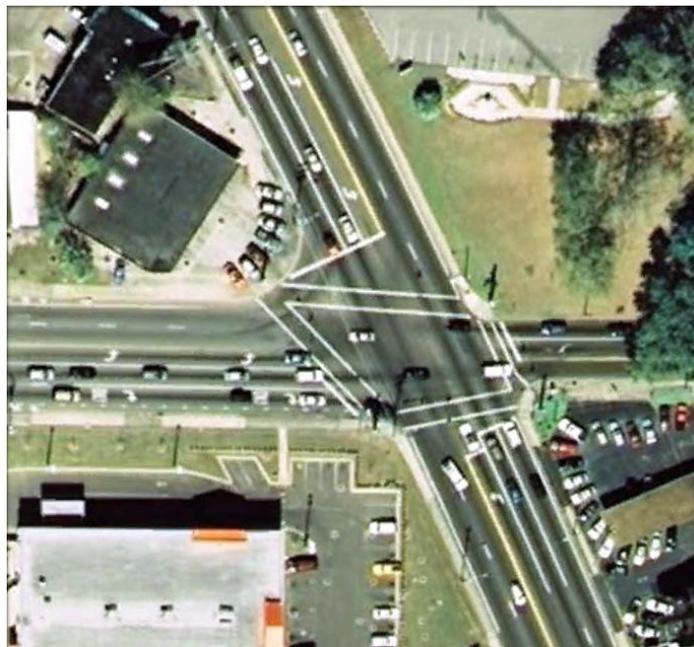
Figure 4.9: North Monroe Street at Tharpe Street

Due to the skewed angle of intersection that is visible in Figure 4.9, the western and northern crosswalk distances far exceed any other along the corridor, placing the pedestrian in the roadway for an extended period of time. However, pedestrian signals are provided at every corner to regulate the timing of the pedestrian crossings.

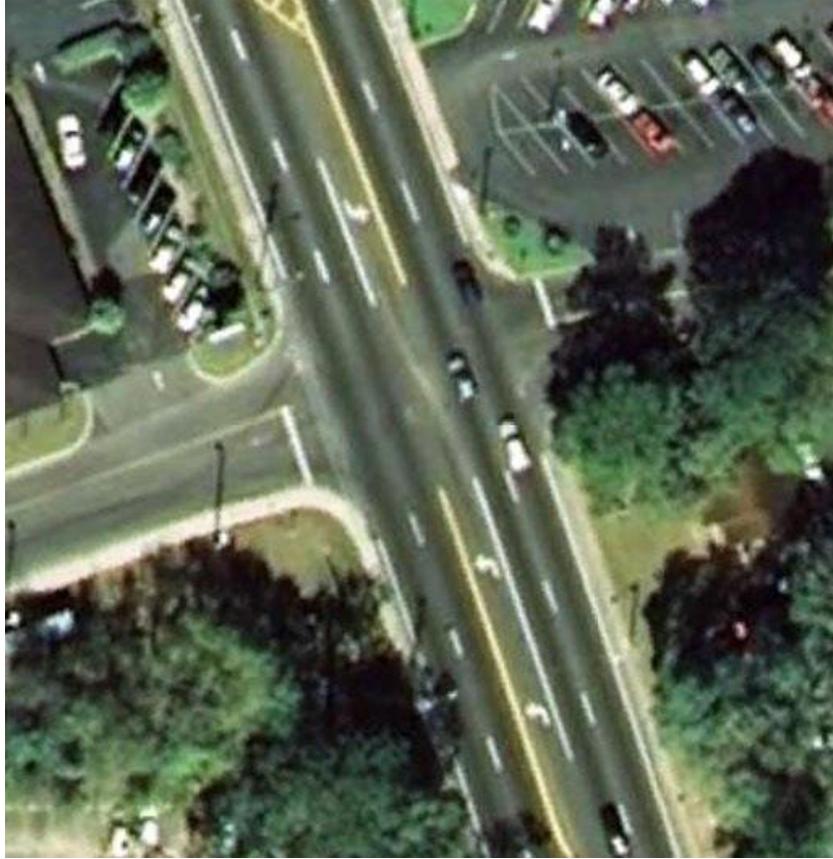
Figure 4.10: North Monroe Street at Lake Ella Drive

This stop-controlled intersection is the northern entrance to Lake Ella Park. Lake Ella Drive is a two-lane road with traffic traveling both ways. Being so close to the park, it is intriguing that there is no crosswalk at this intersection as shown in Figure 4.10. The curb radii at this intersection are within the Florida Intersection Design Guide’s Section 3.13.1 and PEDSAFE recommendations, as seen in Table 4.3.

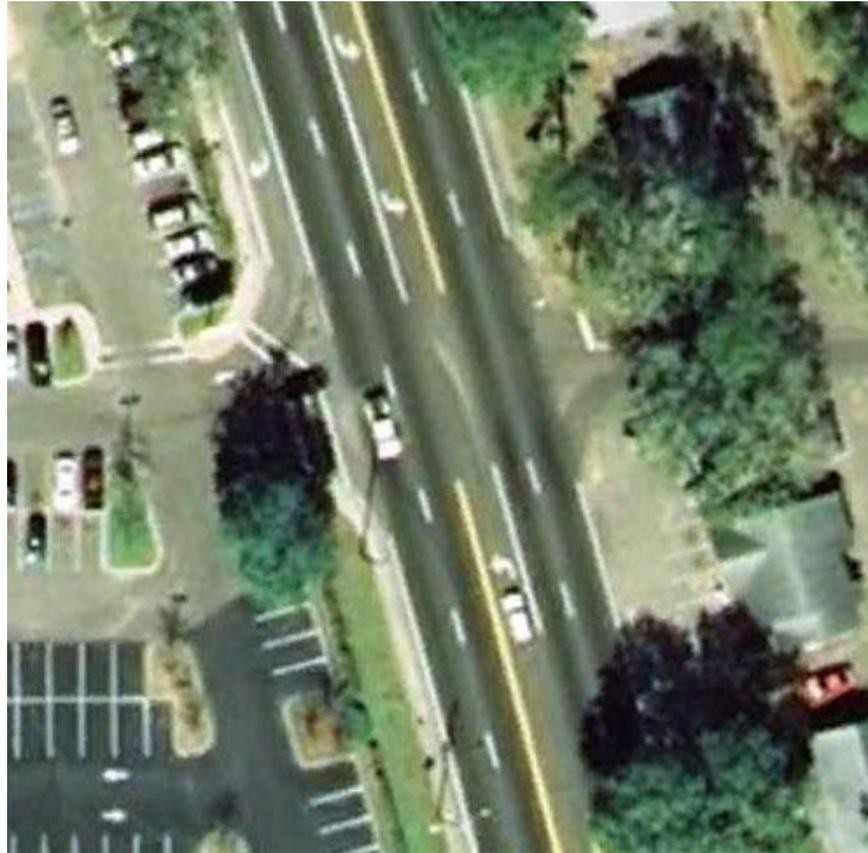
Figure 4.11: North Monroe Street at Legion Street

Legion Street is a small two-lane road that previously connected to Lake Ella Drive, but is now closed to through traffic. This side street is currently utilized as access to parking for the cottage shops at Lake Ella. As seen in Figure 4.11, there is also no crosswalk present at this stop-controlled intersection, which is home to frequent pedestrian traffic. The distance from sidewalk to sidewalk is 56 feet, where a crosswalk would be present. The curb radii here are also surprising, as the northern radius is 23 feet, and the southern is 29 feet, 7 inches, also seen in Table 4.4. The former barely fits within the guidelines set by the PEDSAFE project and the *Florida Intersection Design Guide*, and the later exceeds it by 4 feet, 7 inches. This is not typical for an area with relatively strong pedestrian traffic. Also, given that there is no traffic signalization, it also does not have a pedestrian signalization.

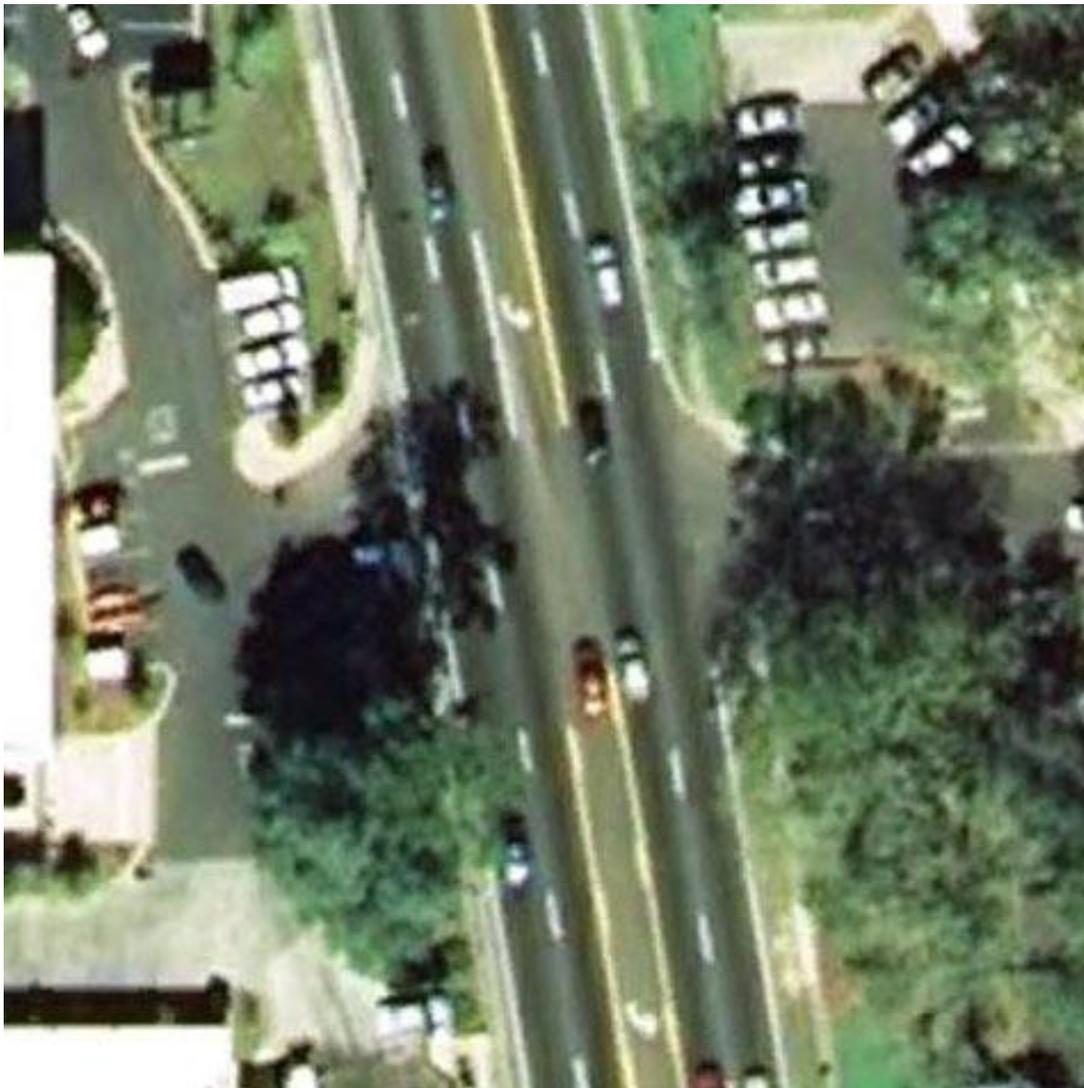
Figure 4.12: North Monroe Street at South Lake Ella Drive

This intersection, which can be viewed as an aerial photograph in Figure 4.12, serves as the southern entrance to the popular pedestrian destination, Lake Ella Park. This entrance only allows traffic flowing one-way eastbound into the park. This eliminates the need for any type of traffic regulation device, as no one is exiting the road onto the arterial roadway. Surprisingly there is not a crosswalk present at this intersection either, meaning that all three park-access roads where a large portion of the corridor's pedestrian activity is located, are without marked

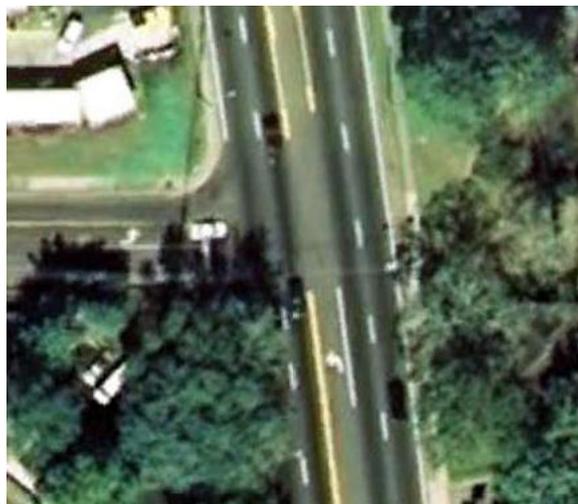
Figure 4.13: North Monroe Street at 8th Avenue

North Monroe Street at 8th Avenue is a stop-controlled intersection, seen in Figure 4.13, which enters the corridor from the west side. It is a two-lane road with traffic traveling eastbound and westbound and does not completely intersect the main arterial. There are no turn prohibitions, and the intersection lacks any crosswalk features to connect the north and south ends of the sidewalk. The measurement for the roadway that would function as a crosswalk is 51 feet 6 inches. As seen in Table 4.6, the curb radii for this intersection are on the upper end of, and even exceed what the acceptable range of 15 to 25 feet. The southern radius is 25 feet 9 inches and the northern radius is 24 feet 2 inches. This is uncharacteristic of a road of this type in this setting. Also, since there is no traffic signal there are also no pedestrian signals present. This intersection requires more features to make it pedestrian friendly.

Measurements were taken of the entire roadway at this point, just north of the intersection. The measurement from the eastern sidewalk to the curb is 7 feet, the western sidewalk to the curb is 11 feet, 5 inches, and the traveled roadway measurement is 64 feet, 10 inches. Combined, this provides a total width of 76 feet, 10 inches.

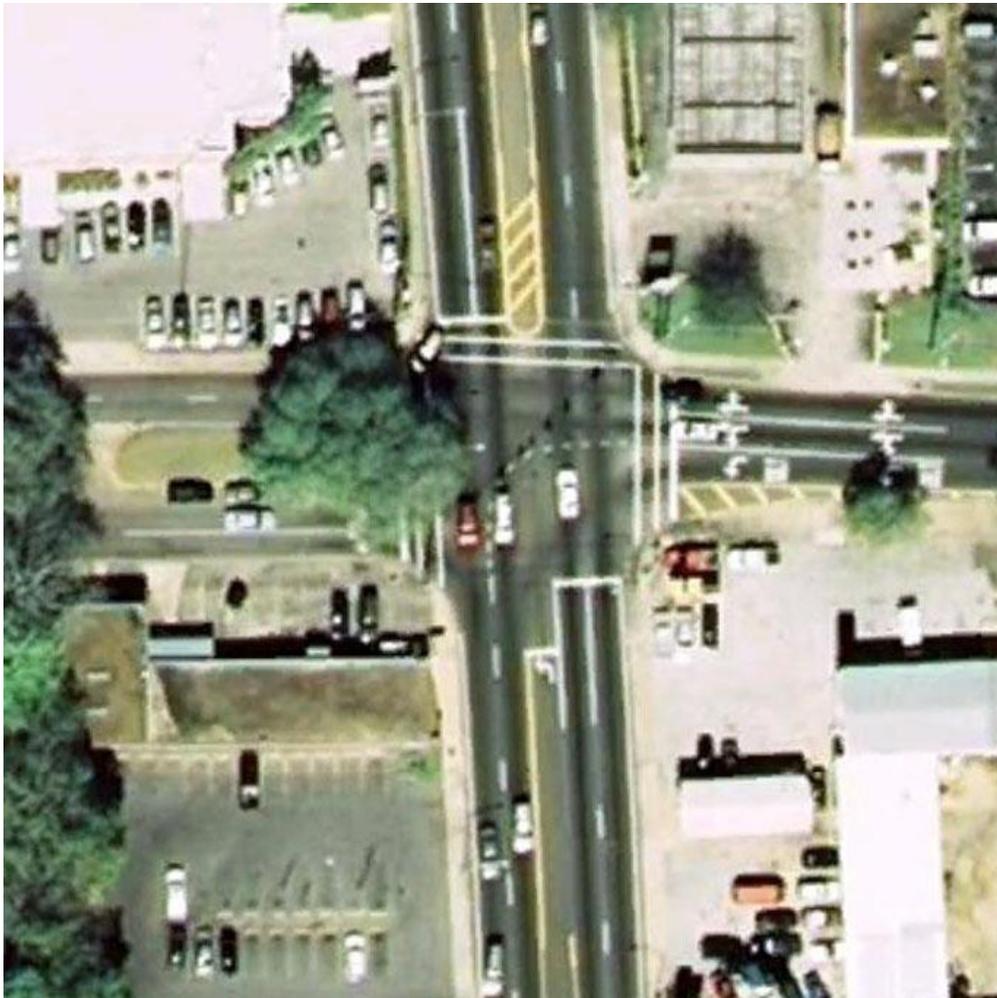
This lack of a crosswalk on the southern portion of the intersection, as visible in Figure 4.17, effectively means that a pedestrian would have to travel 197 feet and cross twelve lanes of traffic to cross from the southwest corner to the southeast corner. The same pedestrian would only have to travel 71 feet, 4 inches and cross five lanes of traffic, were a crosswalk present. These existing conditions result in significantly more time in the roadway. All of the marked crosswalks are regulated by pedestrian signals.

Figure 4.17: North Monroe Street at 7th Avenue

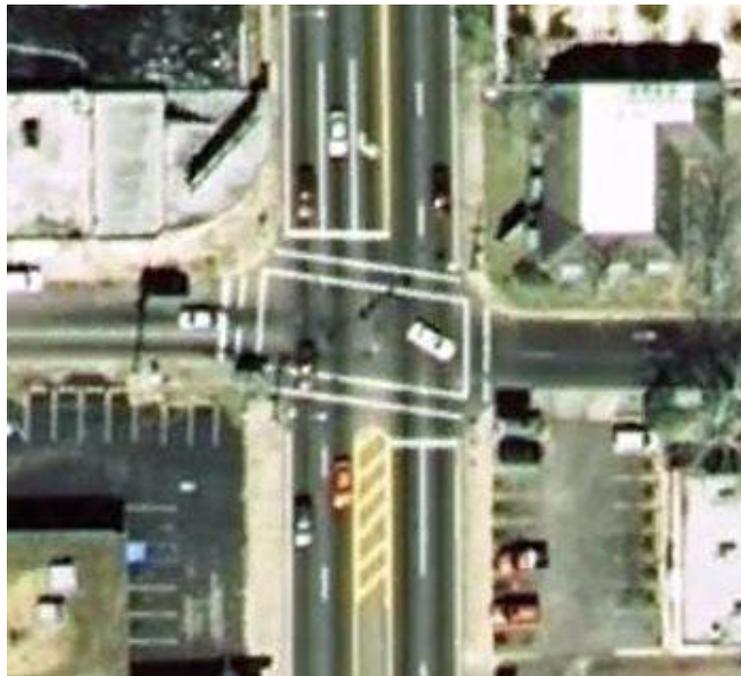
Figure 4.19: North Monroe Street at 6th Avenue

The geometry of this intersection could require some improvements to the crosswalks traversing North Monroe. As visible in Figure 4.19, they are currently skewed on the northern and southern portions of the intersection and could be squared to a right angle to reduce the distance, thereby reducing the amount of time pedestrians spend in the intersection. Pedestrian signals are present in this intersection to help regulate the movement of pedestrians crossing the roadways.

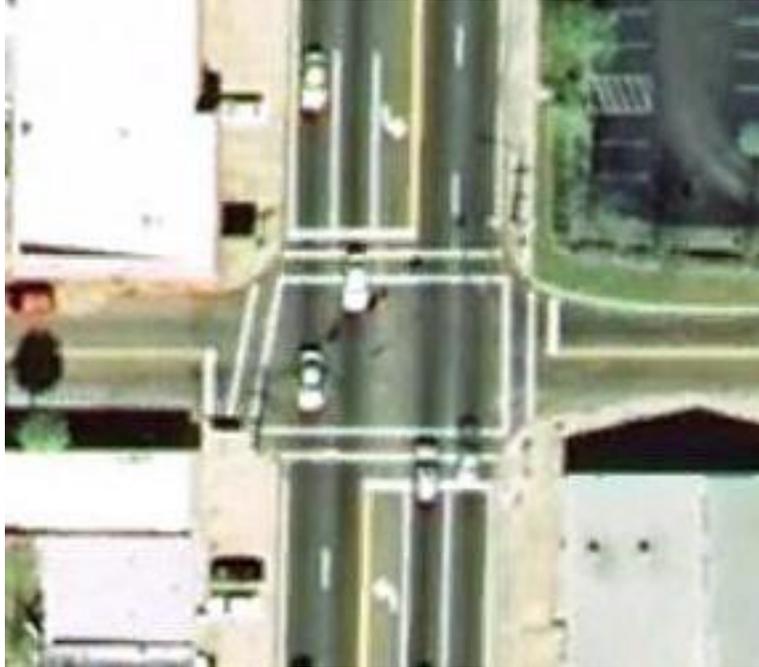
Figure 4.20: North Monroe Street at 5th Avenue

The curb radii listed here meet all the guidelines set forth by the *Florida Intersection Design Guide* and PEDSAFE. The crosswalk measurements are as follows and can be seen with the other intersection measurements in Figure 4.20:

The geometry of this intersection also closely resembles a right angle, though the western crosswalk is a bit elongated due to a slightly skewed intersection angle as seen in Figure 4.20. Pedestrian signalization is also present on all crosswalks; however three of the eight signals are currently not functioning properly and are not illuminated. These signals can be seen in red on the North Monroe and 5th Avenue intersection diagram, Figure 4.21.

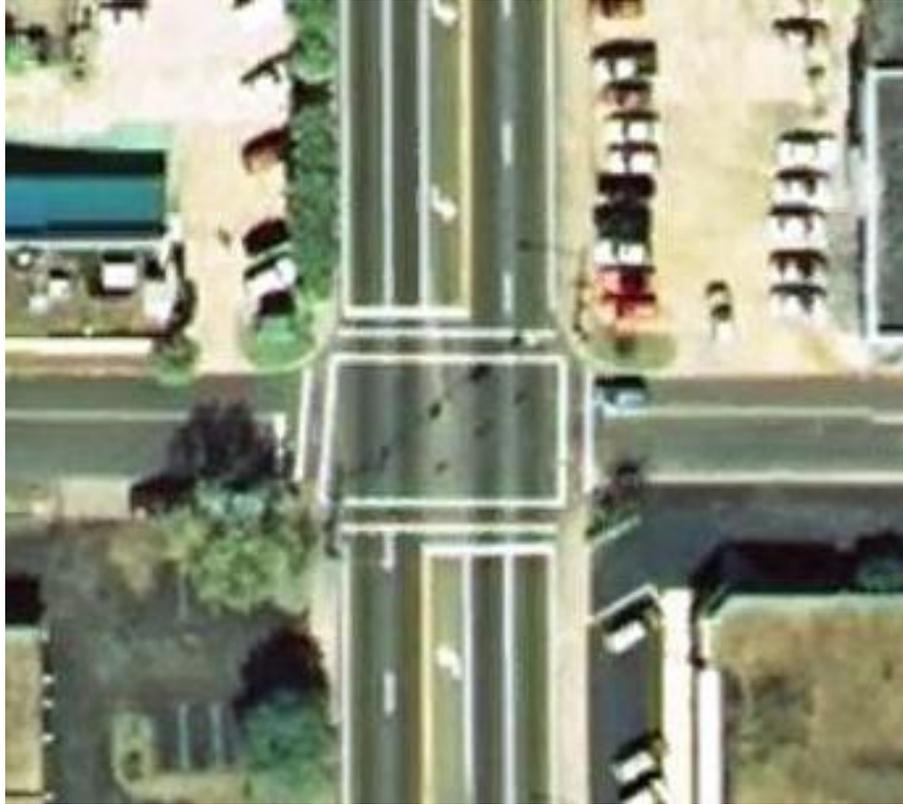
Figure 4.24: North Monroe Street at 3rd Avenue

Given that the geometry of the intersection is almost completely at a right angle, as seen in Figure 4.24, there are very few improvements that could reduce the amount of time pedestrians spend in the roadway while crossing. Pedestrian signalization for all crosswalks is also present to regulate the timing of pedestrian crossing.

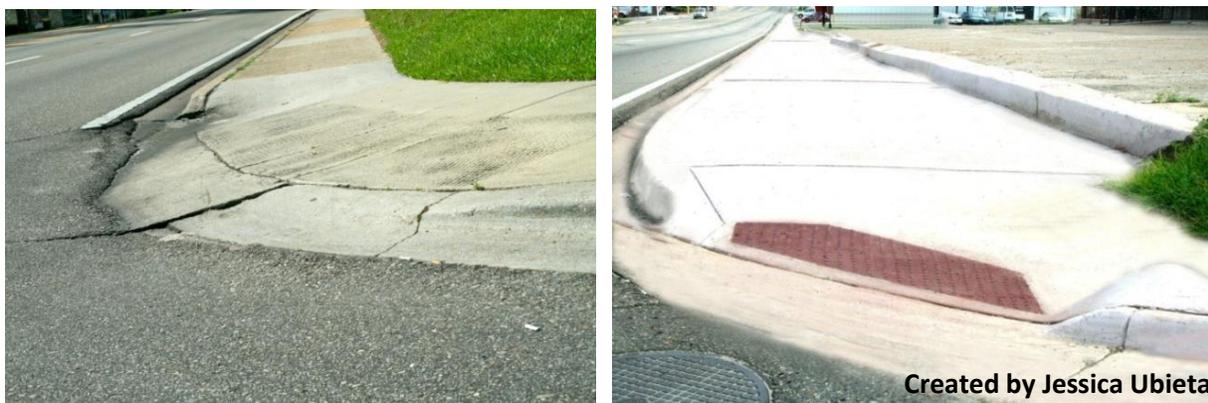
Figure 5.1: Before and potential after image of improved sidewalks and curb ramps

federal regulations on curb ramp safety. According to ADA regulations “transitions from ramps to [side] walks, gutters, or streets shall be flush and free of abrupt changes”; thus providing a smooth transition for wheeled devices such as wheelchairs, strollers, or bicycles to enter or exit the sidewalks and safely into crosswalks (Americans with Disabilities Act, September 2002). Any identified curb ramps that do not align to provide a safe entrance or exit should be replaced. Any intersections where an ADA compliant curb ramps do not exist should be altered to include such ramps, complete with truncated domes. Because of these requirements a total of twenty-nine curb ramps will need to be constructed or replaced throughout the North Monroe corridor, due to failure to meet adequate pedestrian and handicap standards of safety. The Lake Ella District has nine current entrances to sidewalks that have either no curb ramp or are defined as being in poor or fair condition. Within the Midtown District there are currently sixteen out of eighteen curb ramps in poor or fair conditions, as well as three sidewalks with no curb ramp at all. The inclusion of additional crosswalks in the Commercial-Office District would require the installation of an additional curb ramps with truncated domes. Truncated domes are located at crossing ramps and are small domes with flattened tops that help people, especially those with ADA needs, to identify the beginning of a crossing. The definitions for good, fair, or poor curb ramp conditions can be in Section 4 of this report. Figure 5.1 shows a before and potential after image of improved sidewalks and curb ramps with truncated domes that meet ADA regulations.

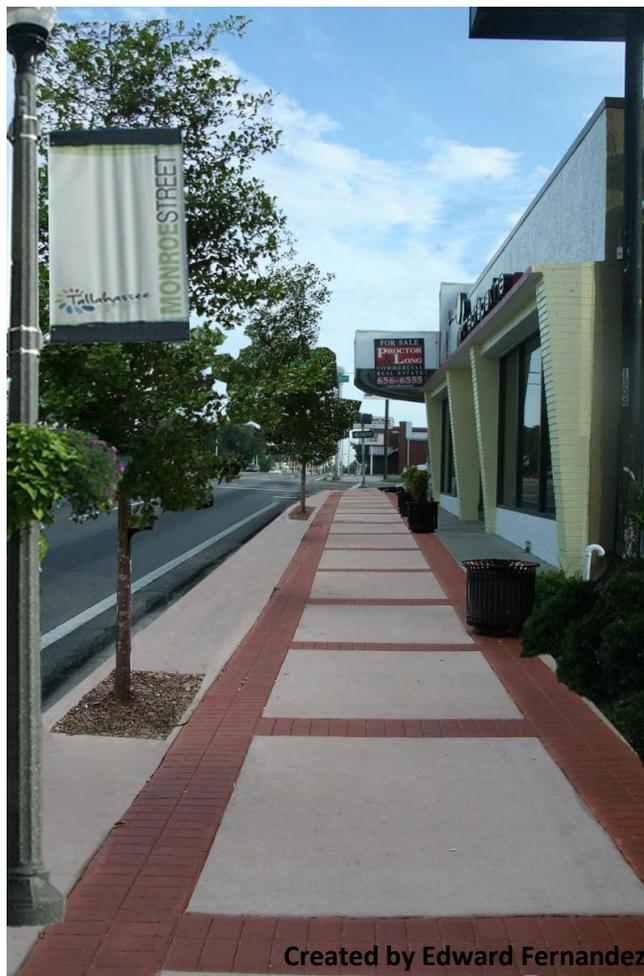
Figure 5.2: Projected ideal streetscape

traffic, it would be beneficial for pedestrian traffic to include a buffer to divide the sidewalk from the roadway. Currently the sidewalks range from 4 to 7 feet in width, and with the recommendations of widening the sidewalks, a 2 to 3 feet wide greenscaped buffer will be included as well, as seen in Figure 5.2.

The width of this buffer would vary in terms of the available right-of-way, and sidewalk width. The greenscaped buffer would provide a safe separation for individuals from oncoming traffic that, as noted earlier, increases pedestrian’s level of comfort and safety. As StarMetro already has a route that goes through this area, it is recommended that right-of-way also be used to place shelters as well as trash cans at these locations to improve and encourage the transit experience. Additionally, to improve the StarMetro experience, maps should be placed either in the shelters or in the absence of such a feature, under the StarMetro sign. These maps should

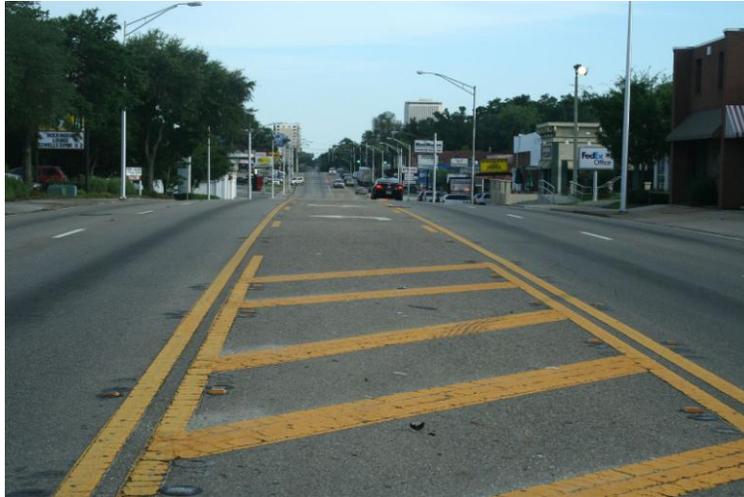
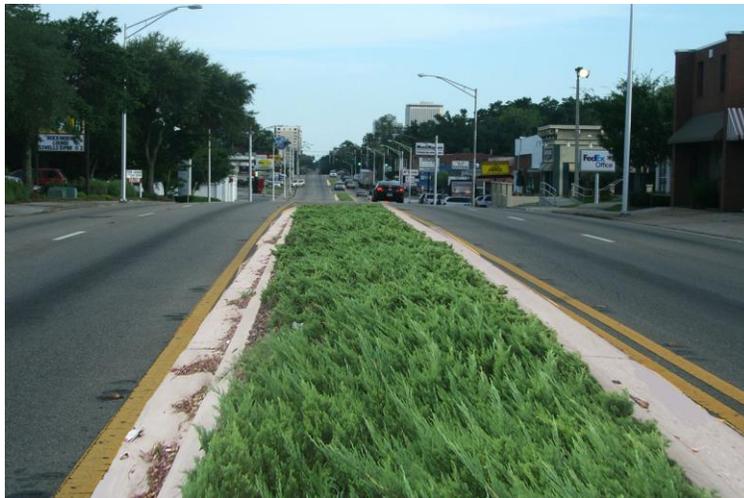
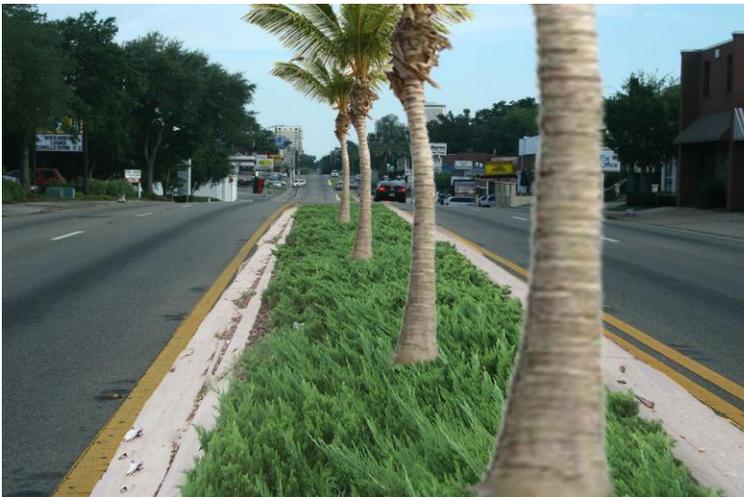
Figure 5.7: Before and potential after renderings of landscaped median alternatives

Based on the median constraints and long term maintenance we would recommend the use of Sabal Palms for planting areas along the medians of North Monroe where feasible (see Figure 5.7). These trees have low nutritional needs, a high tolerance for drought conditions, medium growth rate and are ideal plants for parks and buffers according to the *University of Florida Institute of Agricultural and Food Sciences* (Norcini, 2009). Due to the recommended curb radii improvements of this study on the northwest portion of Tharpe Street and North Monroe Street, as well as on the South East corner of 7th Avenue and North Monroe, there is an opportunity to include landscaping on these corners and curbs. In these instances due to the constraint of the public right-of-way and long-term maintenance it would be ideal to place planters within these greenscaped corners that contain trees to provide further shade for the corridor, but do not hinder the ability of drivers to identify businesses or other motorists.

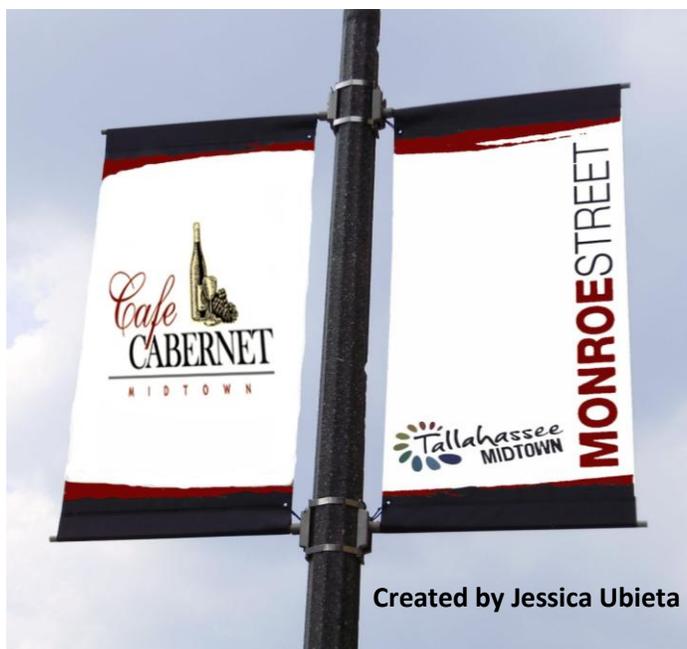
Figure 5.8: Proposed vertical human scale lighting and signage

Including signs that identify both businesses as well as the district in which the traveler is in will assist in the branding or providing a “sense of place” for the region. These banners could be located on the vertical lighting as illustrated in Figure 5.8, to offset costs these banners will have the option to be purchased by businesses for advertisement.

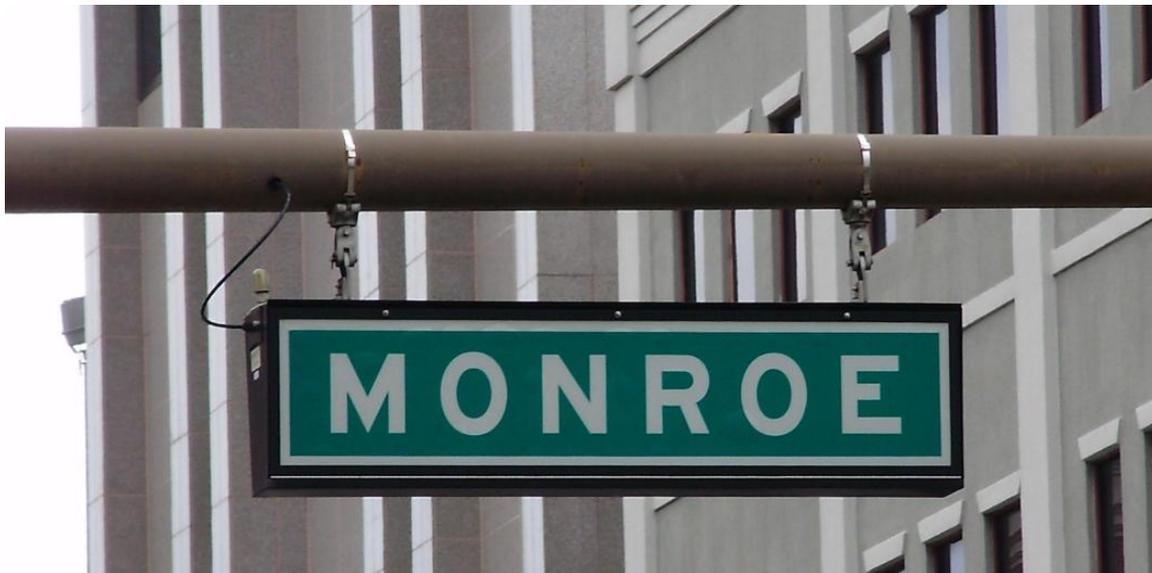
Figure 5.9: Depicts a uniform light box to better illuminate street names

A useful consideration for nighttime lighting for pedestrian visibility and safety is incorporating street name light boxes to make them visible to pedestrians at night. An example of these signs can be seen in Figure 5.9. Additional signage at the pedestrian level was a recommendation received at one of the public input meetings that could be useful for pedestrians in identifying what public facilities, businesses and other attractions exist in the nearby walking areas.
