North Monroe Street Design & Safety Study

Florida State University
Department of Urban & Regional Planning
Summer Studio 2010
Prepared for the CRTPA

| 2 Road Safety Audit Report..... | 7 |

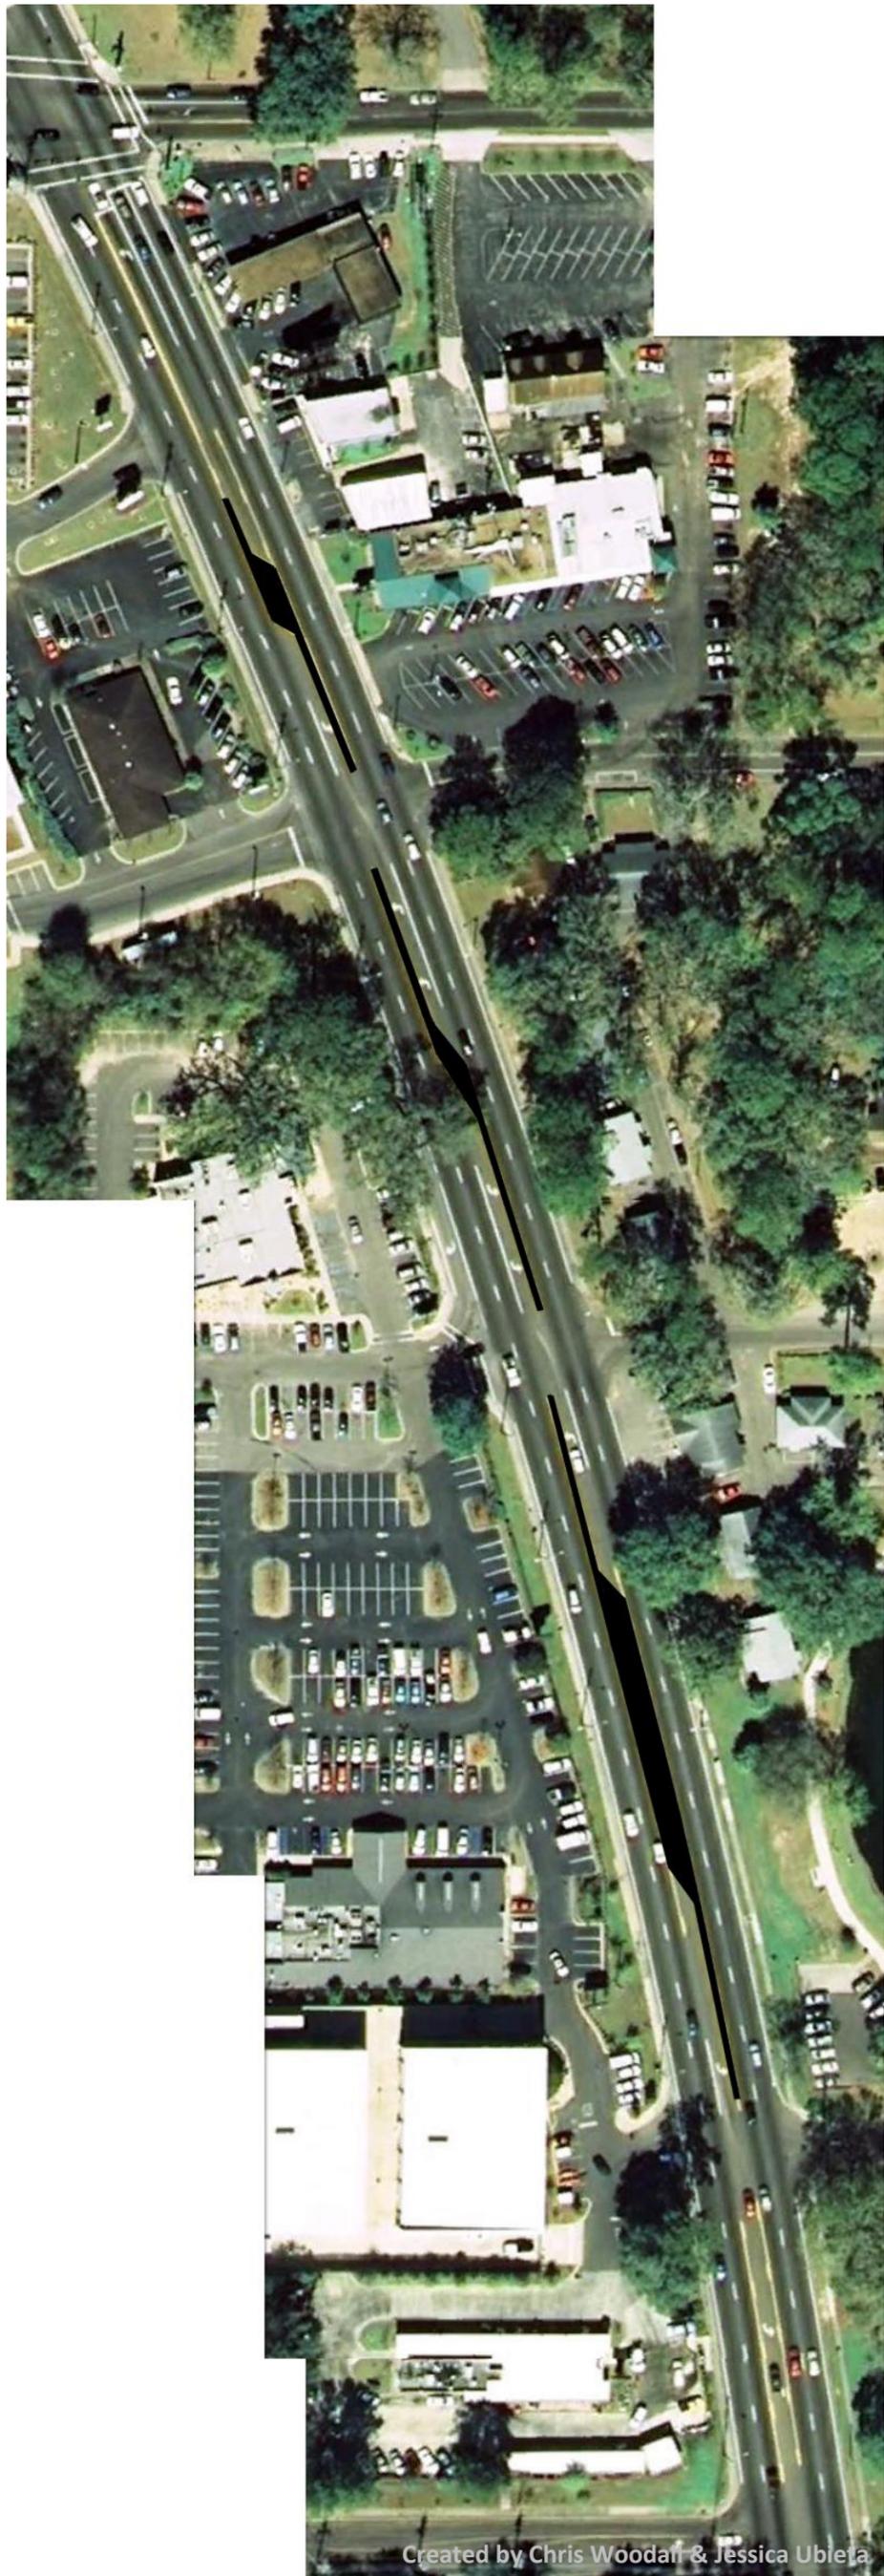
Figure 5.10: Proposed Directional Medians for the Lake Ella District

In considering medians for the North Monroe corridor, the nature of each district were taken into account, including the types of businesses present. Figures 5.10 to 5.12 depict the suggested locations for the medians. The maps were created to show where certain areas of the existing center turn lane have been blacked out to represent the proposed medians. The directional median is the most appropriate type for the corridor, as there are many businesses on both sides of Monroe Street that attract travelers and limiting the turning access could be financially detrimental to certain businesses. The addition of medians would replace the current center “suicide” turning lane, but still provide access and opportunities for vehicles to make u-turns at strategic locations. Landscaping of the medians is highly desirable where feasible. However, in some areas, such as the Midtown Connector District, the landscaping should be minimal so as to not obstruct the view of businesses or traffic on either side of Monroe Street.

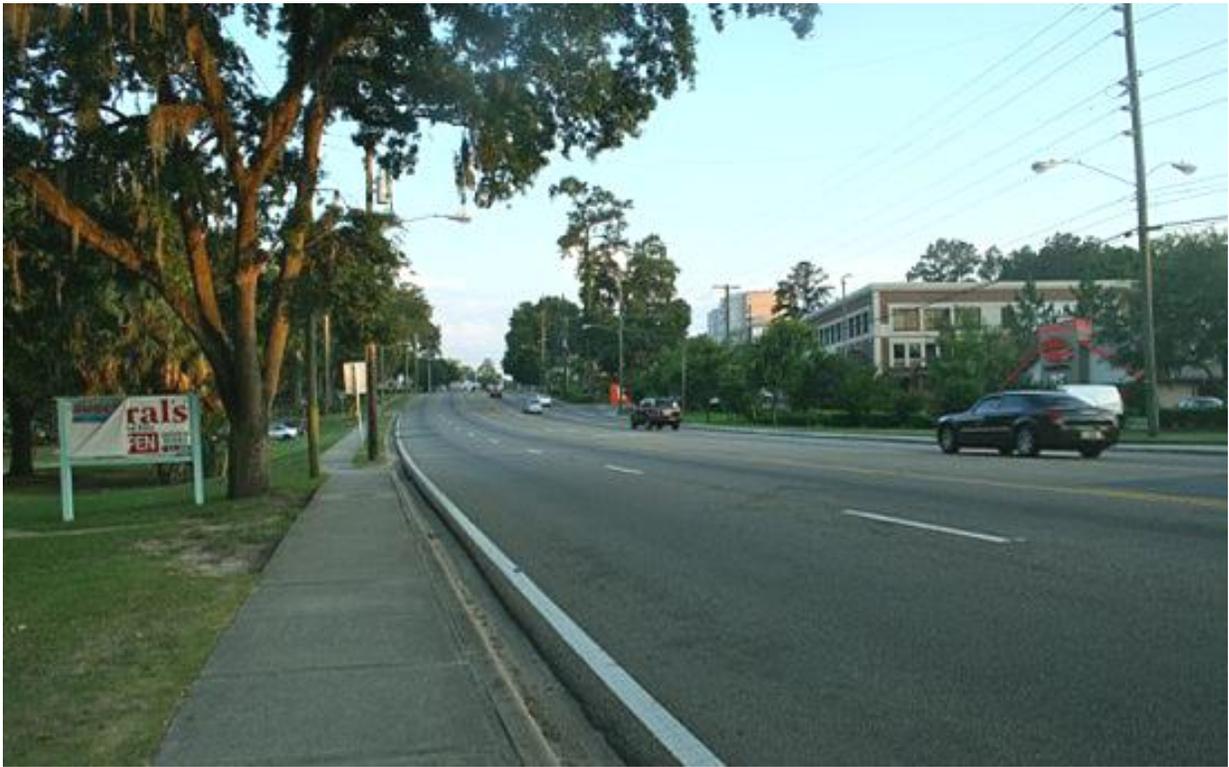
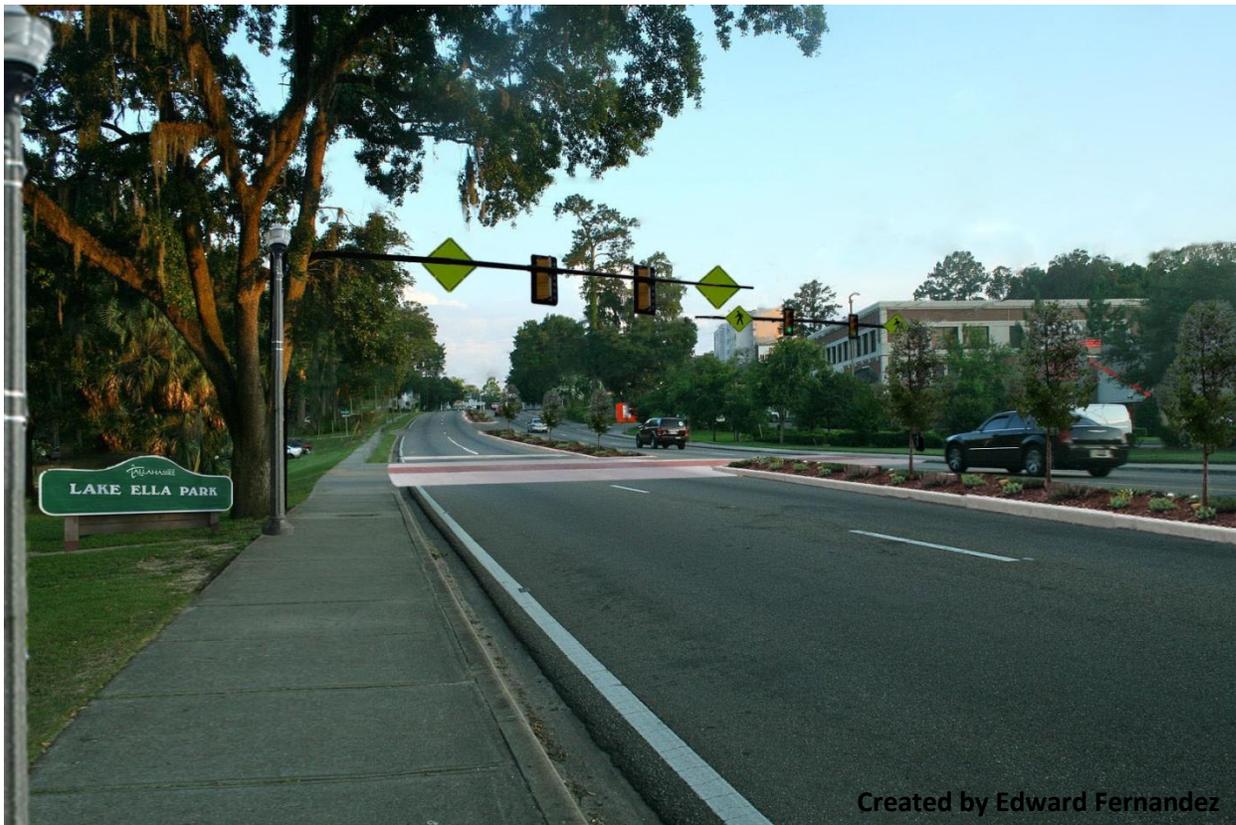
Figure 5.15: Before and potential after rendering of Mid-Block crossing near Lake Ella

A mid-block crossing in the Lake Ella District has been identified as one of the most important improvements desired in the entire corridor by city/county officials as well as the public. Findings and recommendations from the RSA report also support the awareness of a need for a mid-block crossing in the district, as this immediate area is highly populated and utilized by pedestrians accessing the park. Due to the lengthy distance between the closest crosswalks (about a half-mile between 7th Avenue and Tharpe Street), people have been observed by both the studio group and the RSA team unsafely crossing Monroe Street in this area. A lack of adequate public parking is also evident as Lake Ella Park patrons frequently park their vehicle at the Golden Corral parking lot and dangerously cross North Monroe Street to visit the park. Several possible locations and types of crosswalks have been considered for the addition of a mid-block crossing in the Lake Ella district. An image of current conditions and a rendering of a potential crossing is shown in Figure 5.15, as well as median placement, entrance sign to Lake Ella, wider sidewalks, and underground utilities.

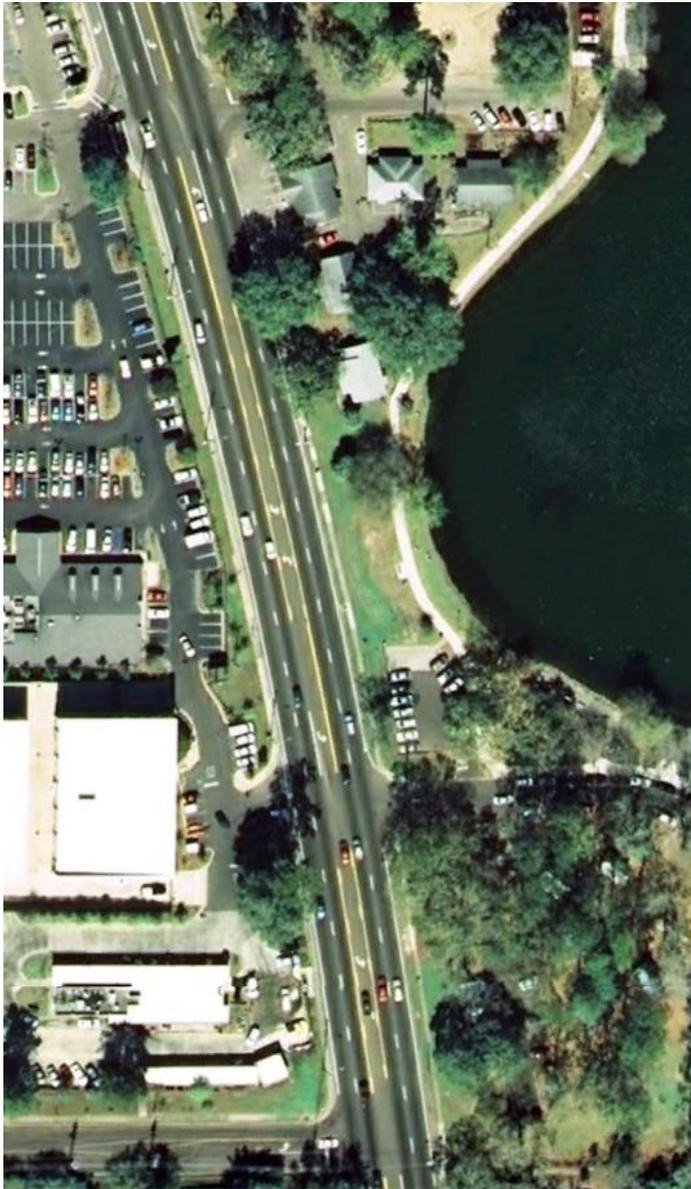
Figure 5.16: Existing conditions: No Mid-block Crossing

Several locations have been identified as practical locations for a crosswalk, described as Options A to C. Option A extends from Legion Street to the parking lot entrance near On the Border; Option B extends from the furthest east point of Lake Ella to just across from Golden Corral; and Option C extends from the parking lot adjacent to the South Lake Ella Drive, across to the sidewalk on the west side of Monroe Street. Figure 5.16 is an aerial of the existing conditions. Figure 5.17 shows a rendered image of the recommended Option B, due to its central proximity between Tharpe Street and 7th Avenue; ease of visibility due to absence of trees or landscaping in the immediate area; clear access to the large parking lot between Golden Coral and On the Border; and the negligible impact on vehicular level of service.

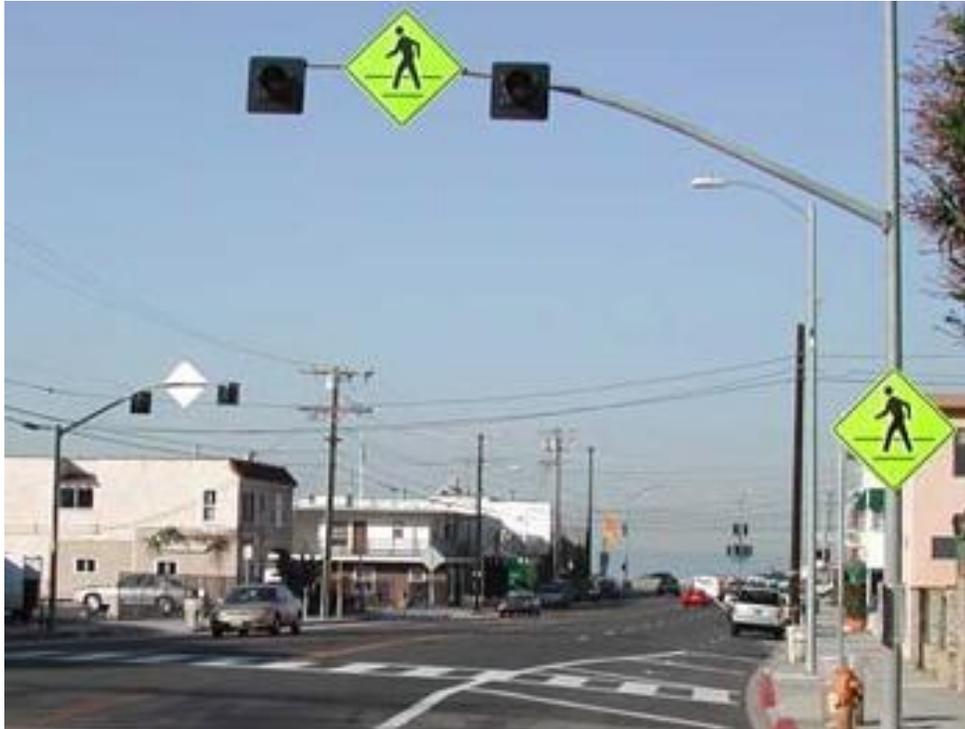
Figure 5.18: Low-Alternative Pedestrian Crosswalk

Various types of crosswalks have been considered for the Lake Ella District based on low, medium and high-cost features. The low-cost alternative consists of a flashing yellow light on a mast-arm pole, seen in Figure 5.18 that warns drivers of the pedestrian crosswalk below it, which is proposed to be either painted with a reflective white paint, made of faux brick material, or brick inlay.

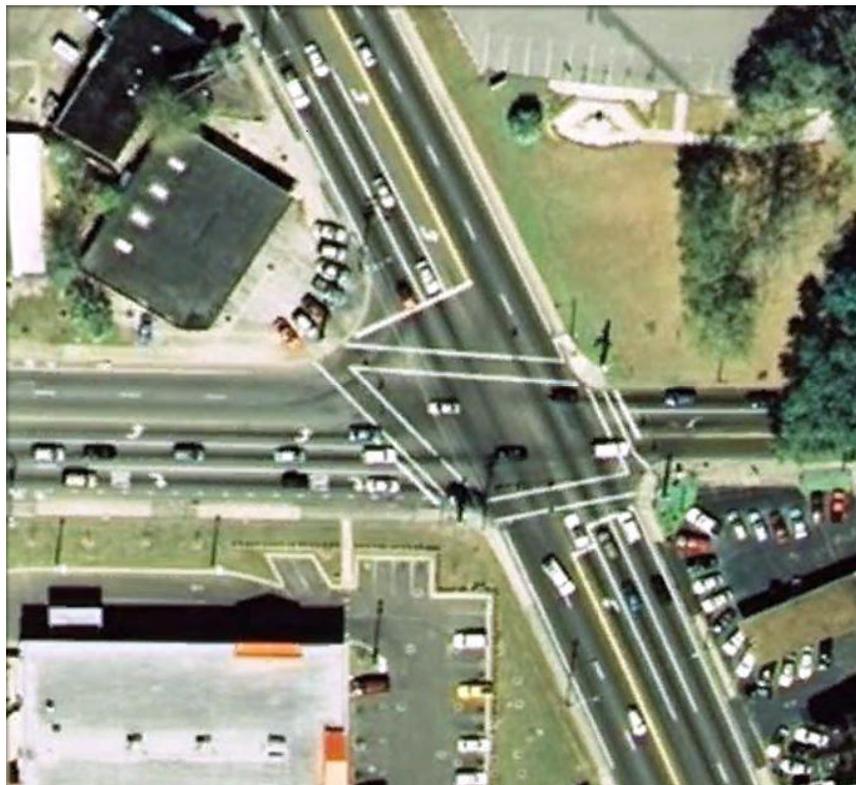
Another improvement for the Tharpe Street intersection is to move the stop-lines back on the western portion of the intersection, in order to square-off the crosswalk to a 90 degree angle to the roadway. This treatment could also be performed on the northern portion of the intersection. This alternative would provide for shorter pedestrian crossing distances and would reduce the amount of time pedestrians are vulnerable to oncoming traffic. Figure 5.21 shows the existing conditions and Figure 5.22 illustrates, via aerial photograph, how these suggested improvements would impact the intersection's geometry. These improvements would decrease the crossing distance on the western crossing from 102.42 feet to 70.5 feet, which is 31.92 feet less and equivalent to almost three lanes of traffic. These alternatives would also decrease the northern crossing distance from 109.58 feet to 66 feet which is a drastic difference of 43.58 feet. With these reductions in crosswalk distance in place, the current pedestrian signal timing for the eastern/western crossing is now appropriate and the southern/northern crossing pedestrian signal timing is well below what it would need to be. This could then be adjusted to allow for more efficient vehicular traffic flow if the signal timing engineer deemed it necessary.

Figure 5.21: Tharpe Street exiting conditions

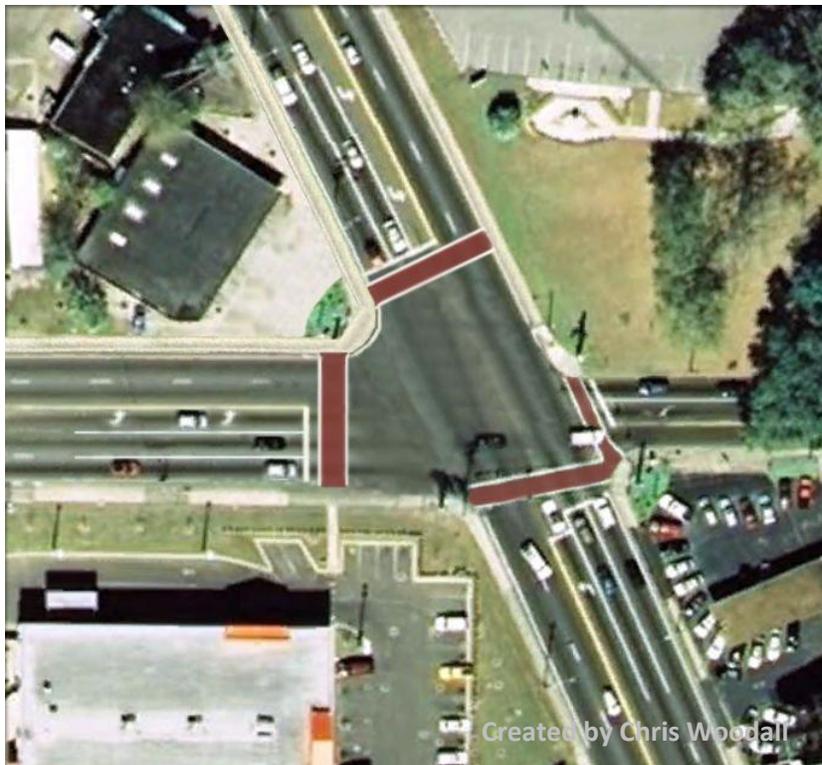
Figure 5.22: Tharpe Street with Proposed Alternatives

Also visible in Figure 5.22 is the alternative of faux brick crosswalks, which is being suggested for all of intersections along the corridor, both existing and proposed. The benefits of this treatment are functional as well as aesthetic. They provide a visual and audible reminder to vehicular traffic that they are sharing the roadway with pedestrians, while creating a more aesthetically pleasing crossing. Real brick inlay is another alternative that can increase the aesthetic quality of the crosswalks and although more expensive, would provide the same effect as faux brick. The third and cheapest option for the crosswalks is thermoplastic striping, which is a reflective material that can be fashioned in a number of different patterns to alert oncoming traffic of a pedestrian presence.

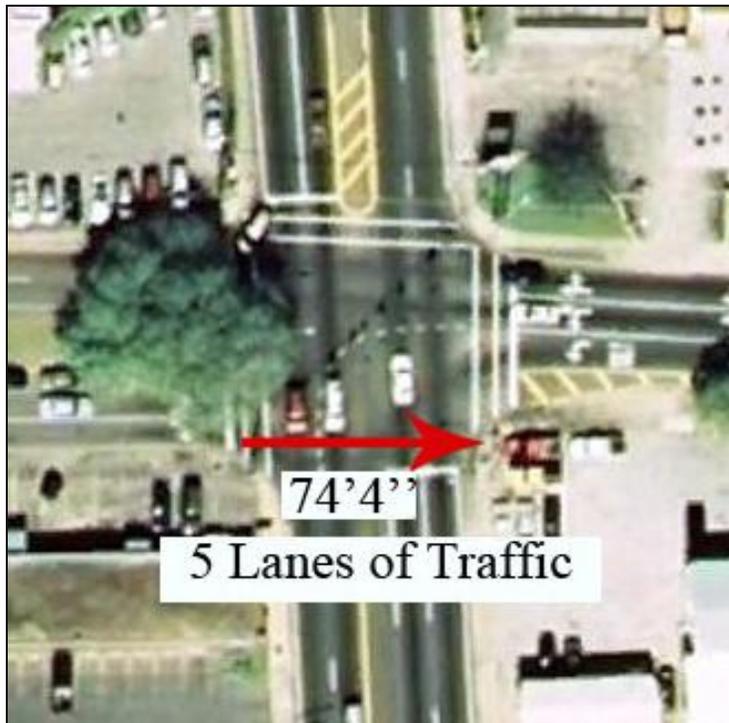
Figure 5.24: 7th Avenue with Proposed Crosswalk

As previously mentioned the Midtown Connector District is a rapidly growing area of Tallahassee and is home to many restaurants and pedestrian destinations. Intersection alternatives for this district will primarily concentrate on pedestrian safety. The 7th Avenue intersection is the entrance to this district from the north and is the subject of most of the alternatives proposed. Here, only three crosswalks exist, as there is not one present on the southern portion of the intersection. As mentioned in the existing conditions, and found in Figure 5.23, the distance traveled from the southwestern portion of the intersection to the southeastern, or vice versa, is currently 197 feet and 12 lanes of traffic. The first recommendation is to install a crosswalk with proper pedestrian signalization at this location oriented at a 90 degree angle to the roadway. This would reduce the travel distance from 197 feet to 71 feet, 4 inches, and from 12 lanes of traffic, to 5 as seen in Figure 5.24. Reducing the crossing distance will reduce the amount of time pedestrians are vulnerable to traffic, thereby making the intersection safer. This is particularly important due to the Tallahassee Senior Center's location on the northwestern corner of Monroe Street and 7th Avenue. These elderly citizens in many cases require additional time to cross. The less distance they have to cover exposed to traffic, the safer their journey will be.

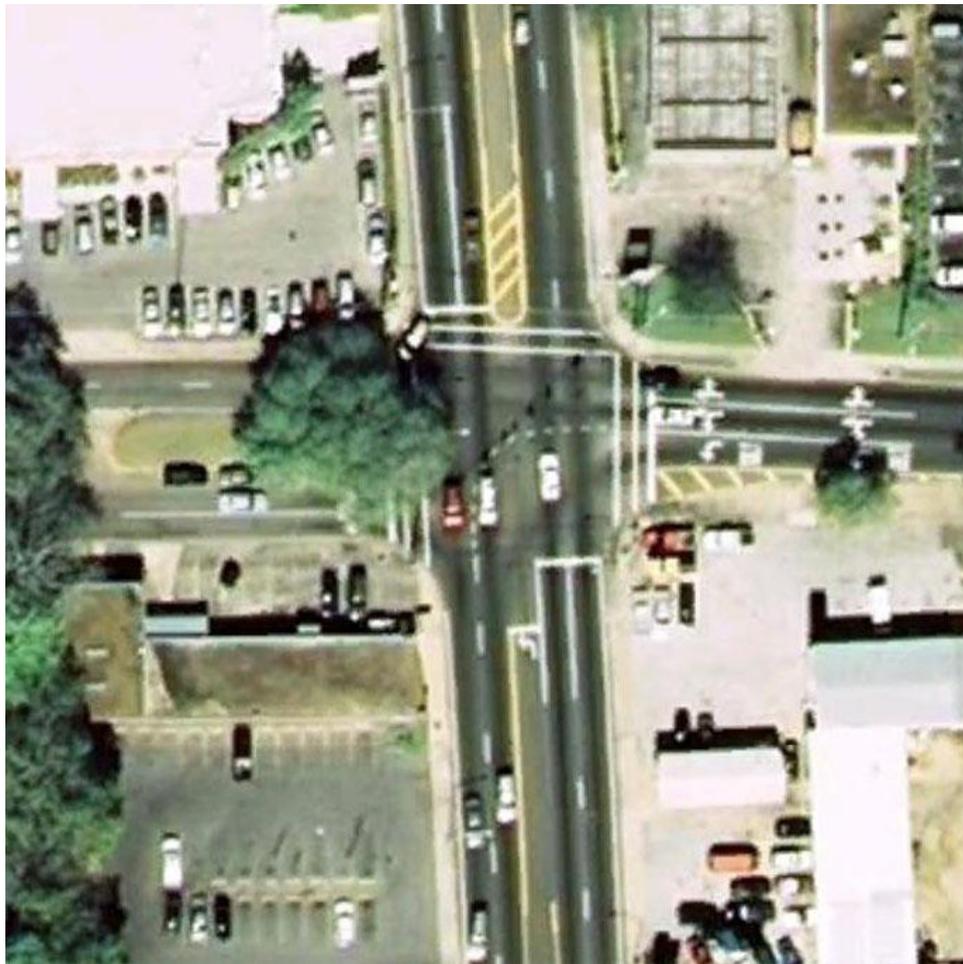
Another factor contributing to the unnecessarily long pedestrian crossing distances at this intersection is the large curb radius on the southeastern corner. This curb radius measures 34 feet and a painted section is located between the left turn lane and the curb. This painted section prohibits traffic, but does not decrease the crossing distance for pedestrians along the eastern crossing. An alternative solution would be to extend the curb over the painted section and reduce the curb radius at this point to diminish the crossing distance. Figure 5.25 illustrates the existing conditions and Figure 5.26 presents how the proposed alternatives would affect the geometry of the intersection.

Figure 5.25: 7th Avenue Existing Conditions

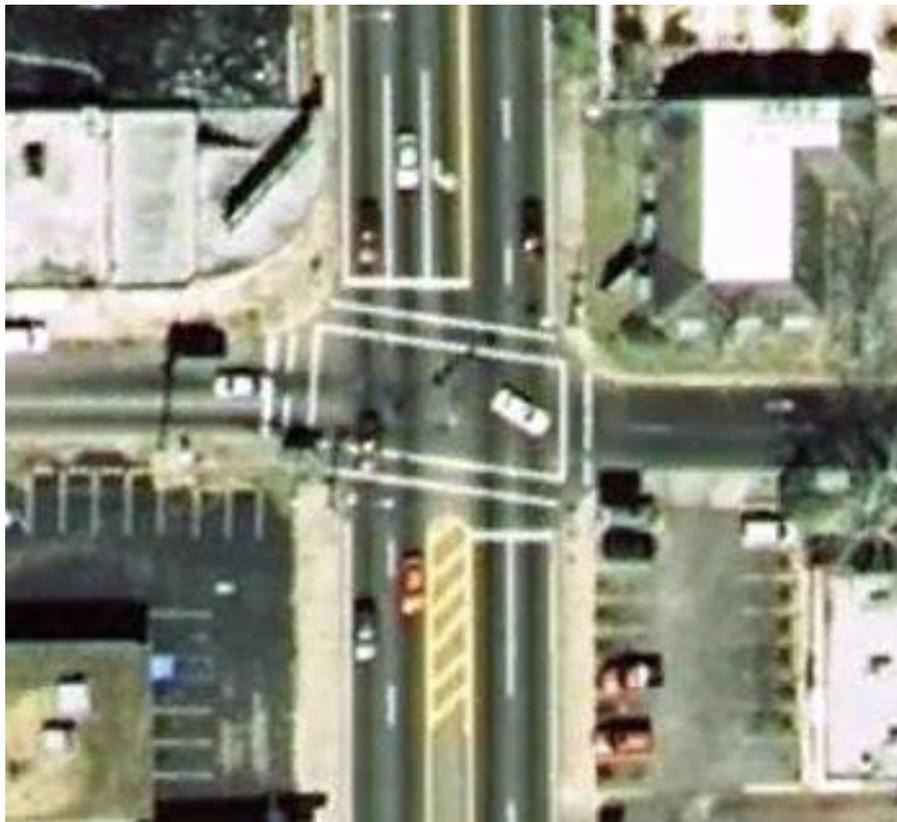
Figure 5.27: 6th Avenue Existing Conditions

In contrast to 7th Avenue, 6th Avenue does not require many alterations from an intersection standpoint. The curb radii are appropriate for this type of intersection and therefore do not require any changes. The only alternative suggested for this intersection is to square-off the northern and southern crosswalks to 90 degrees to minimize the distance pedestrians must cross to traverse North Monroe at this location. An aerial shot of 6th Avenue, Figure 5.27 shows the skewed crossings. This alternative would require expanding the pedestrian landings to the new sidewalk entry locations and could be constructed as the crosswalks are being resurfaced with one of the three options listed at the beginning of this section.

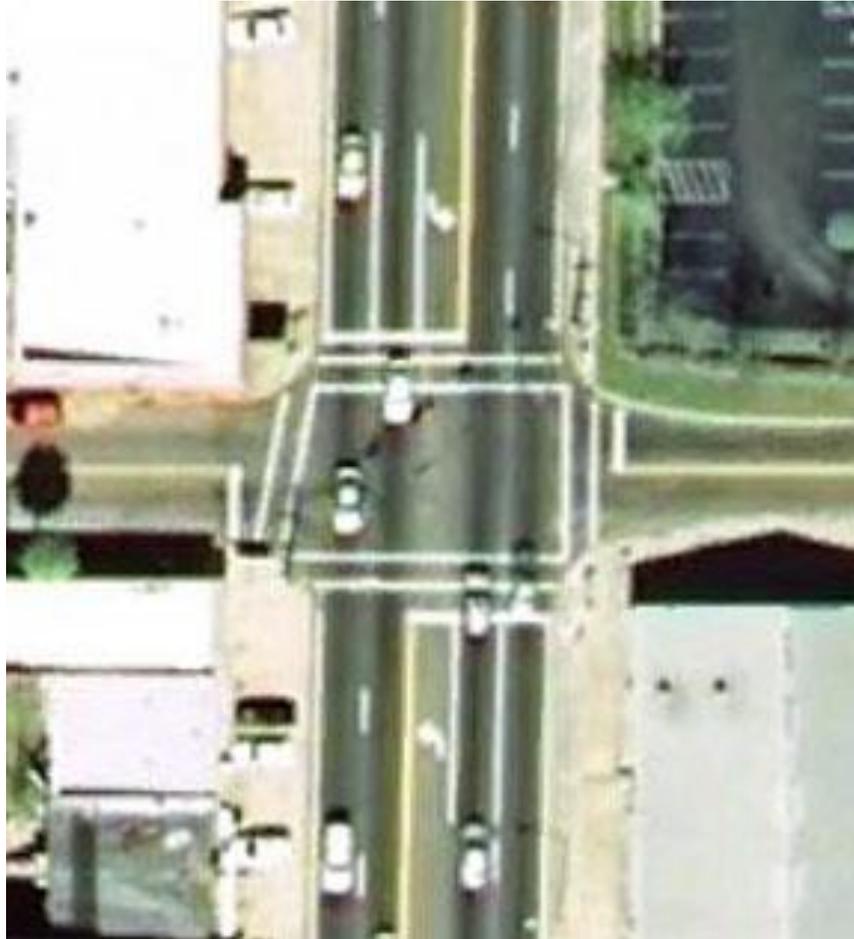
Figure 5.28: 5th Avenue Existing Conditions

Like 6th Avenue, 5th Avenue does not require many changes to the geometry of the intersection, with the exception of the western crosswalk. Figure 5.28 illustrates the skewed angle for this crossing and the alternative suggestion mirrors that of 6th Avenue. Squaring-off this

crosswalk to a 90 degree angle will slightly reduce the walking distance for pedestrians and thereby reduce their exposure to traffic. This alternative could also require extending the pedestrian landings to meet the new crosswalk location, and is the single geometric change recommended.

There is, however, an additional and more important alternative suggestion for this intersection. As reviewed in the existing conditions of this intersection, there are three pedestrian signals that are not functioning. It is imperative for the pedestrian safety of this intersection to correct this issue. Ensuring that all pedestrian signals are functioning properly is a very important aspect of safety along the entire corridor. Replacing these existing signals with new “count-down” signals could ensure that they are all current and functioning properly.

Another recommendation for this intersection is to increase the pedestrian signal timing for the southern/northern crossings. The current signal timing allows a walk speed of 4.3 ft/sec which is .8 ft/sec over the recommended industry standard of 3.5 ft/sec. Meeting this guideline would require an increase from 15.3 seconds of allowable crossing time to 18.9 seconds; a difference of 3.5 seconds. This would permit an acceptable walking rate for people of all ages and abilities and would allow enough time to safely cross this intersection. All pedestrian signal timing calculations and methodology can be found in Appendix H.

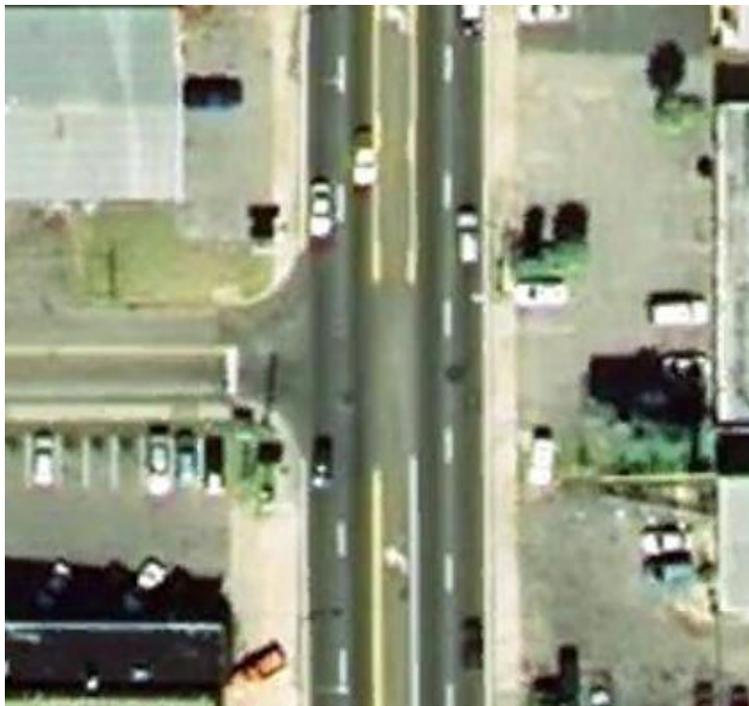
Figure 5.29: 4th Avenue Existing Conditions

The last intersection in the Midtown Connector District is the stop-controlled intersection of 4th Avenue, as seen in Figure 5.29. This is a smaller side street, but it is located in close proximity to several popular local restaurants, which are destination locations for the corridor. This T-intersection does not currently have a crosswalk installed to inform incoming traffic that this is a pedestrian traveled area. An alternative for this would be installing one at this location, complete with brick, or faux brick material to give the vehicular traffic visible and audible cues that pedestrian traffic may be present. This would also improve the aesthetics of the intersection, and tie it in to the rest of the corridor’s sense of place.

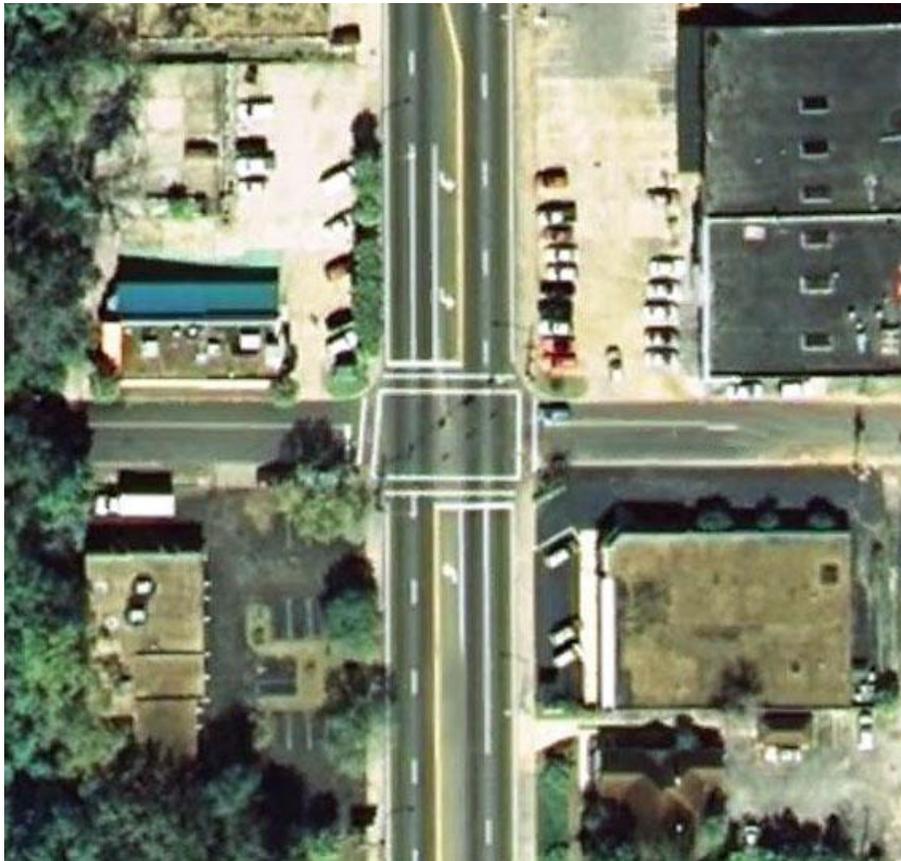
The intersection at 3rd Avenue is the best example of good intersection geometry of any on the corridor. It includes tight angles and the shortest available crossing distances, as seen in Figure 5.30.

Figure 5.30: 3rd Avenue Existing Conditions

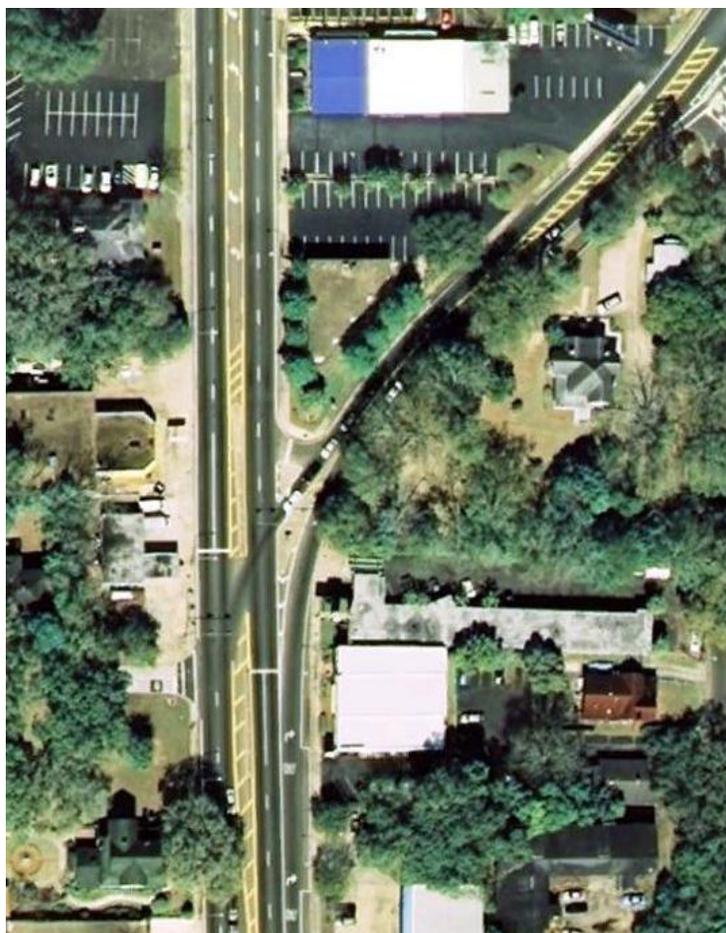
Figure 5.31: Thomasville Road Existing Conditions

Thomasville Road, the second signalized intersection in this district, is the only intersection along the corridor that does not include any pedestrian amenities. There are no provisions for pedestrians to cross Monroe Street or Thomasville Road. This creates an issue for those traveling north or south on the east side of Monroe Street as they cannot access the rest of the corridor or downtown, depending on which way they are traveling. This cut-off is detrimental to pedestrian mobility between these two areas and alternatives are necessary to correct the issue. The existing conditions are reiterated in Figure 5.31.

One alternative to correct this issue would be eliminating the free-flowing right turn-lane from Monroe Street onto northbound Thomasville Road, and signaling it with a pedestrian activated signal. This would allow pedestrians to concentrate only on the incoming traffic from one direction, and would permit the addition of crosswalks connecting the two islands that currently exist between the Monroe Street sidewalks and Thomasville Road. This would require moving the stop-lines back on Thomasville Road to allow more space for proper crosswalks. Prohibiting right turns on red here would also provide for more pedestrian safety while crossing at this location by removing an unexpected traffic movement. Pedestrian signals would also need to be included to ensure the safety of those crossing at this intersection. This alternative would be the least costly, but as expressed in a corridor public input meeting, it could potentially cause traffic to back up to Brevard. Having the signal only activated when pedestrians are present should make these issues occur very infrequently.

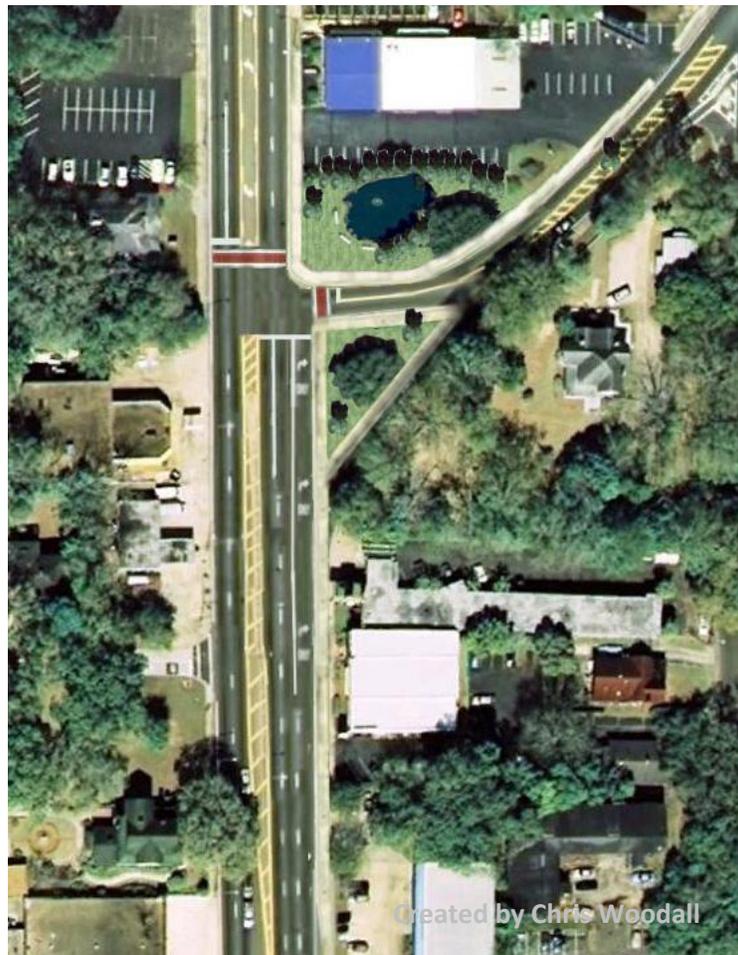
Figure 5.32: Thomasville Road: High Alternative

Another high cost and long-term alternative for this intersection would be to acquire right-of-way directly north of the intersection where the Bank & Morris attorney's office and parking lot is located and create a standard T-intersection at this location, as seen in Figure 5.32. This would eliminate the free-flowing right-turn traffic, but would allow more space for the turn traffic to queue, keeping the intersections south of Thomasville Road free of obstruction during peak hours. This option is preferable because it would remove all unexpected traffic movements and would create a standard crossing that both pedestrians and motorists are familiar with. This option would require greater investment and more public and political will, but would provide the safest option for this intersection. It would also include more landscaping opportunities to improve the aesthetic qualities of the corridor. This alternative would also create a crossing for Monroe Street where one does not currently exist providing for even more pedestrian mobility along the corridor.

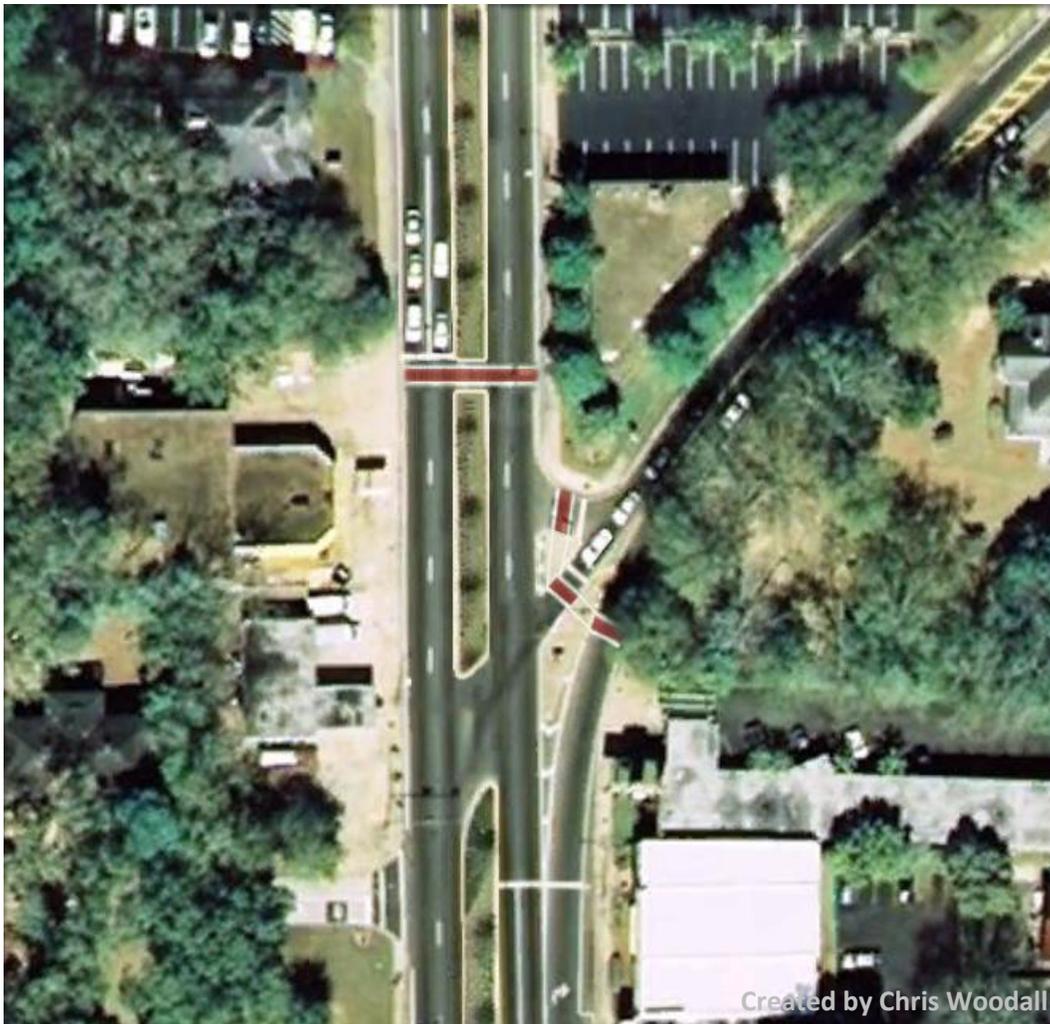
Figure 5.33: Thomasville Road: Low Alternative

Another alternative exists for creating a crossing traversing Monroe Street at this location without implementing this T-intersection. Moving the stop-line back on southbound Monroe Street here would allow enough space to create a crosswalk at a 90 degree angle to the roadway. This option would require also moving the stoplight northward and installing pedestrian signals to regulate the pedestrian traffic. This alternative would not alter the current traffic-flow pattern greatly, as the current traffic signal cycle should provide enough time to cross. This could be combined with the alternative to regulate the free-flowing turn-lane and install crosswalks across Thomasville Road shown in Figure 5.33.
