RETREAT AGENDA ITEM
CRTPA CORRIDOR REPORTS

CRTPA
TRAFFIC AND OPERATIONS ANALYSIS
THARPE STREET

DRAFT RECOMMENDATIONS

October 2018

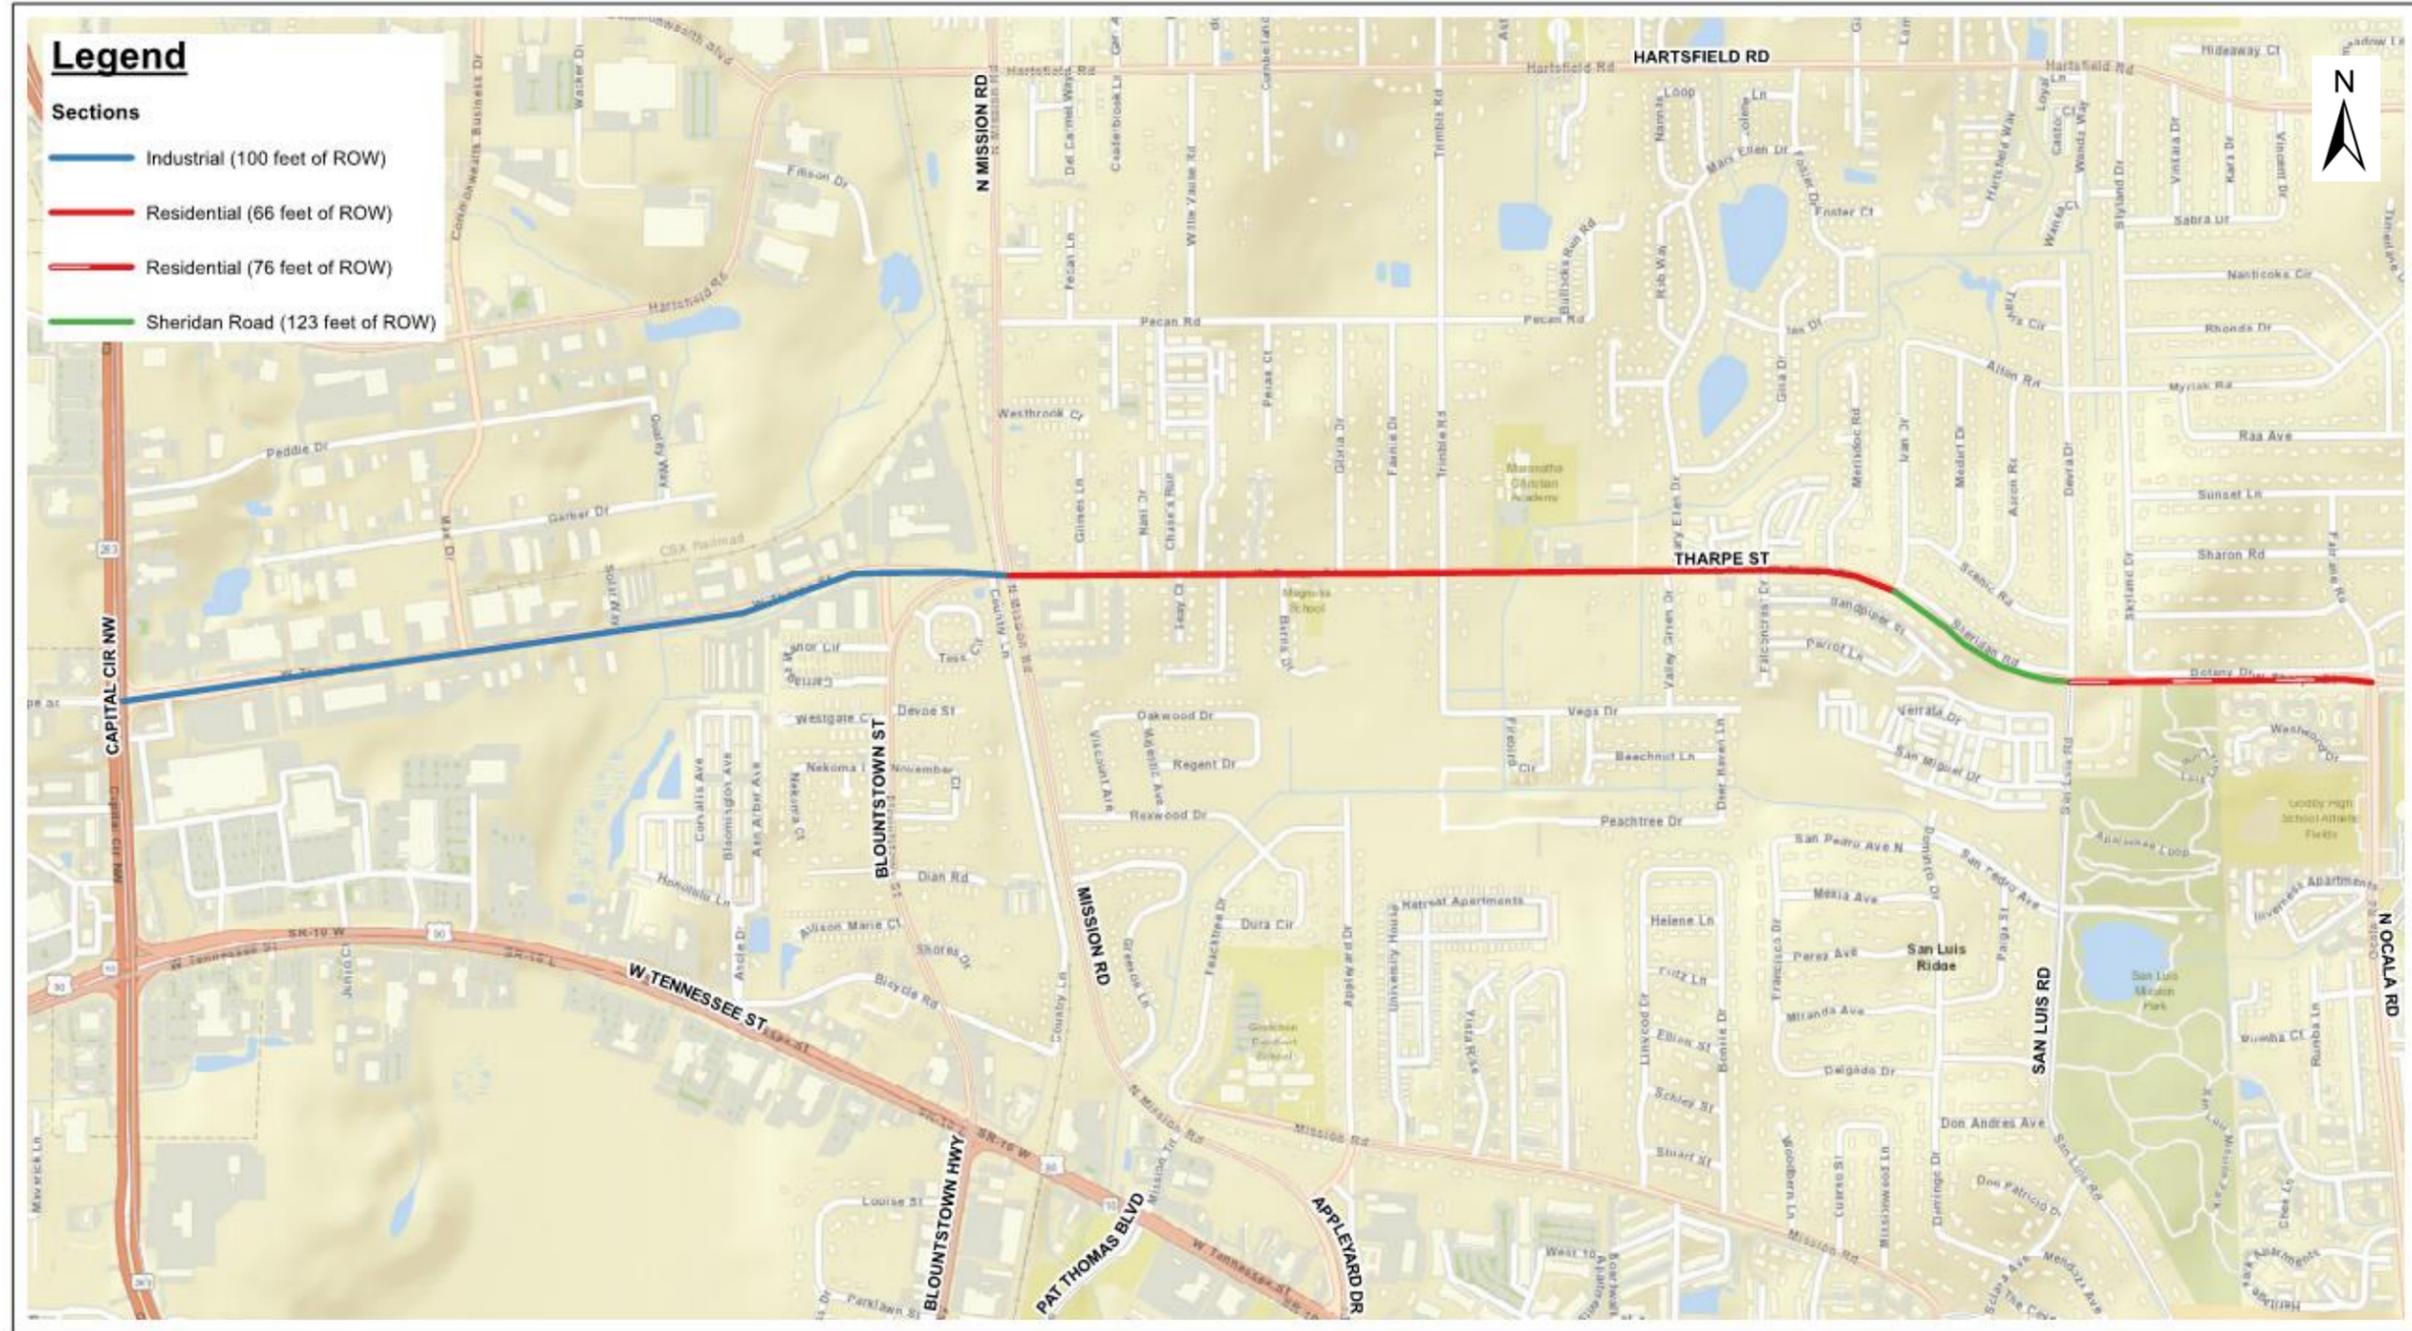
Figure 1. Project Overview

Recommendations from this package reference three distinct sections along the corridor. These sections are identified as the Industrial Section, the Residential Section, and the Sheridan Road Section (see **Figure 1**). The Residential Section is divided into two sections: Mission Road to Ivan Drive and Devra Drive to West of Ocala Road. Number of lanes, travel lanes widths, and right-of-way (ROW) widths are shown in **Table 2**. Following a review of the existing conditions, five major issues were identified and are discussed in this report.

Capital Region Transportation Planning Agency (CRTPA) identified the need for additional capacity along Tharpe Street in the 2040 Regional Mobility Plan (RMP) (see **Figure 1**). The RMP proposes the widening of this corridor. The purpose of this study is to investigate existing conditions along Tharpe Street and identify potential projects to improve mobility and efficiency without major capacity expansions. This study will propose improvements from Ocala Road to Capital Circle NW.

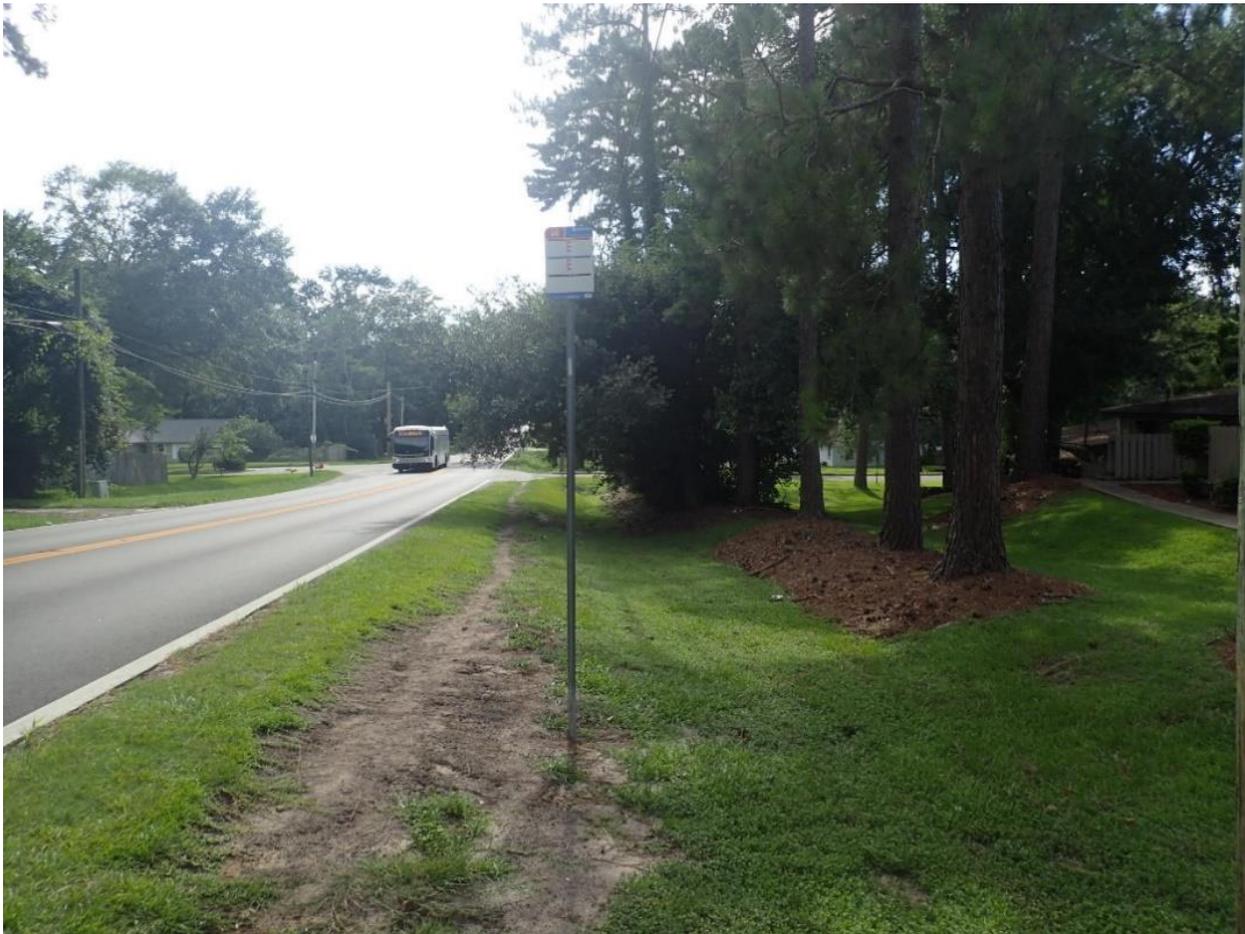
Figure 2. Typical Bus Stop Along Tharpe Street

StarMetro serves as the public bus service for the City of Tallahassee and Florida State University. Currently, bus stops along Tharpe Street are not compliant with the Americans with Disabilities Act (ADA) and offer limited information to passengers (see **Figure 2**). Current ADA compliance is only required when bus shelters and sidewalks already exist. StarMetro desires to make all public transit links adhere to current ADA standards, making the system more accessible and safe for all riders. In addition, bus schedules and route maps should be available to riders at all stops.

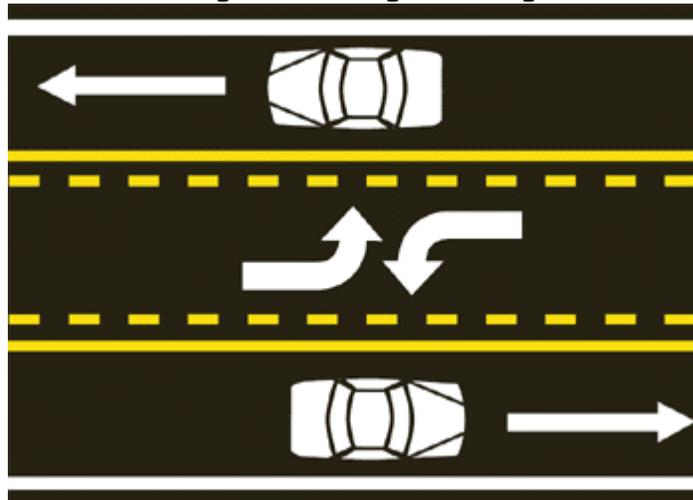
Figure 3. Existing Lane Design

Spot congestion along Tharpe Street is primarily caused by routine traffic events such as: bus pick up/drop off, trash collections, and left turn traffic. Some portions of the corridor have one through lane in each direction that is separated by a dual left turn lane (see **Figure 3**). Left turn traffic is especially common in the residential section of Tharpe Street where minor streets tend to cluster together. During routine bus stops, motorists often travel over painted medians due to the lack of maneuvering space provided by the current two lane design (as seen in **Figure 4**). For this reason, spot congestion is especially prevalent in the residential section of Tharpe Street during peak AM/PM hours.

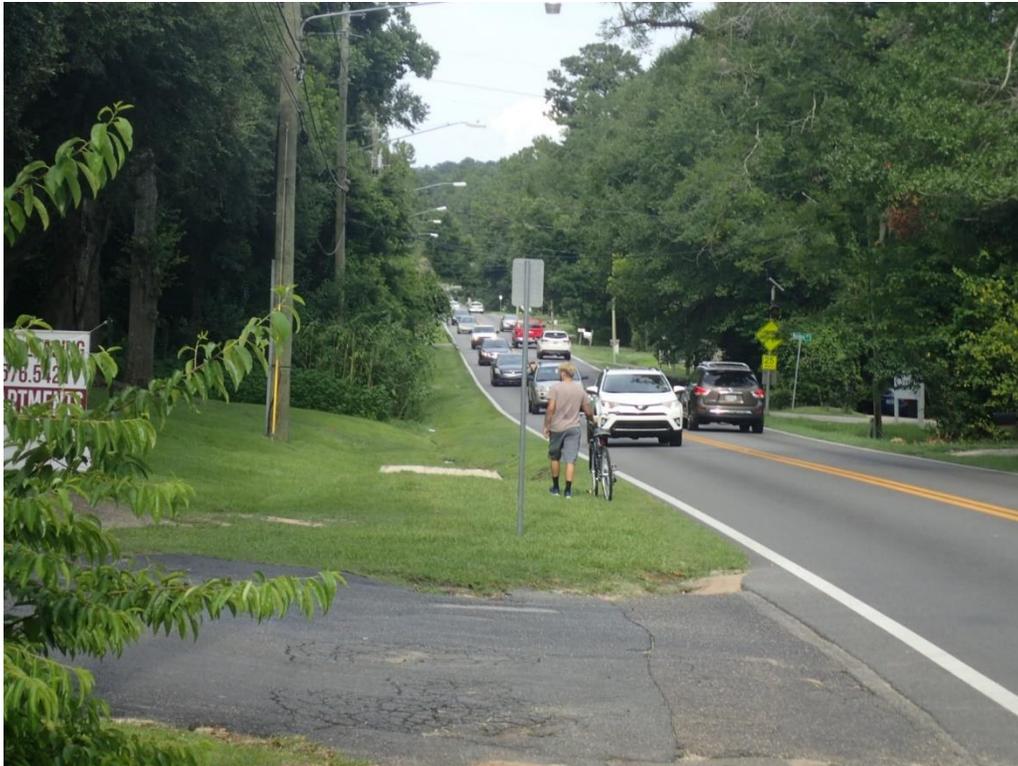
Figure 5. Pedestrian Travel Pattern

Presently 90% of the land parcels along Tharpe Street have no access to sidewalks or bicycle facilities. For this reason, cyclists and pedestrians are given no choice but to travel along grassed ditches to avoid interaction with motorists (see Figure 5). However, grassed ditches are not always made available. One area in particular, located 500 feet east of Trimble Road, poses a high risk area for pedestrians as they are given no choice but to travel on the roadway with vehicular traffic (see Figure 6).

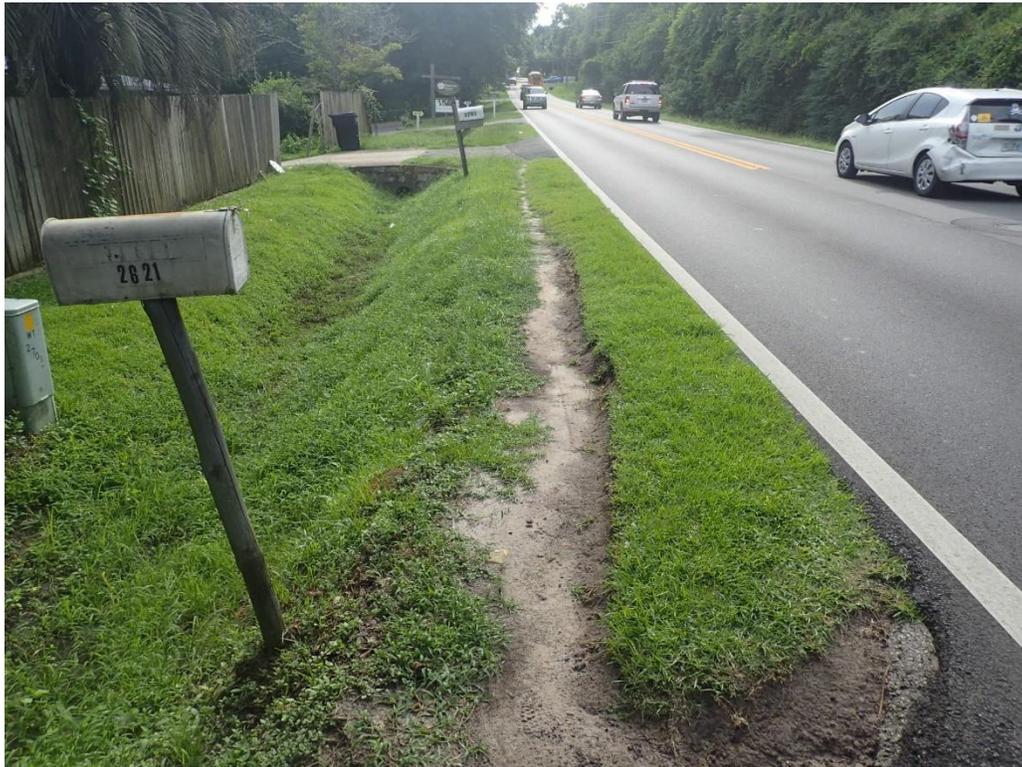
Figure 7. Desire Lanes along Tharpe Street

Desire lanes are paths that result from on-going pedestrian foot traffic and can be found at multiple locations along Tharpe Street. This not only lacks pedestrian safety benefits but also uniformity throughout the corridor. Prevalence of desire lanes signify the need for sidewalks (see **Figure 7**).

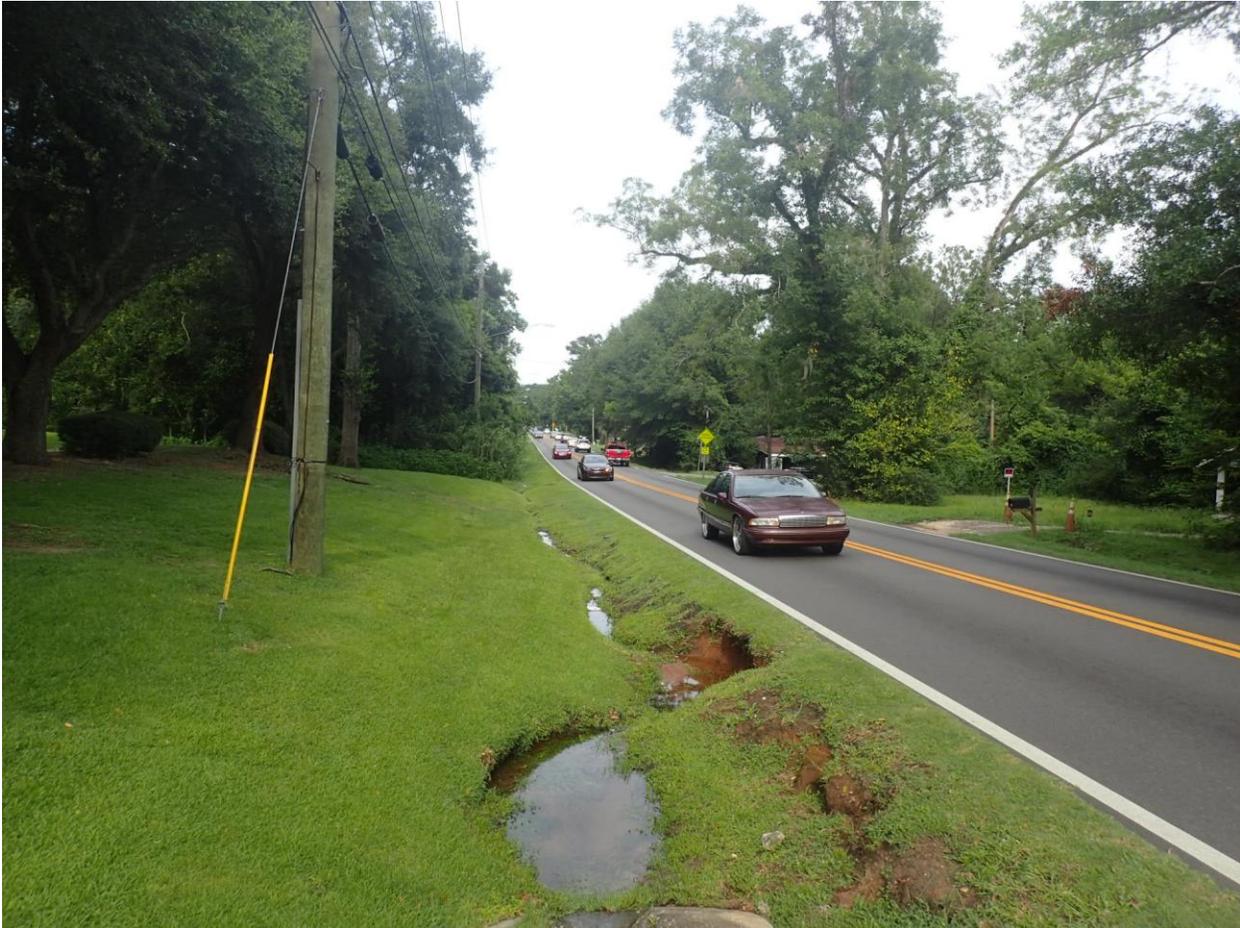
Figure 8. Slope Erosion Caused By Stormwater Runoff along Tharpe Street

Evidence of roadside erosion can be observed throughout the corridor. Existing conditions show roadway drainage traveling to nearby roadside ditches that transports water runoff to the nearest outfall point (see **Figure 8**). Presently, no stormwater treatment is provided for the roadway other than the flow time in grassed ditches.

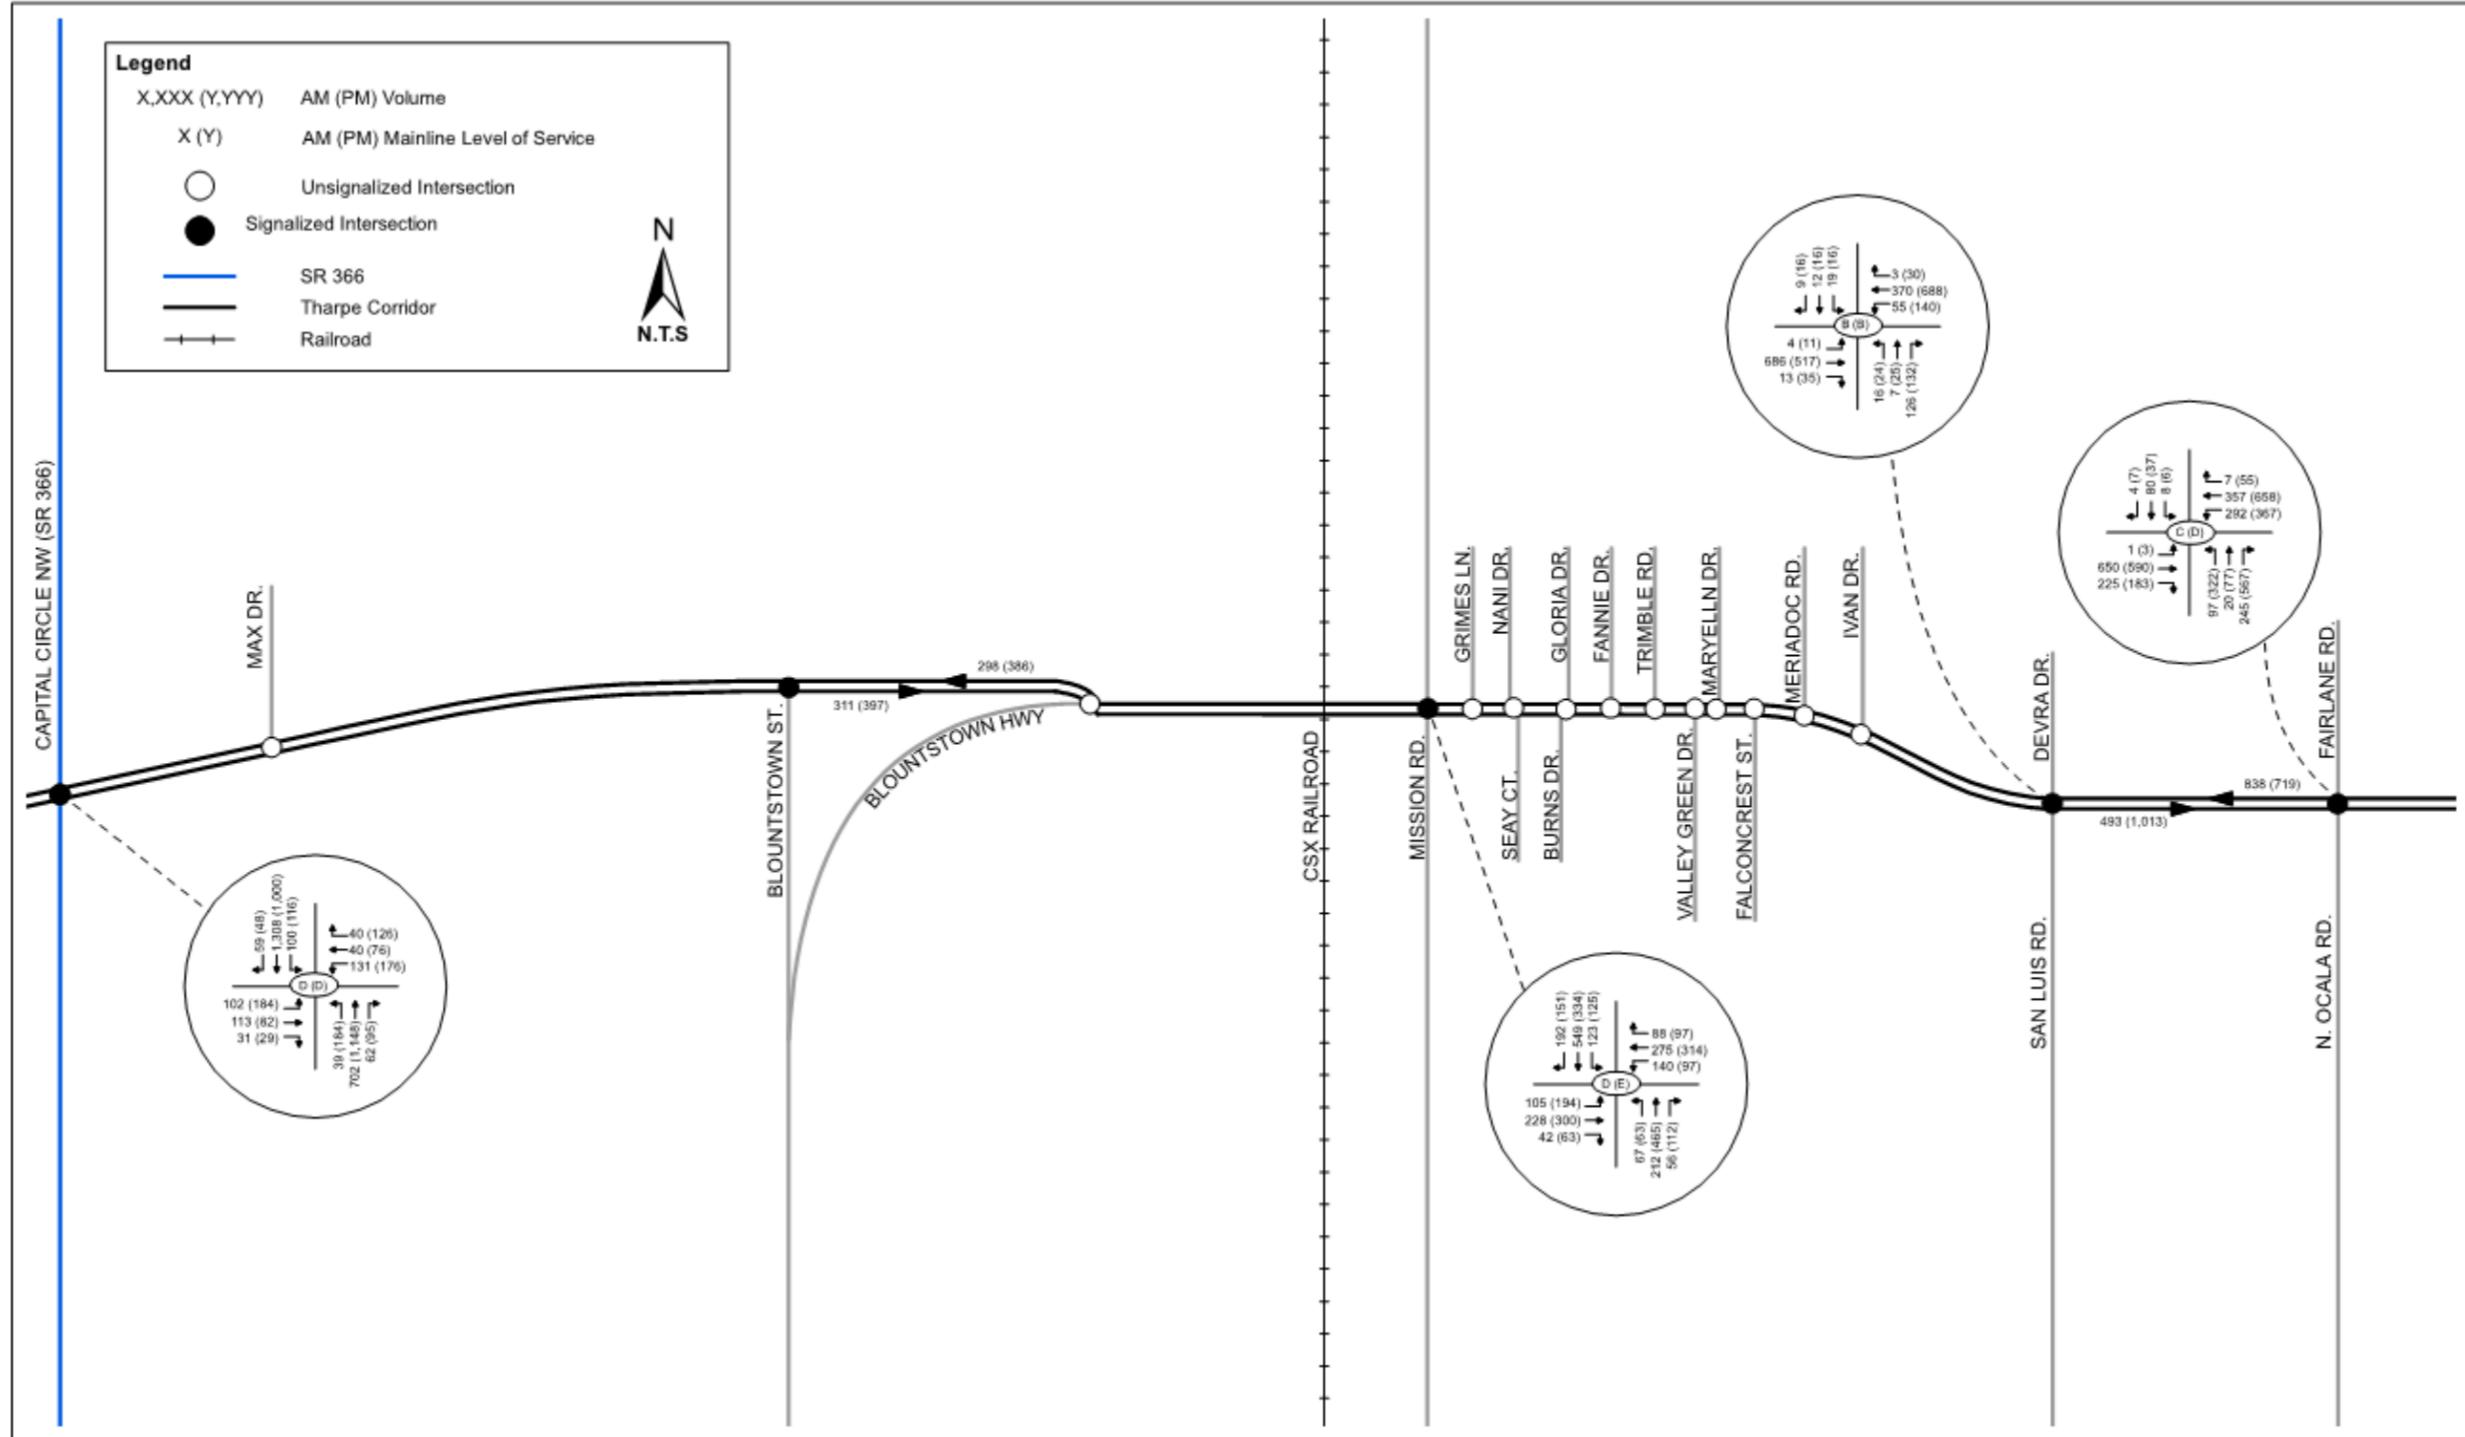
Figure 9. Existing Peak Hour Volumes and Level of Service

Historical and county traffic sites provided the source of existing traffic for the Tharpe Street study area. Existing intersection analysis is summarized in **Table 3**. Under current conditions, the Mission Road intersection is not operating at an acceptable LOS for the peak hour. Mission Road operates at LOS E under existing traffic conditions, which does not meet established standards and would trigger the need for capacity improvements.

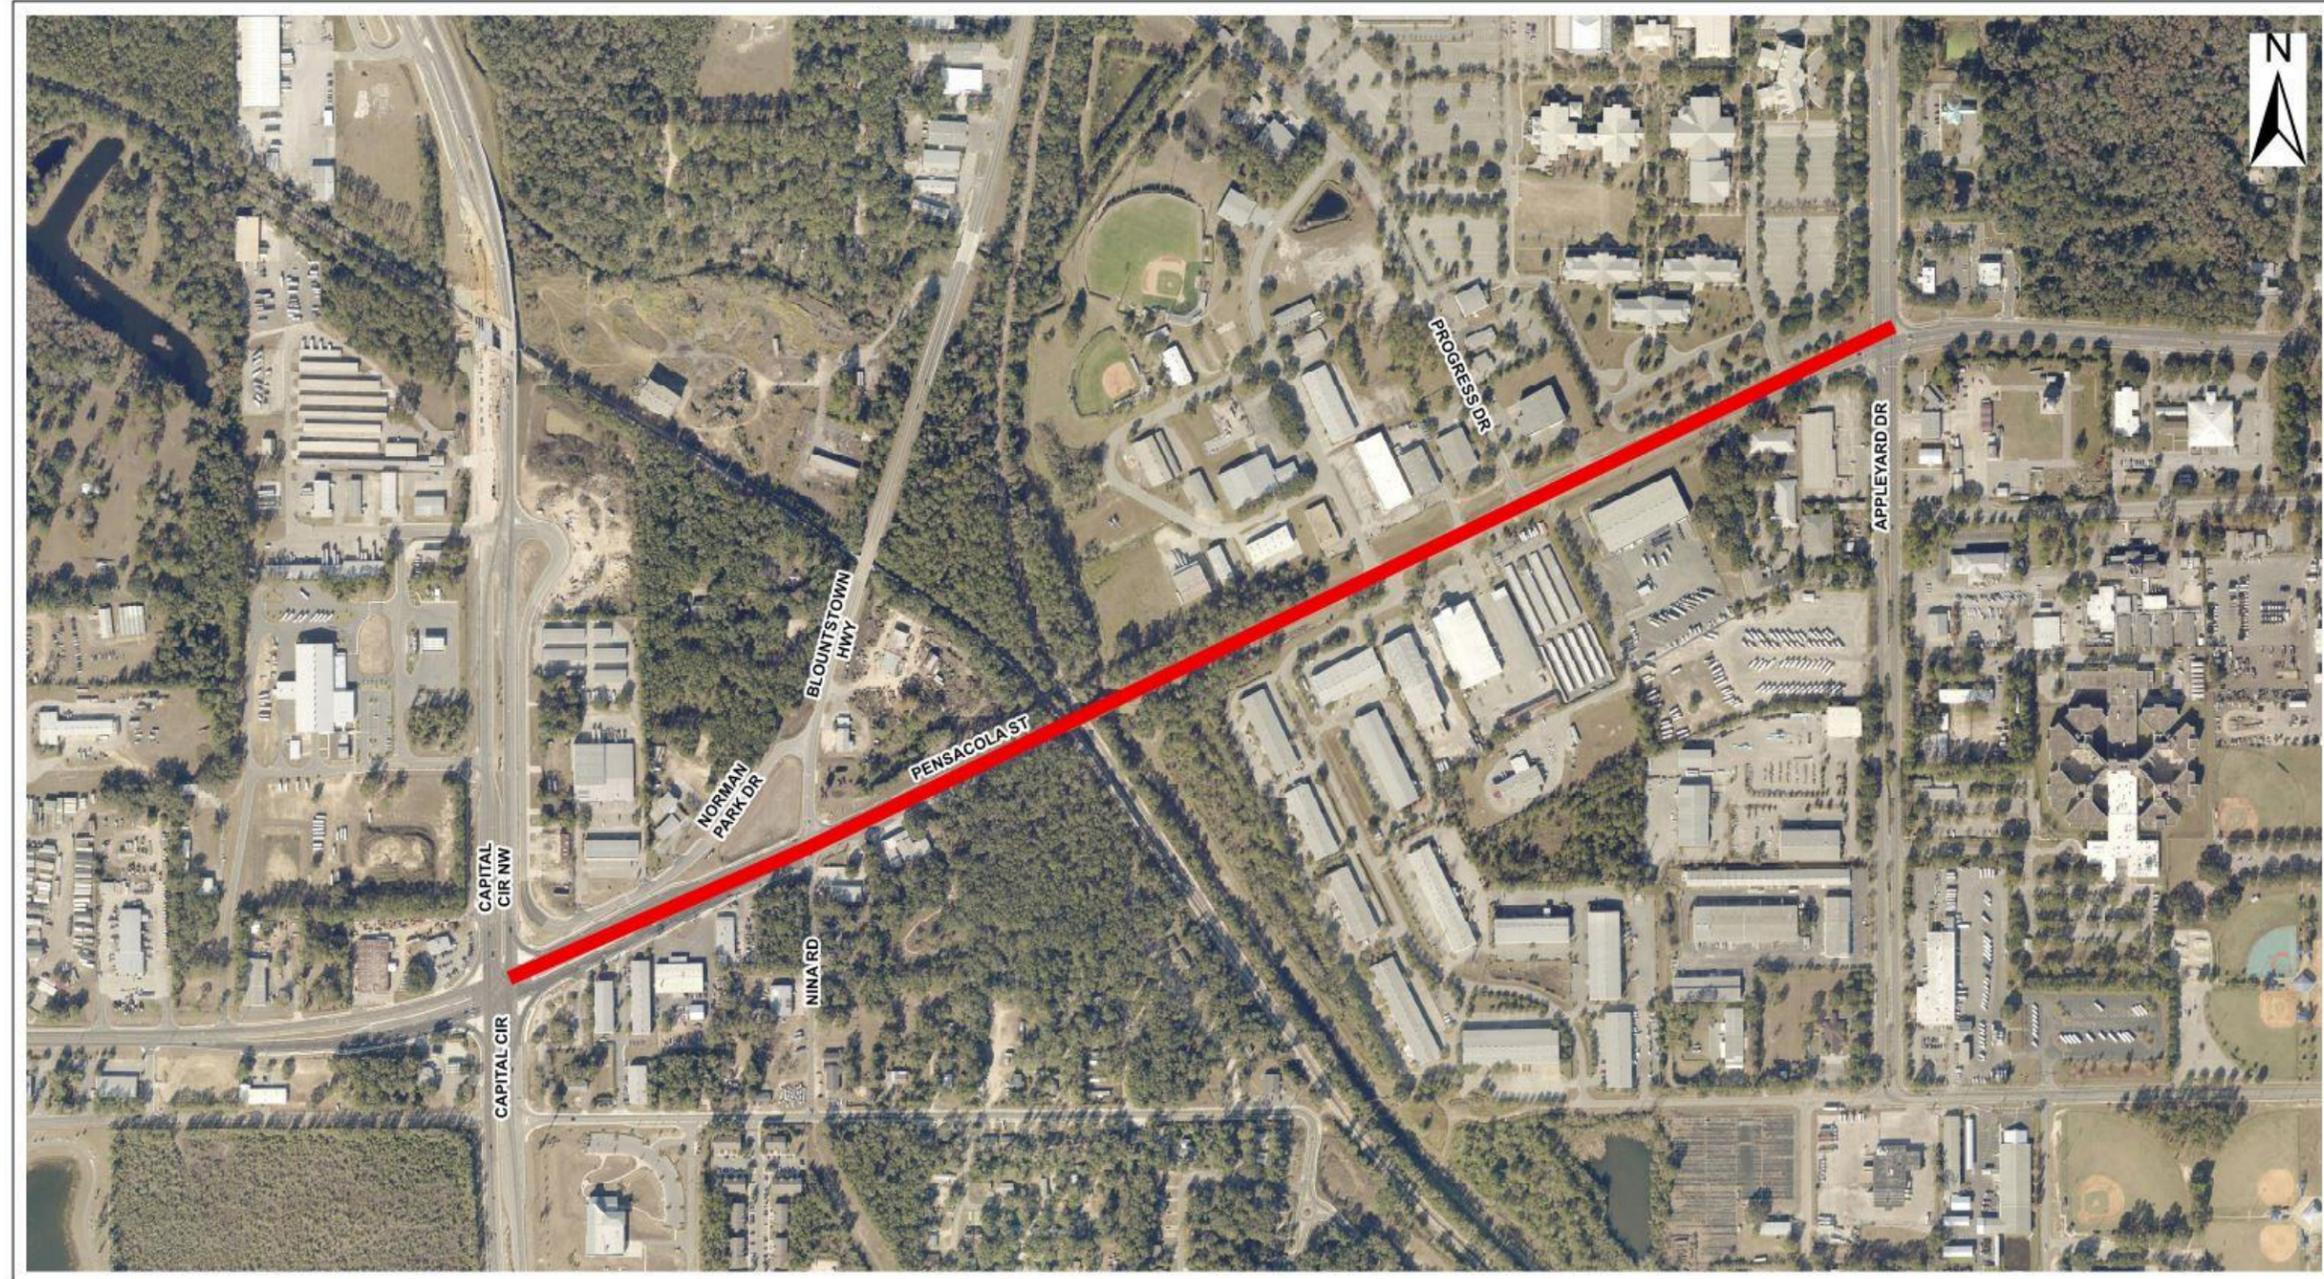
Figure 1. Study Limits

Capital Region Transportation Planning Agency’s (CRTPA) identified the need for additional capacity for Pensacola Street in the 2040 Regional Mobility Plan (RMP). The RMP proposes the widening of this corridor. The purpose of this study is to investigate existing and future conditions along Pensacola Street (SR 366) and identify potential projects to improve mobility and efficiency without major capacity expansions. This study will propose improvements from Appleyard Drive to Capital Circle (see **Figure 1**). Existing conditions were established using the following data sources listed in **Table 1** below:

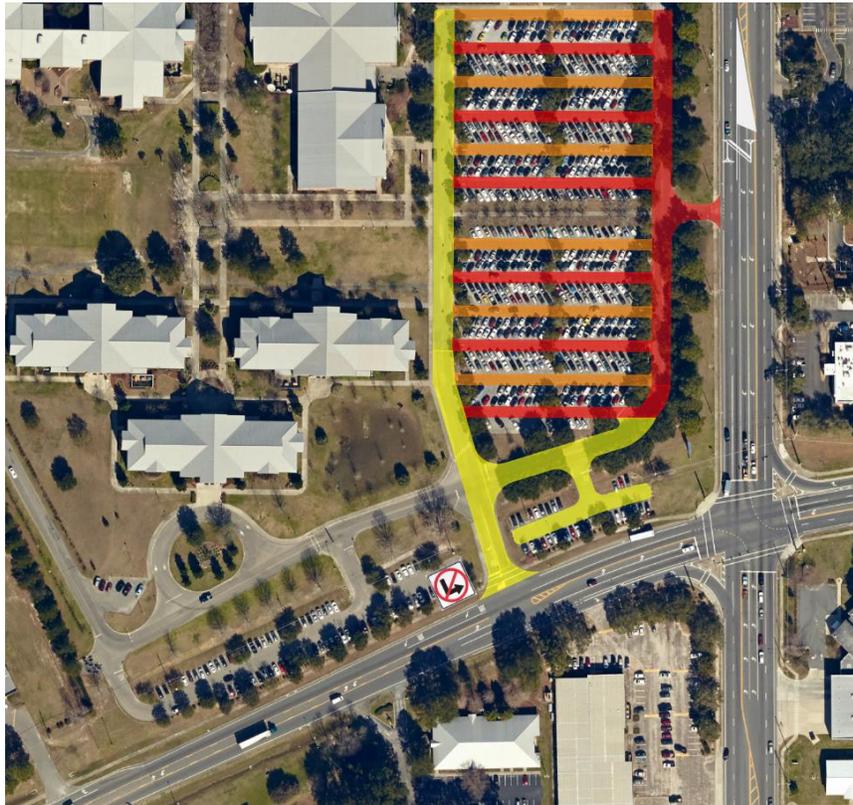
Figure 2. Typical Congestion from TCC Campus

Figure 2 above illustrates typical congestion conditions from high (red) to low (yellow). Field observations report drivers located in the southeast – Learning Commons - parking lot egress exit to the south onto Pensacola Street. Left turn movements are restricted at this location due to its proximity to the intersection at West Pensacola Street and Appleyard Drive. Despite left turn restrictions, motorists often make illegal left turns, crossing double yellow lane lines in U-turn maneuvers, utilizing private driveways to turn around. These traffic patterns exacerbate spot congestion during AM/PM peak hours.

Field observations report uniform dismissal from classes at Tallahassee Community College (TCC) as the primary cause of congestion along the corridor. The result is a short term spike in traffic as students and faculty begin to exit the TCC parking lot. As congestion worsens internally, motorists tend to follow a “path of least resistance” strategy.

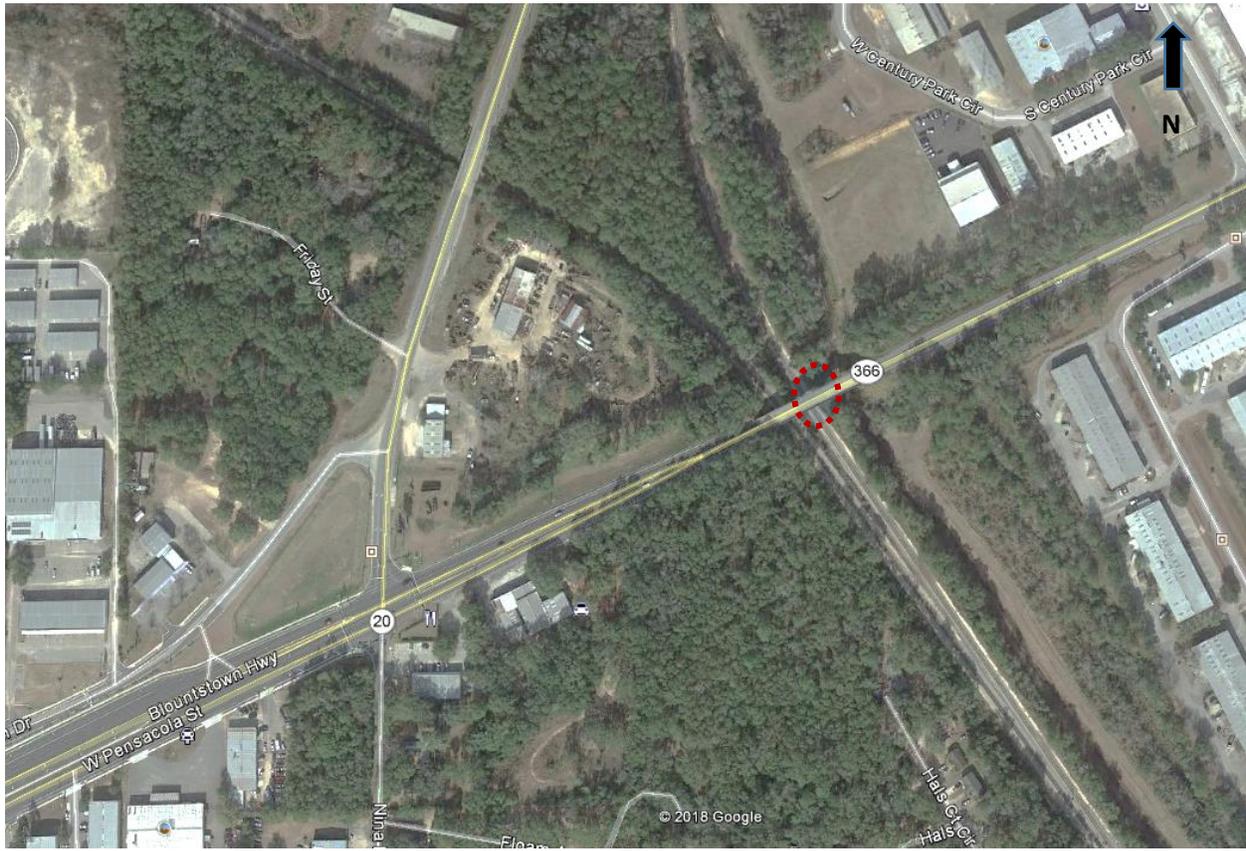
Figure 3. Bottleneck along Pensacola Street

Increased east bound traffic volumes are likely to occur due to the increased capacity of the 6-lane section of Pensacola Street. Furthermore, increase in traffic volumes would intensify congestion along Pensacola Street. For this purpose, the existing bottleneck is a candidate for remediation.

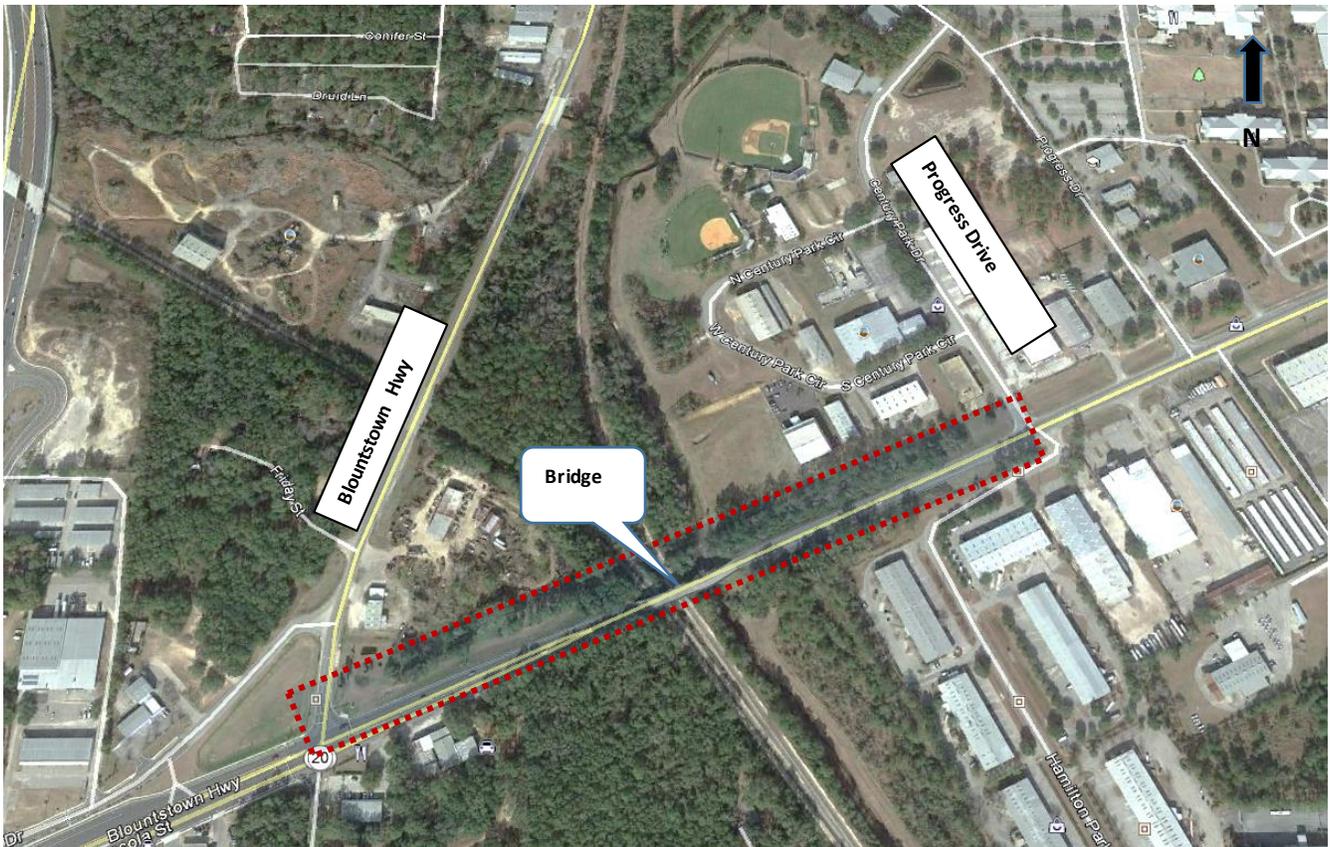
Figure 4. Lack of Bicycle/Pedestrian Facilities Along Pensacola Street

Currently, the 2-lane section between Blountstown Hwy and Progress Drive lacks bike and pedestrian facilities (see **Figure 4**). For this reason, cyclists and pedestrians are given no choice but to travel along grassed areas to avoid interaction with motorists. However, grassed ditches are not always made available. The bridge located in this section poses a high risk area for pedestrians as they are given no choice but to travel on the roadway with vehicular traffic.

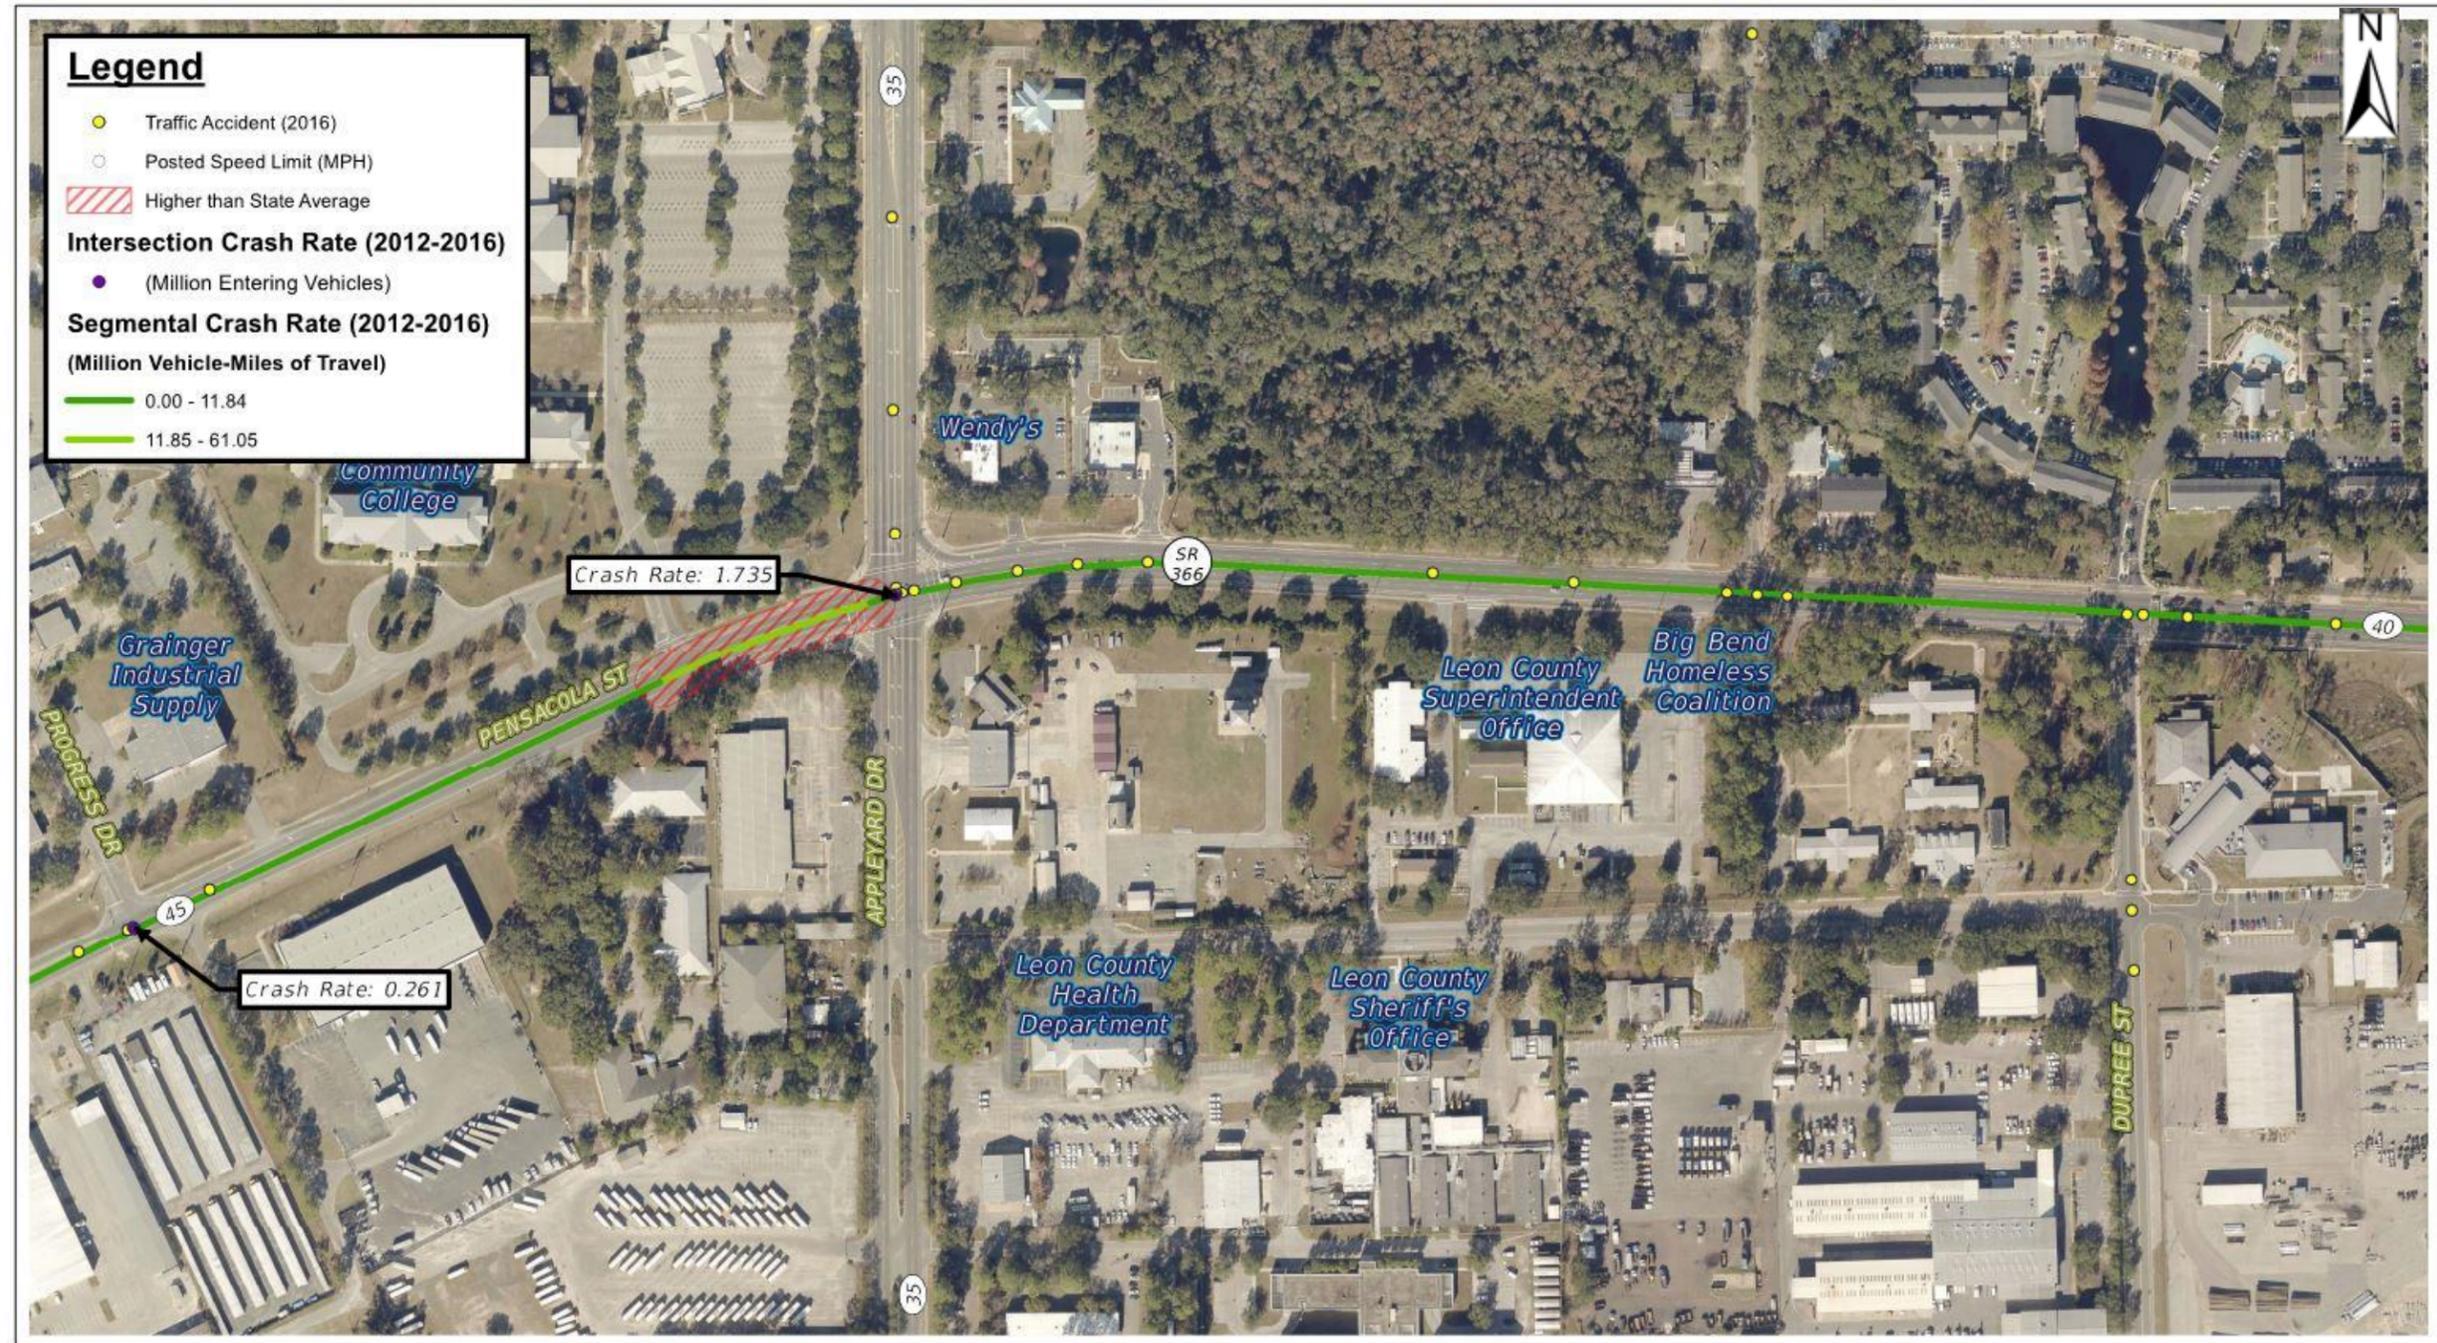
Figure 6. Highest Reported Crash Rate Along Pensacola Street

As described in **Figure 6**, the highest incidence of crashes occurs at the existing two-way access point near the intersection at Appleyard Dr. Managing access and reducing illegal movements will contribute to improved safety conditions along the corridor.
