RETREAT AGENDA ITEM
CRTPA CORRIDOR REPORTS

CRTPA
TRAFFIC AND OPERATIONS ANALYSIS
THARPE STREET

DRAFT RECOMMENDATIONS

October 2018

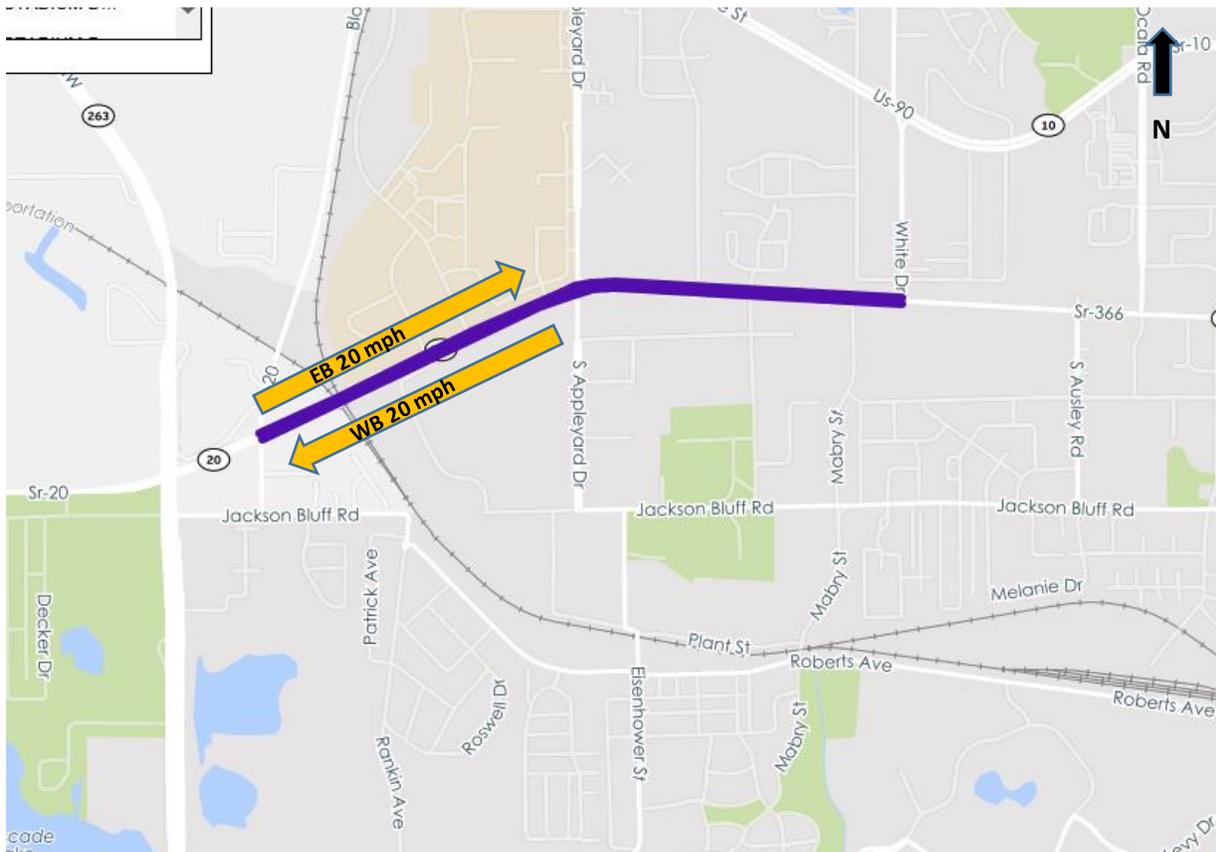
Figure 7. Generalized AM/PM Peak Hour Travel Speeds

Westbound congestion analysis report average travel speed between Appleyard Drive and Blountstown Hwy as 20 miles-per-hour (mph) between the AM/PM peak hours (see **Figure 7**). This is significantly lower than the current posted speed limit of 45 mph. Similar results are reported for eastbound traffic. **Figure 8** illustrates the congestion scan output used to generalize average travel speed along Pensacola Street.

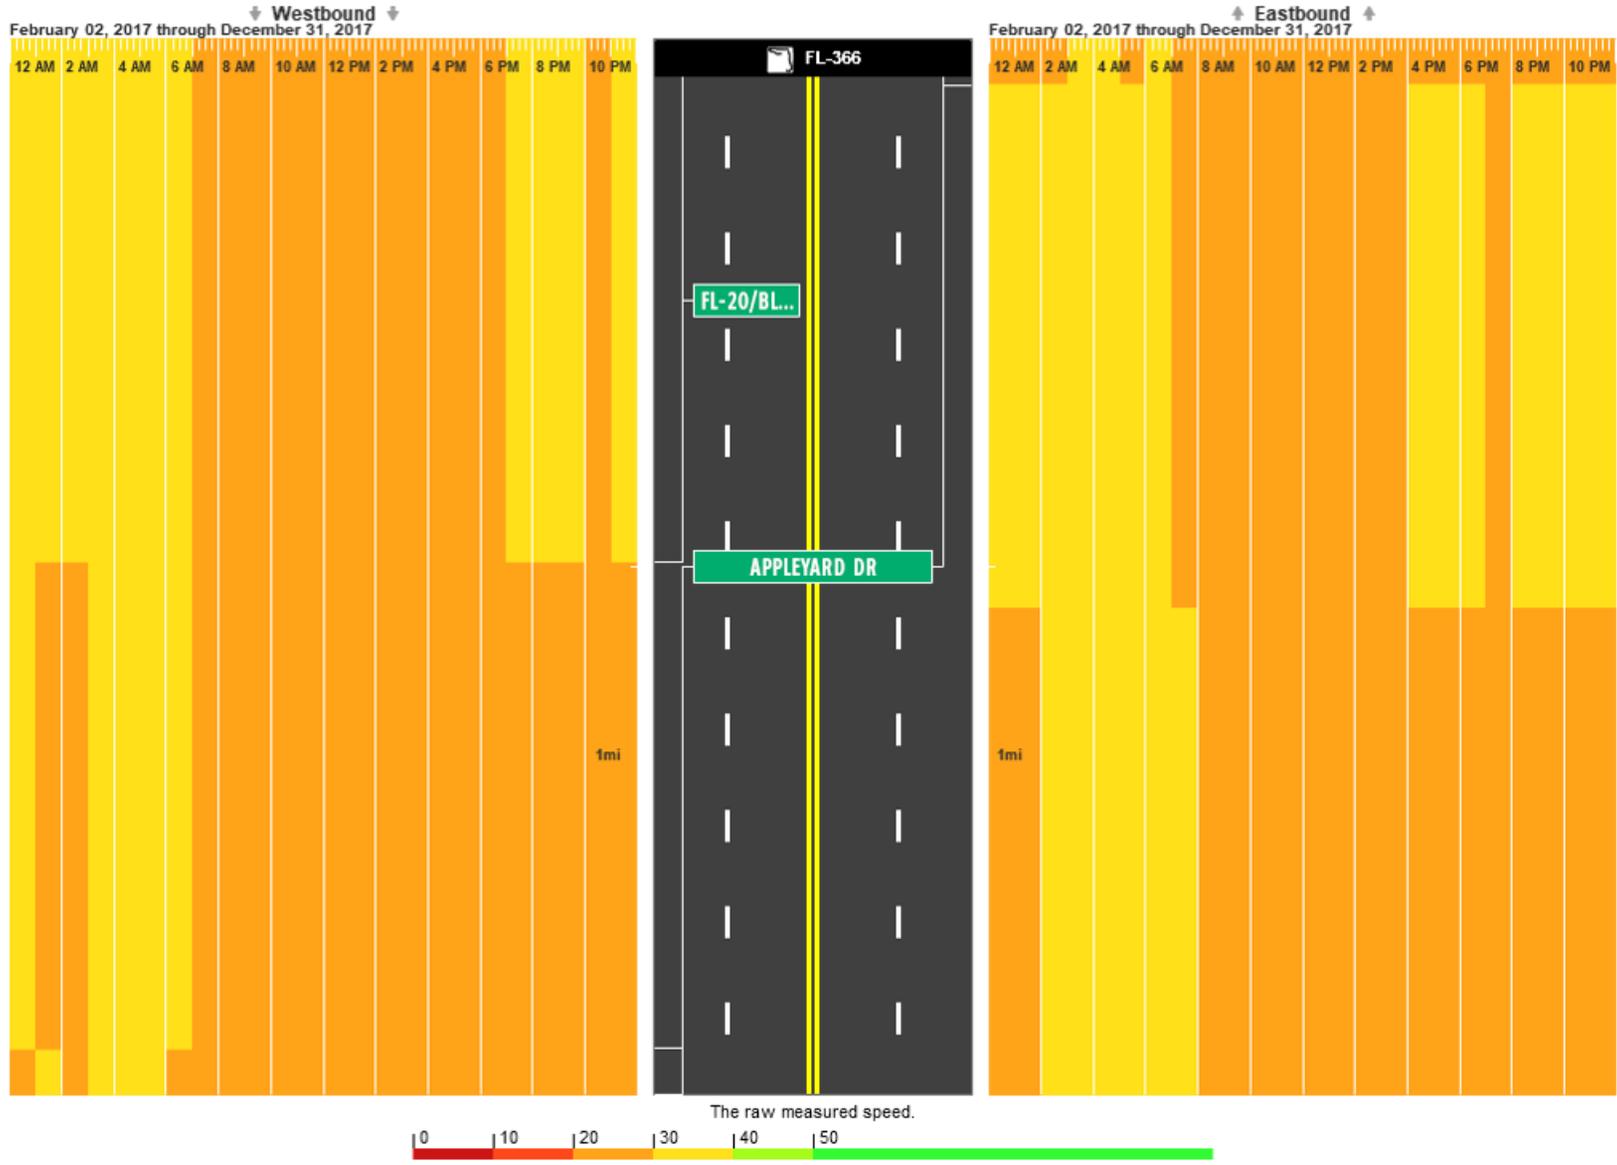
Figure 8. Pensacola Street Corridor Scan

Congestion scans show how peak periods vary by roadway facility and location and help determine the number of congested hours that occur on a roadway. As a tool, it can indicate the cause of congestion at a certain location. INRIX is a private company that collects and process speed and travel time statistics gathered by volunteering individual vehicles equipped with global positioning system (GPS) tracking devices. Corridor scans utilize predetermined roadway links set forth by the Federal Highway Associate (FHWA). The existing link that encompass our study area lies between White Drive and Blountstown Hwy. Using INRIX data records, a corridor scan was performed for Pensacola Street.

Averaged by 1 hour for February 02, 2017 through December 31, 2017

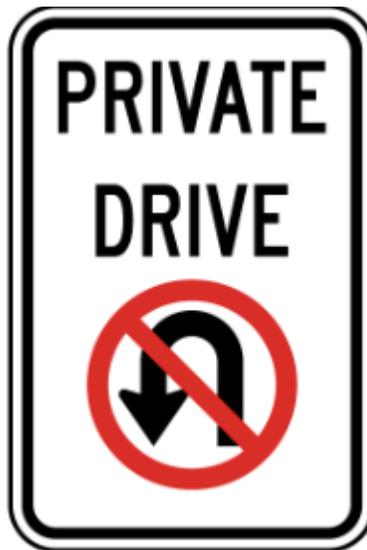
Figure 9. Proposed No U-Turn Sign

As a low-cost alternative to address one of these unadvised movements, the addition of signage may deter a portion of motorists (see **Figure 9**). With the consent of all parties, a "Private Drive, No U-Turn" sign is proposed to be placed at the entrance(s) of Disc Village, Grainger, and/or Pepsico.

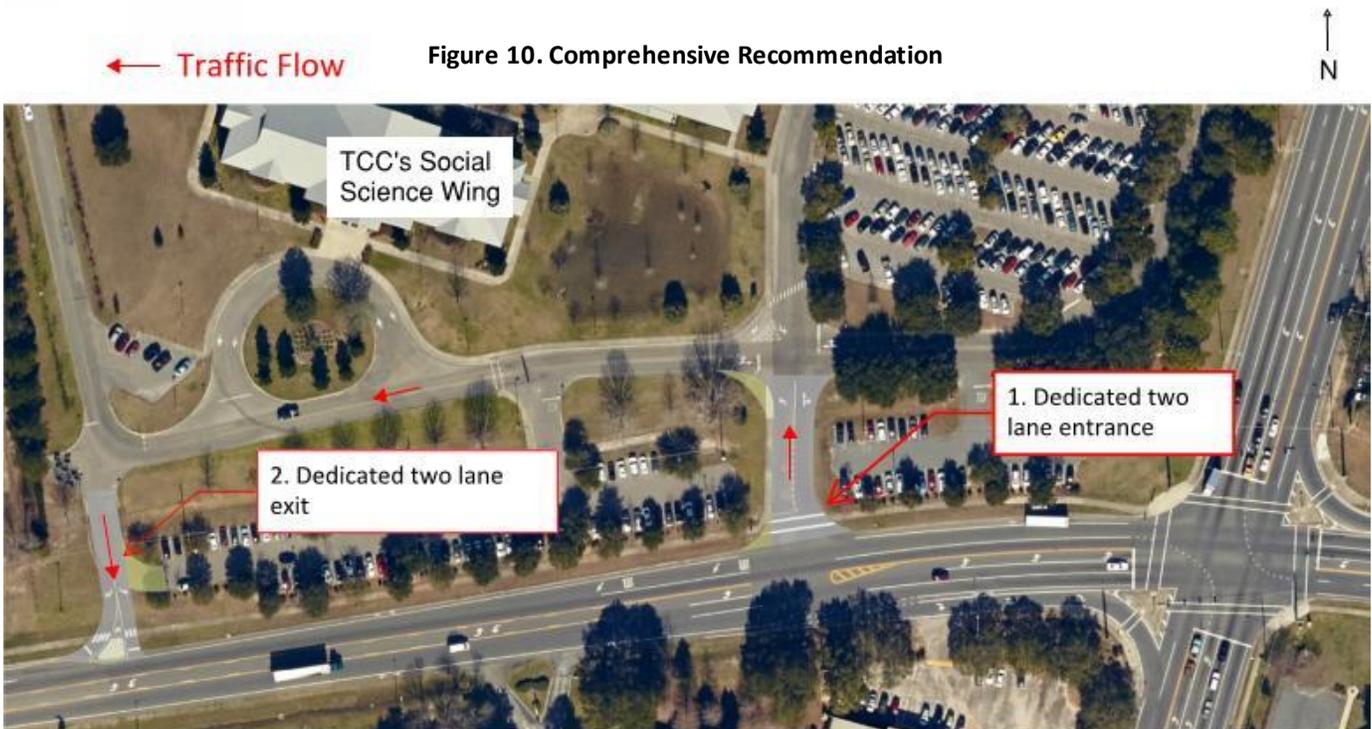
A more comprehensive solution to the issues described above involves reconfiguring the points of access to TCC from Pensacola. The first element of the proposed scheme involves creating a dedicated two lane entrance for TCC. The entrance will be restriped to create both a left turn and right through lane.

A second element involves the addition of a two-lane dedicated exit -- southwest of the Social Science Wing of TCC (see **Figure 10**). Locating this access further upstream from the Pensacola/Appleyard intersection allows motorists to safely make left turns eastward without affecting the queue and increasing the site distance of oncoming traffic. Minor striping changes, depicted below, will need to take place in order to guide motorists in a seamless fashion. Additionally, "Do Not Enter" signs will be warranted at the heads of the one way pair to alert drivers who may be unaware of the scheme.
