**Trees Along Thomasville Road Between Betton Road and
Metropolitan Boulevard (Data Collected as of August 2021)**

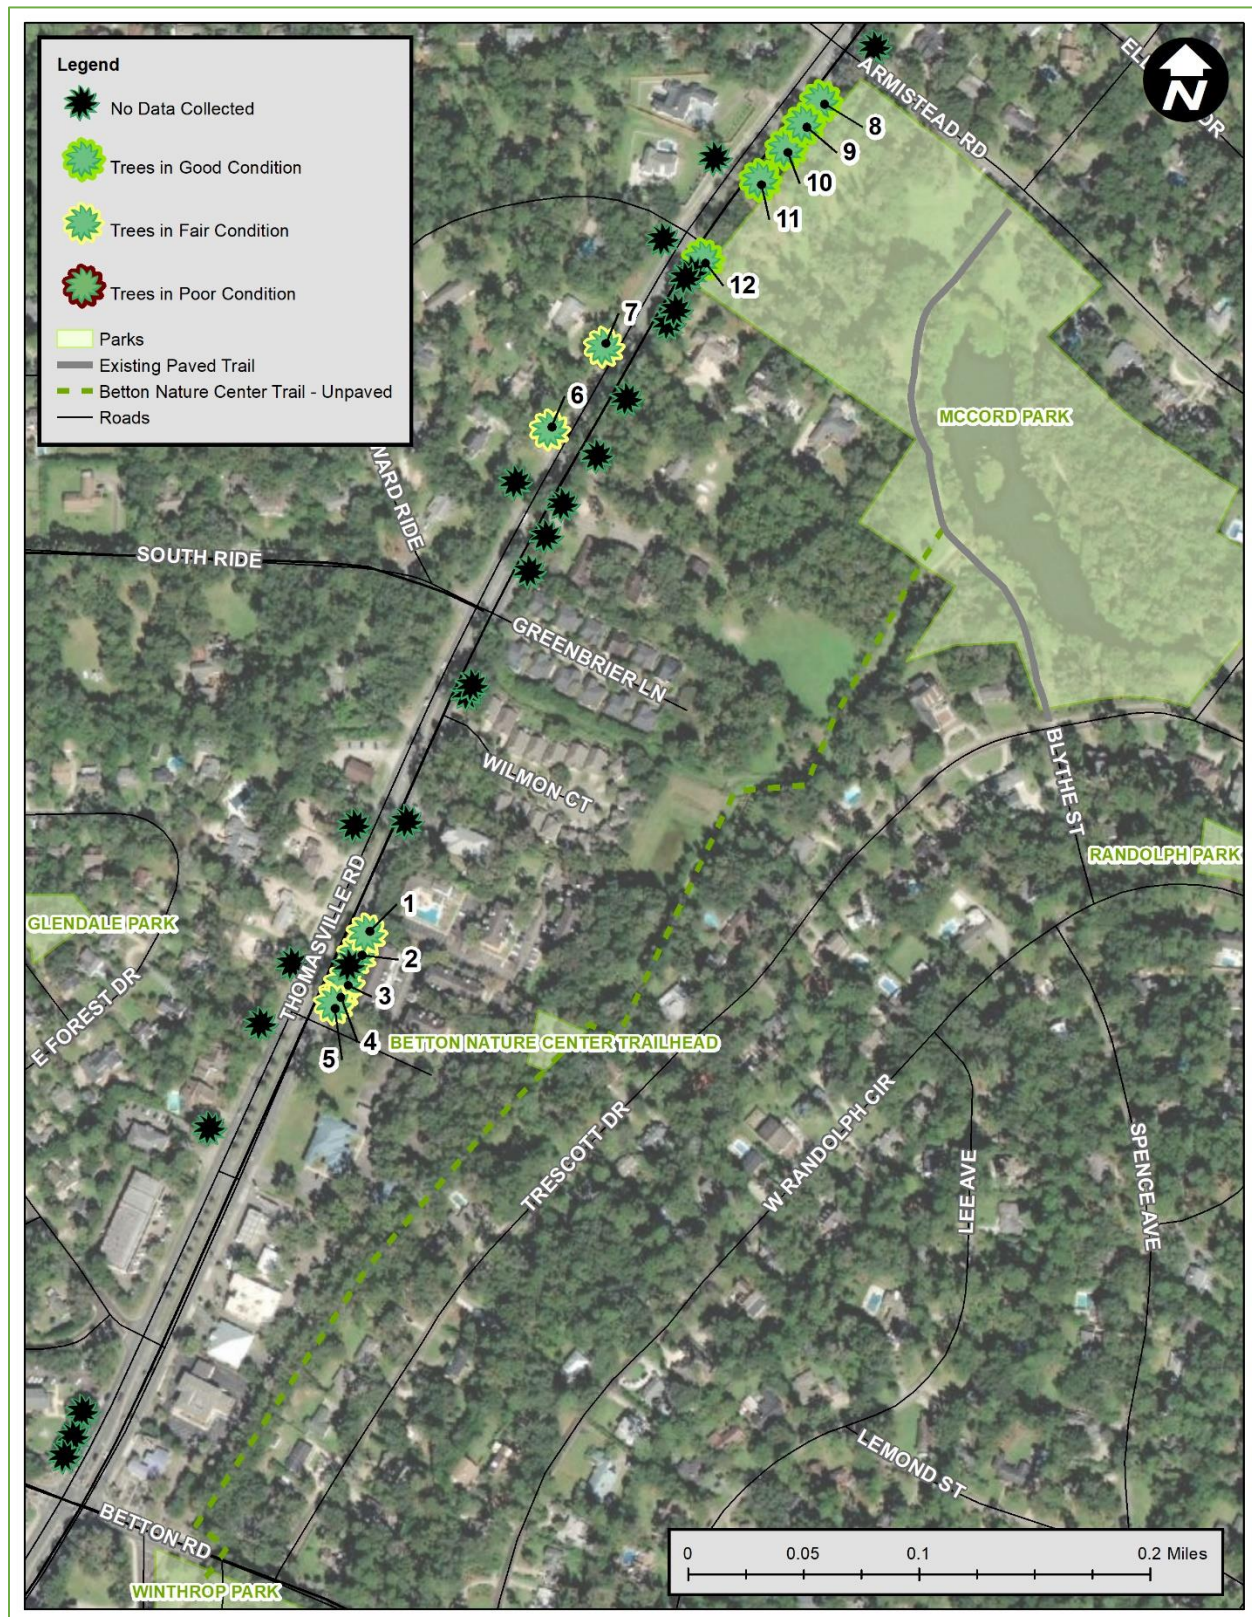
Figure 1. Trees – Segment 1

<u>Map Reference</u>	<u>Tree</u>	<u>Condition</u>	<u>Side of Corridor</u>	<u>Location</u>	<u>Characteristics</u>
<u>Segment 1: Betton Road to Armistead Road</u>					
1	21" live oak	Fair	East	North of Post Road	Trimmed for utility lines, somewhat one-sided canopy
2	15" live oak	Fair	East	North of Post Road	Trimmed for utility lines, somewhat one-sided canopy
3	26" live oak	Fair	East	North of Post Road	Trimmed for utility lines, somewhat one-sided canopy, Heritage tree
4	27" live oak	Fair	East	North of Post Road	Trimmed for utility lines, somewhat one-sided canopy, Heritage tree
5	22" live oak	Fair	East	North of Post Road	Trimmed for utility lines, somewhat one-sided canopy, Heritage tree
6	24" live oak	Fair	West	Between South Ride and North Ride	
7	42" live oak	Fair	West	Between South Ride and North Ride	Multi-stem live oak
8	19" sugar maple	Good	East	McCord Park, south of Armistead Road	
9	31" live oak	Good	East	McCord Park, south of Armistead Road

10	21" live oak	Good	East	McCord Park, south of Armistead Road	Somewhat weak canopy due to shade competition
11	31" live oak	Good	East	McCord Park, south of Armistead Road	
12	15" live oak	Good	East	McCord Park, south of Armistead Road	
<u>Segment 2: Armistead Road to Woodgate Way</u>					
13	33" live oak	Fair	West	South of Mimosa Drive	
14	23" water oak	Poor	West	South of Mimosa Drive	Major decay
15	70" live oak	Good	West	South of Mimosa Drive	Some canopy decline typical of older trees

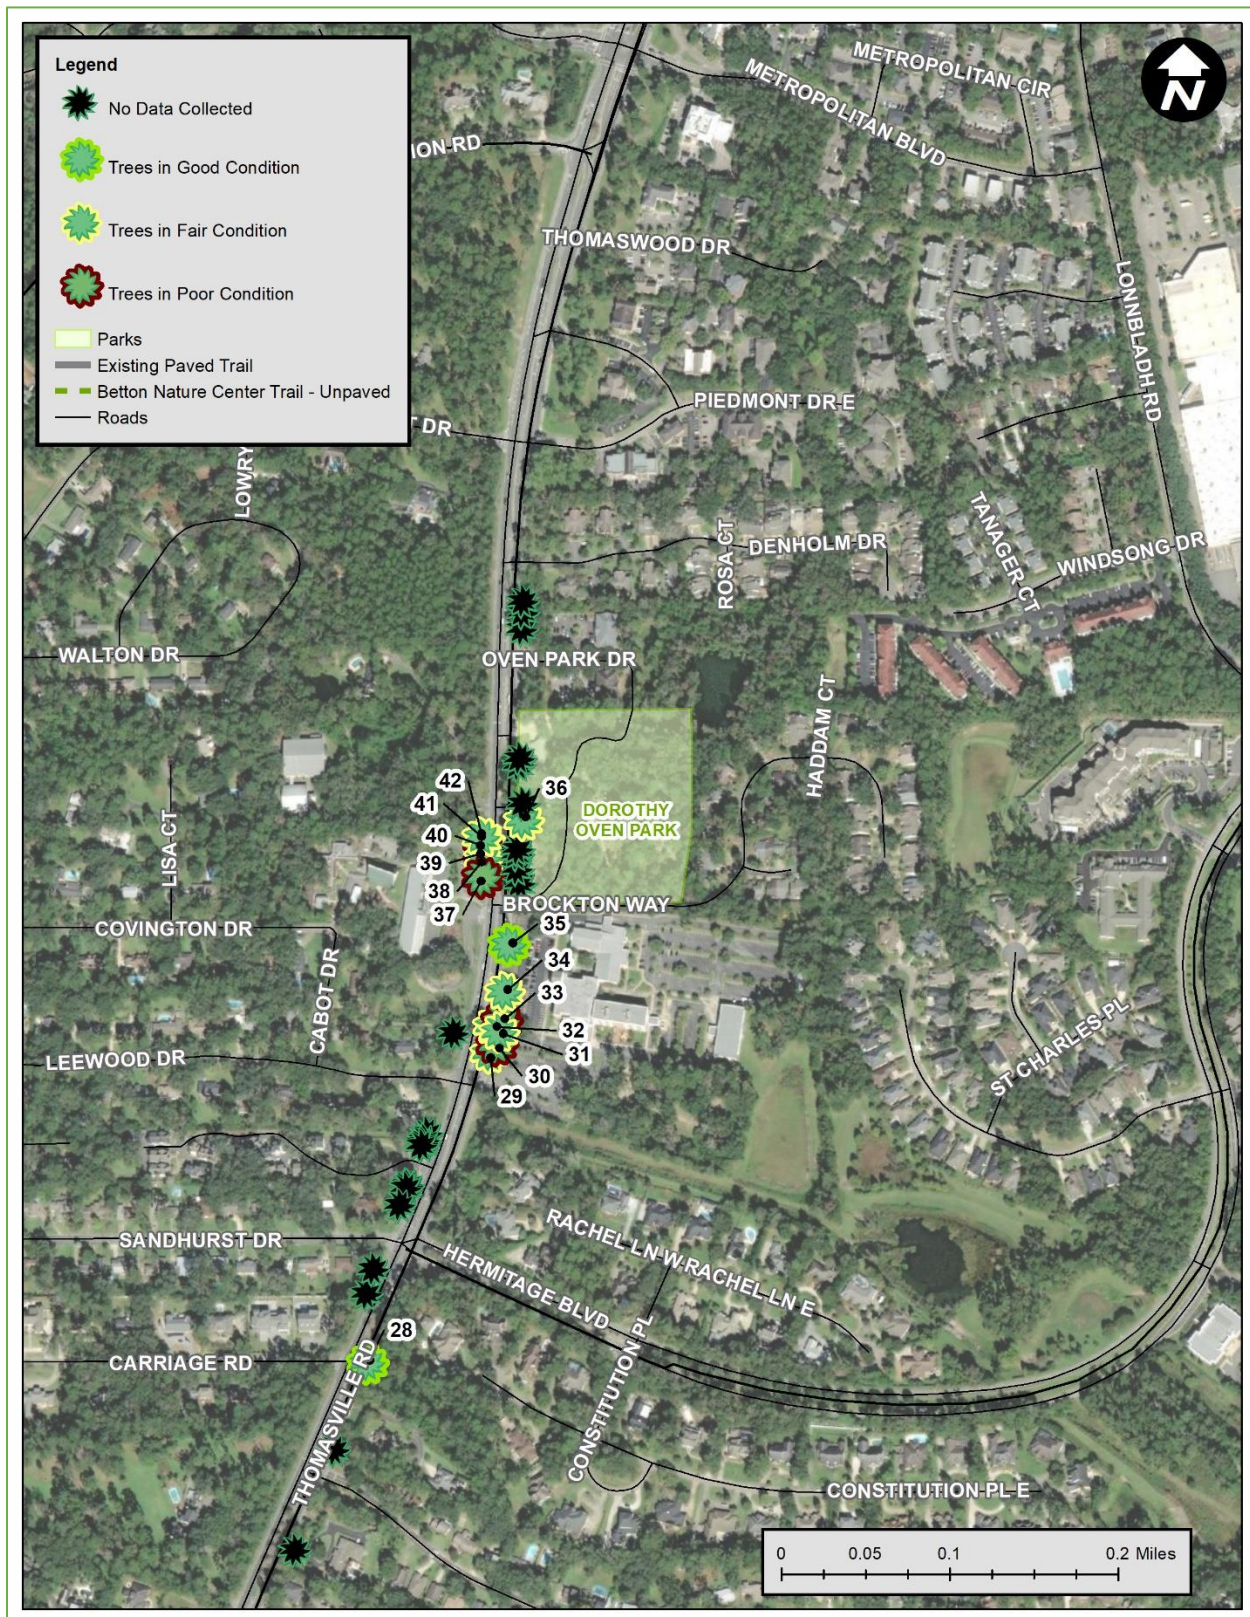
Figure 3. Trees – Segment 3

27	28" live oak	Fair	West	North of Penny Lane	Trimmed for utility lines, one-sided canopy
<u>Segment 3: Woodgate Way to Metropolitan Boulevard</u>					
28	46" live oak	Good	East	South of Hermitage Boulevard	Previous root impact
29	Live Oak	Fair	East	In front of Thomasville Road Baptist Church	In decline, with thin canopies, missing branches, and some degree of cavity and decay
30	Live Oak	Poor	East	In front of Thomasville Road Baptist Church	In decline, with thin canopies, missing branches, and some degree of cavity and decay
31	Live Oak	Fair	East	In front of Thomasville Road Baptist Church	In decline, with thin canopies, missing branches, and some degree of cavity and decay

<u>Map Reference</u>	<u>Tree</u>	<u>Condition</u>	<u>Side of Corridor</u>	<u>Location</u>	<u>Characteristics</u>
32	Live Oak	Fair	East	In front of Thomasville Road Baptist Church	In decline, with thin canopies, missing branches, and some degree of cavity and decay
33	Live Oak	Poor	East	In front of Thomasville Road Baptist Church	In decline, with thin canopies, missing branches, and some degree of cavity and decay
34	Live Oak	Fair	East	In front of Thomasville Road Baptist Church	In decline, with thin canopies, missing branches, and some degree of cavity and decay
35	Live Oak	Good	East	In front of Thomasville Road Baptist Church	
36	Live Oak	Fair	East	In front of Dorothy B. Owen Park	Large cavity/decay
37	Water Oak	Poor	West	In front of School of Arts and Sciences	Trimmed for utility lines, one-sided canopy
38	Water Oak	Fair	West	In front of School of Arts and Sciences	Trimmed for utility lines, one-sided canopy

39	Unknown	Dead	West	In front of School of Arts and Sciences	Trimmed for utility lines, one-sided canopy
40	Sweetgum	Fair	West	In front of School of Arts and Sciences	Trimmed for utility lines, one-sided canopy
41	Laurel Oak	Fair	West	In front of School of Arts and Sciences	Trimmed for utility lines, one-sided canopy
42	Sweetgum	Fair	West	In front of School of Arts and Sciences	Trimmed for utility lines, one-sided canopy
