## **CITIZENS MULTIMODAL ADVISORY COMMITTEE (CMAC)**

**MEETING OF TUESDAY, MARCH 5, 2024  
(11:30 AM – 1:30 PM)**

**A. CRTPA Regional Freight Study**

**B. Congestion Management Plan**

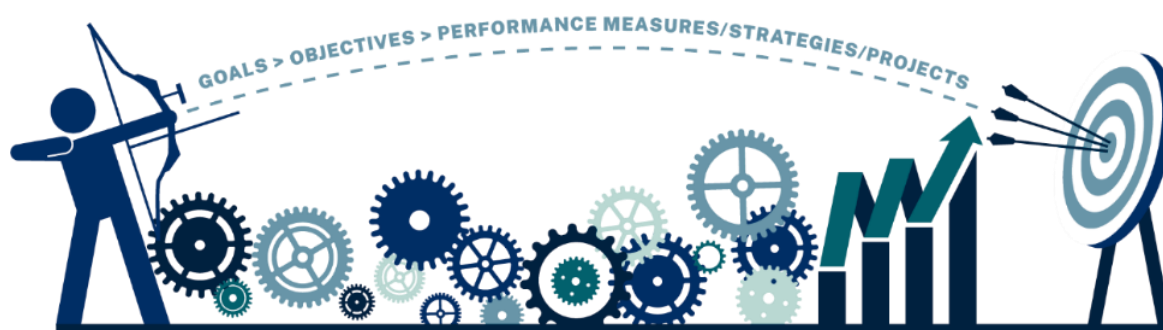
**Figure 4: Relationship of Key Components**

The relationship of the key components is shown in **Figure 4**.

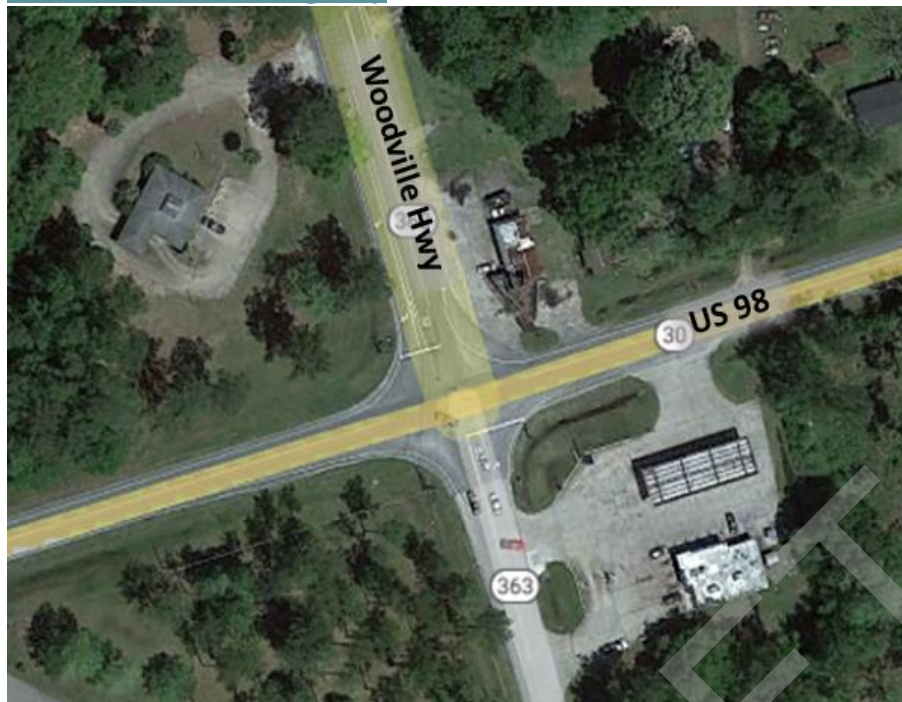
### US 98 and Woodville Highway

**Table 10: US 98 and Woodville Highway Fatal/Serious Injury Crash Data**

Year	All Crashes	Angle
2017	1	1
2018	0	0
2019	2	2
2020	0	0
2021	0	0
<b>TOTAL</b>	<b>3</b>	<b>3</b>

Additional Notes: Lighting could be considered at the intersection to enhance visibility.

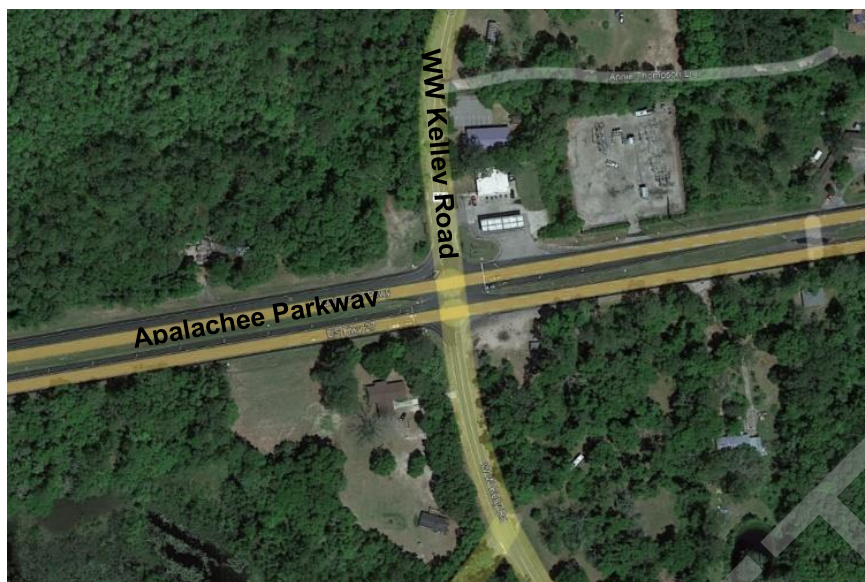
### Apalachee Parkway and WW Kelley Road

**Table 11: Apalachee Parkway and WW Kelley Road Fatal/Serious Injury Crash Data**

Year	All Crashes	Left Turn	Right Angle	Rollover
2017	1	1	0	0
2018	0	0	0	0
2019	2	0	1	1
2020	0	0	0	0
2021	0	0	0	0
<b>TOTAL</b>	<b>3</b>	<b>1</b>	<b>1</b>	<b>1</b>

1. Sight Distance
  - a. Remove tree debris and relocate “Hunt’s Pizza” sign in NE quadrant (sight distance issue).

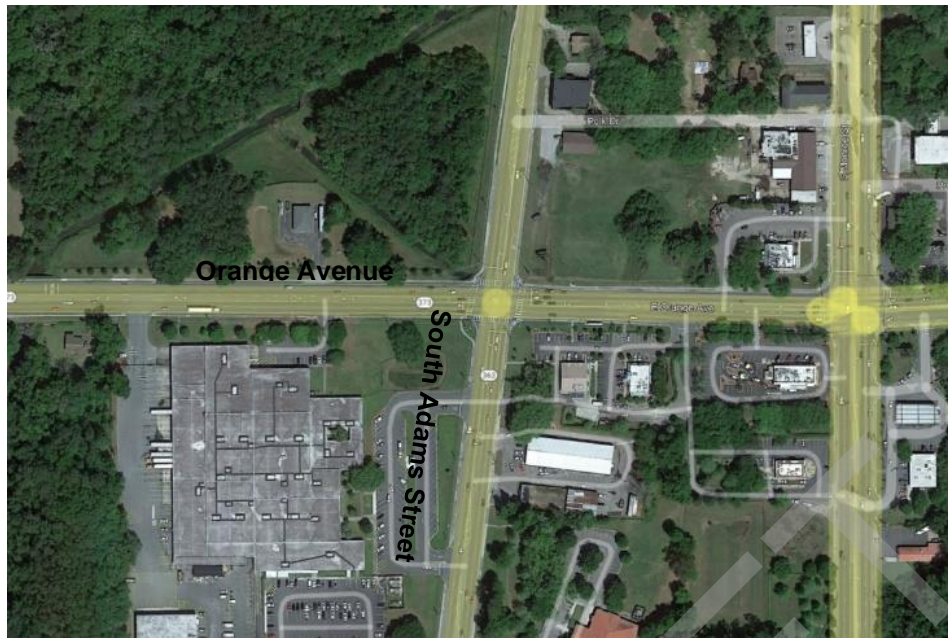
### Orange Avenue and South Adams Street

**Table 12: Orange Avenue and South Adams Street Fatal/Serious Injury Crash Data**

Year	All Crashes	Left turn	Angle	Rear End	Other
2017	2	0	0	1	1
2018	1	1	0	0	0
2019	1	1	0	0	0
2020	3	2	1	0	0
2021	0	0	0	0	0
<b>TOTAL</b>	<b>7</b>	<b>4</b>	<b>1</b>	<b>1</b>	<b>1</b>

1. Driveway Conflicts (2810 S Adams Street – Two driveways)
  - a. Relocate “Do Not Enter” sign to next driveway to the north.
  - b. Include “Right-Turn Only” signs for vehicles exiting the driveway.
  - c. Install SB “No Left Turn” signs on the south leg, right shoulder.

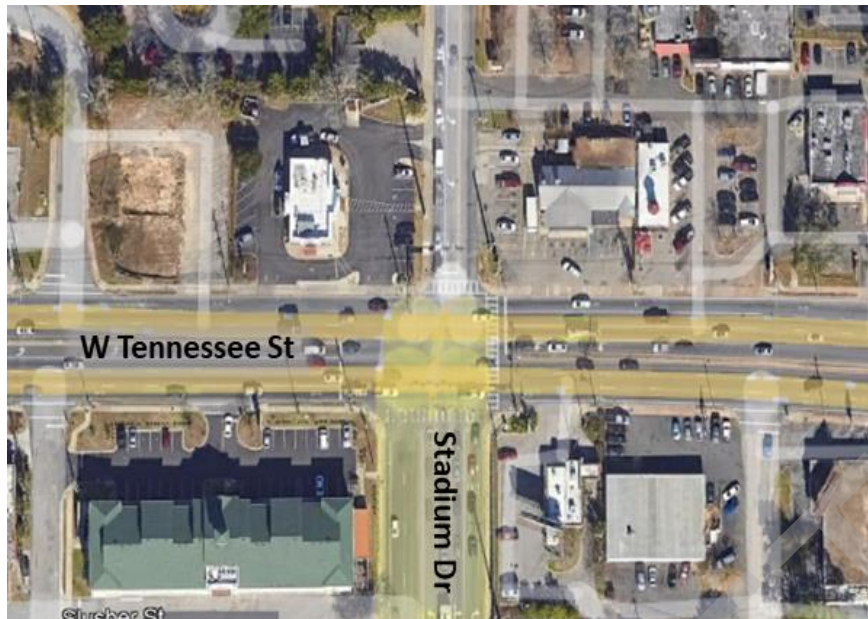
### West Tennessee Street and Stadium Drive

**Table 13: West Tennessee Street and Stadium Drive Fatal/Serious Injury Crash Data**

Year	All Crashes	Left Turn	Other
2017	3	1	2
2018	0	0	0
2019	1	0	1
2020	1	1	0
2021	1	0	1
<b>Total</b>	<b>6</b>	<b>2</b>	<b>4</b>

Additional Notes: Consider removing sharrows on W Tennessee Street.

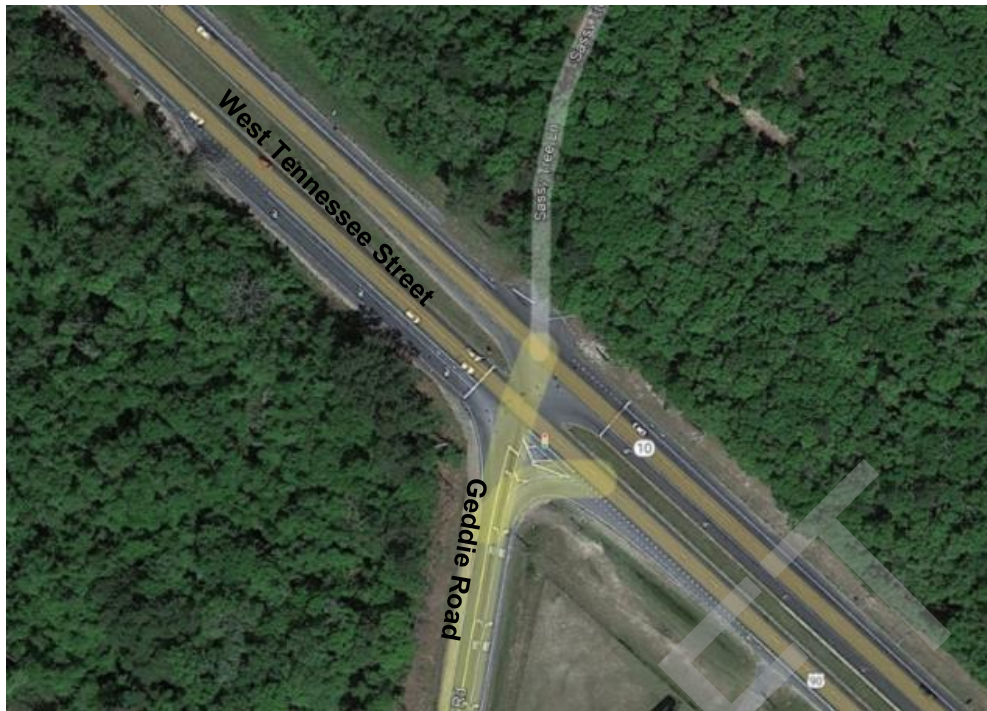
**Table 14: West Tennessee Street and Geddie Road Fatal/Serious Injury Crash Data**

Year	All Crashes	Rear End	Left Turn
2017	0	0	0
2018	1	1	0
2019	1	0	1
2020	1	1	0
2021	0	0	0
<b>TOTAL</b>	<b>3</b>	<b>2</b>	<b>1</b>

Additional Notes: Consider removing sharrows on W Tennessee Street.

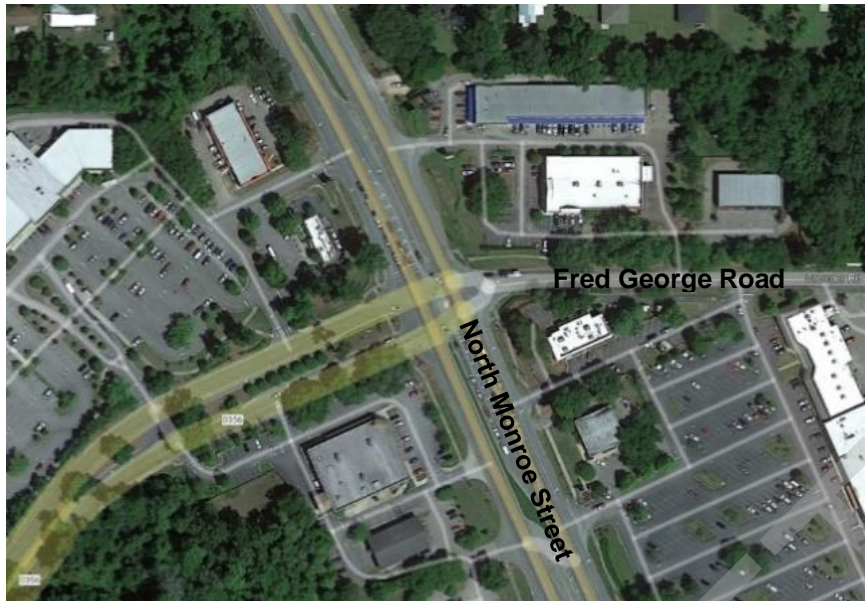
### North Monroe and Fred George Road

**Table 15: North Monroe Street and Fred George Road Fatal/Serious Injury Crash Data**

Year	All Crashes	Left Turn	Off Road
2017	1	0	1
2018	2	2	0
2019	0	0	0
2020	0	0	0
2021	0	0	0
<b>TOTAL</b>	<b>3</b>	<b>2</b>	<b>1</b>

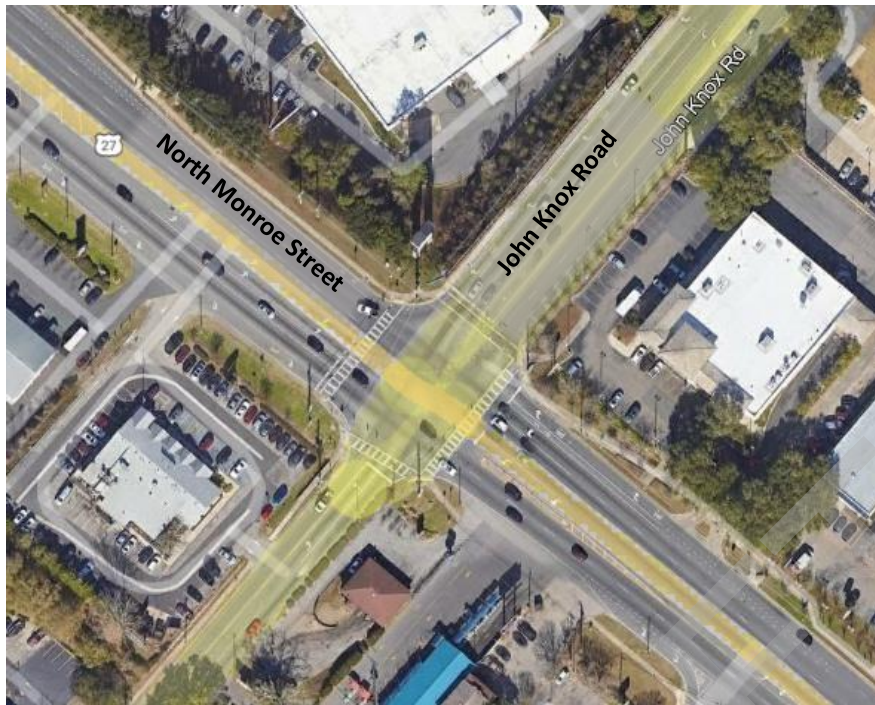
### North Monroe and John Knox Road

**Table 17: North Monroe Street and John Knox Road Fatal/Serious Injury Crash Data**

Year	All Crashes	Left Turn	Rear End
2017	2	1	1
2018	0	0	0
2019	1	1	0
2020	0	0	0
2021	1	0	1
<b>TOTAL</b>	<b>4</b>	<b>2</b>	<b>2</b>

1. Roadway Improvements
  - a. Consider median installation on N Monroe Street (northward) to reduce conflicting movements.
2. Signal Phasing
  - a. Change NB left-turn phase to "Protected Only."

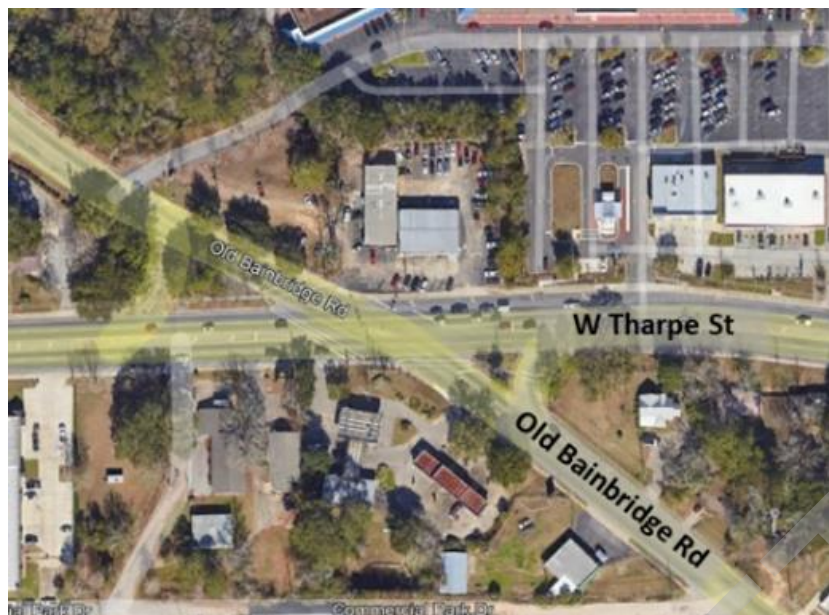
### West Tharpe Street and Old Bainbridge Road

**Table 18: West Tharpe Street and Old Bainbridge Road Fatal/Serious Injury Crash Data**

Year	All Crashes	Left Turn	Right Angle	Head On
2017	1	1	0	0
2018	0	0	0	0
2019	1	0	0	1
2020	0	0	0	0
2021	1	0	1	0
<b>TOTAL</b>	<b>3</b>	<b>1</b>	<b>1</b>	<b>1</b>

1. Signal Phasing
  - a. Change NB and SB left turn phases to "Protected Only."
2. Pavement Markings
  - a. Restripe dotted lane line extensions for left turns through the intersection.
3. Pedestrian Detection
  - a. Convert pedestrian detectors to "Countdown" and/or "Audible" detection signals.
  - b. Consider exclusive pedestrian phase (i.e., all traffic approaches stop when pedestrian detectors are activated)

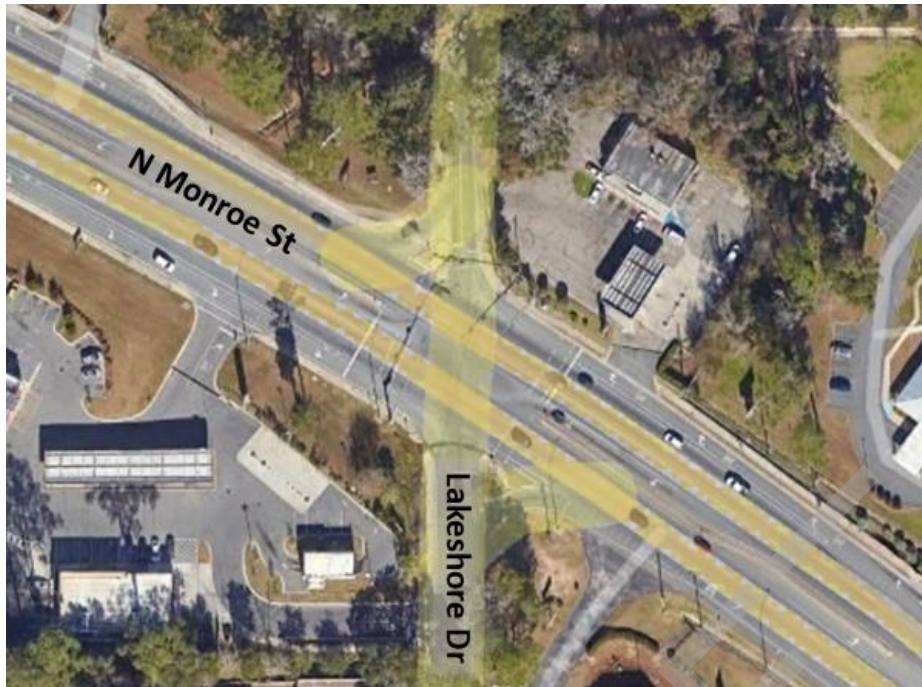
**North Monroe Street and Lakeshore Drive**

**Table 19: North Monroe Street and Lakeshore Drive Fatal/Serious Injury Crash Data**

Year	All Crashes	Pedestrian	Bicyclist
2017	0	0	0
2018	0	0	0
2019	1	0	1
2020	1	1	0
2021	1	1	0
<b>TOTAL</b>	<b>3</b>	<b>2</b>	<b>1</b>

Crashes at this intersection involved excessive speeding and pedestrian failure to yield right-of-way.

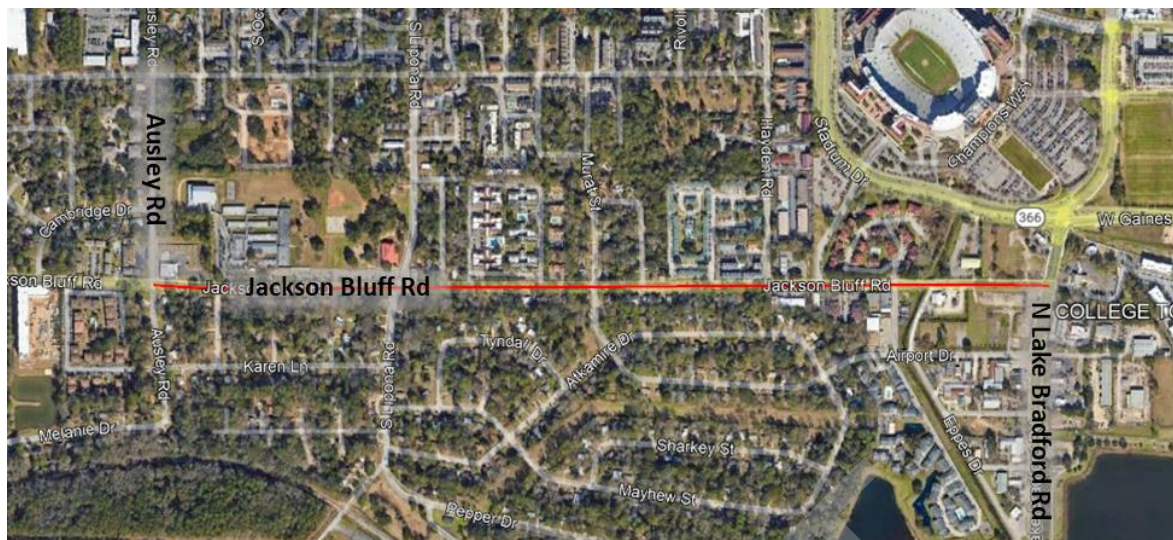
### Jackson Bluff Road between Ausley Road and North Lake Bradford Road

**Table 23: Jackson Bluff Road Fatal and Serious Injury Crash Data**

Year	All Crashes	Left Turn	Off Road	Other
2017	2	1	0	1
2018	0	0	0	0
2019	1	0	1	0
2020	0	0	0	0
2021	0	0	0	0
<b>TOTAL</b>	<b>3</b>	<b>1</b>	<b>1</b>	<b>1</b>

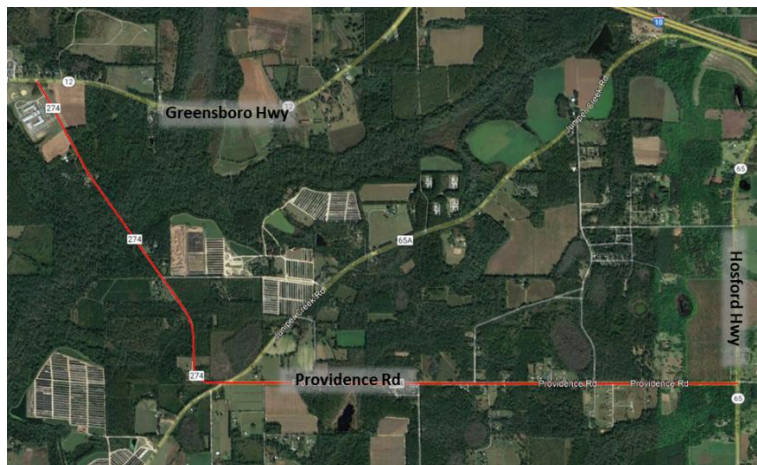
**Providence Road (Greensboro Highway to Hosford Highway)**

**Table 33: Providence Road Fatal and Serious Injury Crash Data**

Year	All Crashes	Left Turn	Pedestrian	Rollover
2017	0	0	0	0
2018	1	1	0	0
2019	0	0	0	0
2020	1	0	1	0
2021	1	0	0	1
<b>TOTAL</b>	<b>3</b>	<b>1</b>	<b>1</b>	<b>1</b>

1. Pavement Markings
  - a. Restripe segment (Striping currently faded/not visible).
  - b. Replace reflective markers on segment (90% of markers are currently missing).
2. Speed Limit Signage
  - a. Install eastbound speed limit signs on the segment.
3. Providence Road and Noah Lane/Union Chapel Road
  - a. Provide advance intersection warning signs.
  - b. Provide striping for southbound approach stop bar on Union Chapel Road (Missing).
  - c. Relocate "Precinct 7" sign (Sight Distance issue).
4. Providence Road near Juniper Creek Road
  - a. Fix rutting on the inside shoulder of the horizontal curve (Shoulder drop-off).
  - b. Fix flashing light on horizontal alignment signs.
  - c. Install high visibility horizontal curve advisory features such as reflective pavement markers and chevron alignment signs (including reflective post).

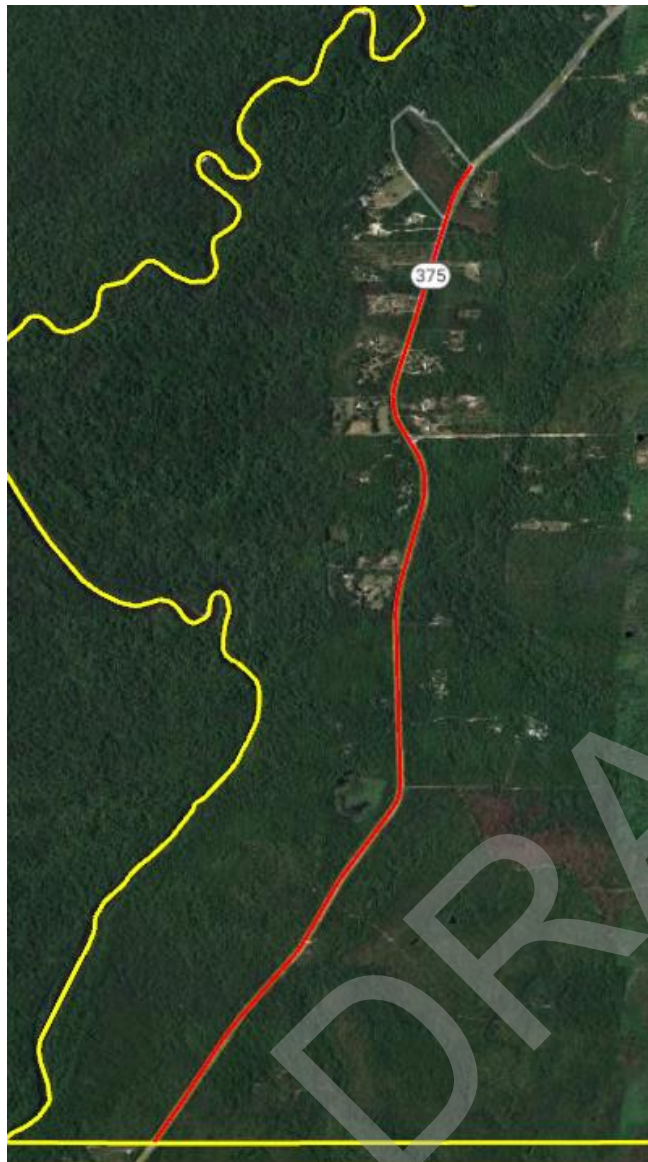
Smith Creek Road (Stoutamire Landing Rd to Leon/Wakulla County Line)

**Table 34: Smith Creek Road Fatal and Serious Injury Crash Data**

Year	All Crashes	Off Road	Other
2017	1	1	0
2018	1	0	1
2019	0	0	0
2020	1	0	1
2021	0	0	0
<b>TOTAL</b>	<b>3</b>	<b>1</b>	<b>2</b>

1. Pavement Markings
  - a. Replace reflective markers on segment (90% of markers are currently missing).
2. Smith Creek Road near Generation Gap Trail
  - a. Fix rutting on shoulder (Shoulder drop-off).
  - b. Install high visibility horizontal curve advisory features such as reflective pavement markers and chevron alignment signs (including reflective post).

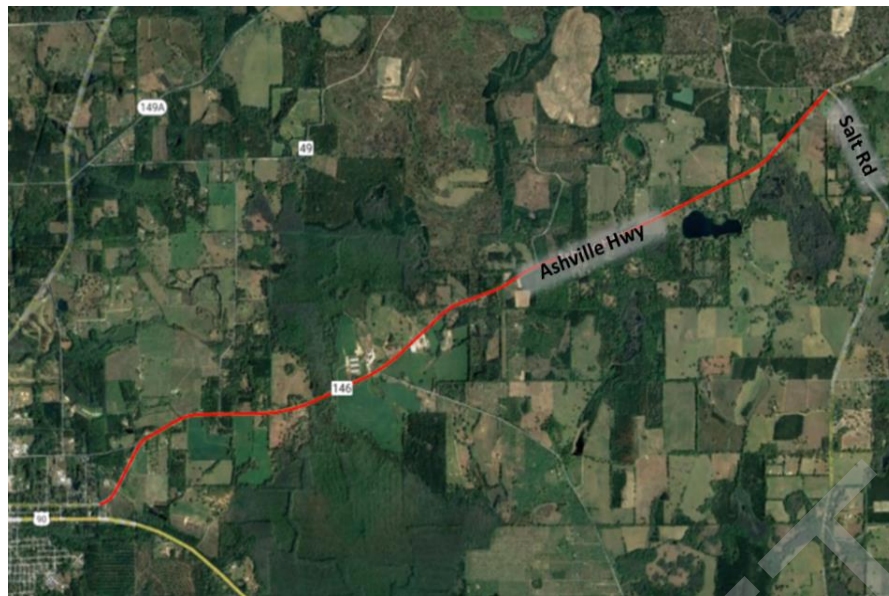
Ashville Highway between St. Margaret's Church Road and Salt Road

**Table 41: Ashville Highway Fatal and Serious Injury Crash Data**

Year	All Crashes	Off Road	Head On
2017	2	2	0
2018	0	0	0
2019	1	1	0
2020	0	0	0
2021	2	1	1
<b>TOTAL</b>	<b>5</b>	<b>4</b>	<b>1</b>

- Overall pavement condition has degraded (poor to satisfactory).

1. Pavement Condition
  - a. Fix rutting on shoulder as needed (Shoulder drop-offs).
2. Pavement Markings
  - a. Install longitudinal rumble strips or profiled pavement markings on centerline and edge of travel lane line.
