**CITIZENS MULTIMODAL  
ADVISORY COMMITTEE**

**February 5, 2019**

#### **B. Tharpe Street and Pensacola Street Operational Analyses**

In February of 2018, the CRTPA directed its general consultant, RS&H, to initiate corridor studies for Tharpe Street and Pensacola Street, both of which are within Leon County. These corridors were identified as needing additional capacity improvements (roadway widening) in the currently adopted 2040 Regional Mobility Plan (RMP). The corridor studies were initiated to identify existing and projected future conditions along the corridor limits for Pensacola Street (Appleyard Drive to Capital Circle SW) and Tharpe Street (Ocala Road to Capital Circle, NW) and to identify potential projects to improve mobility and efficiency without major capacity expansions.

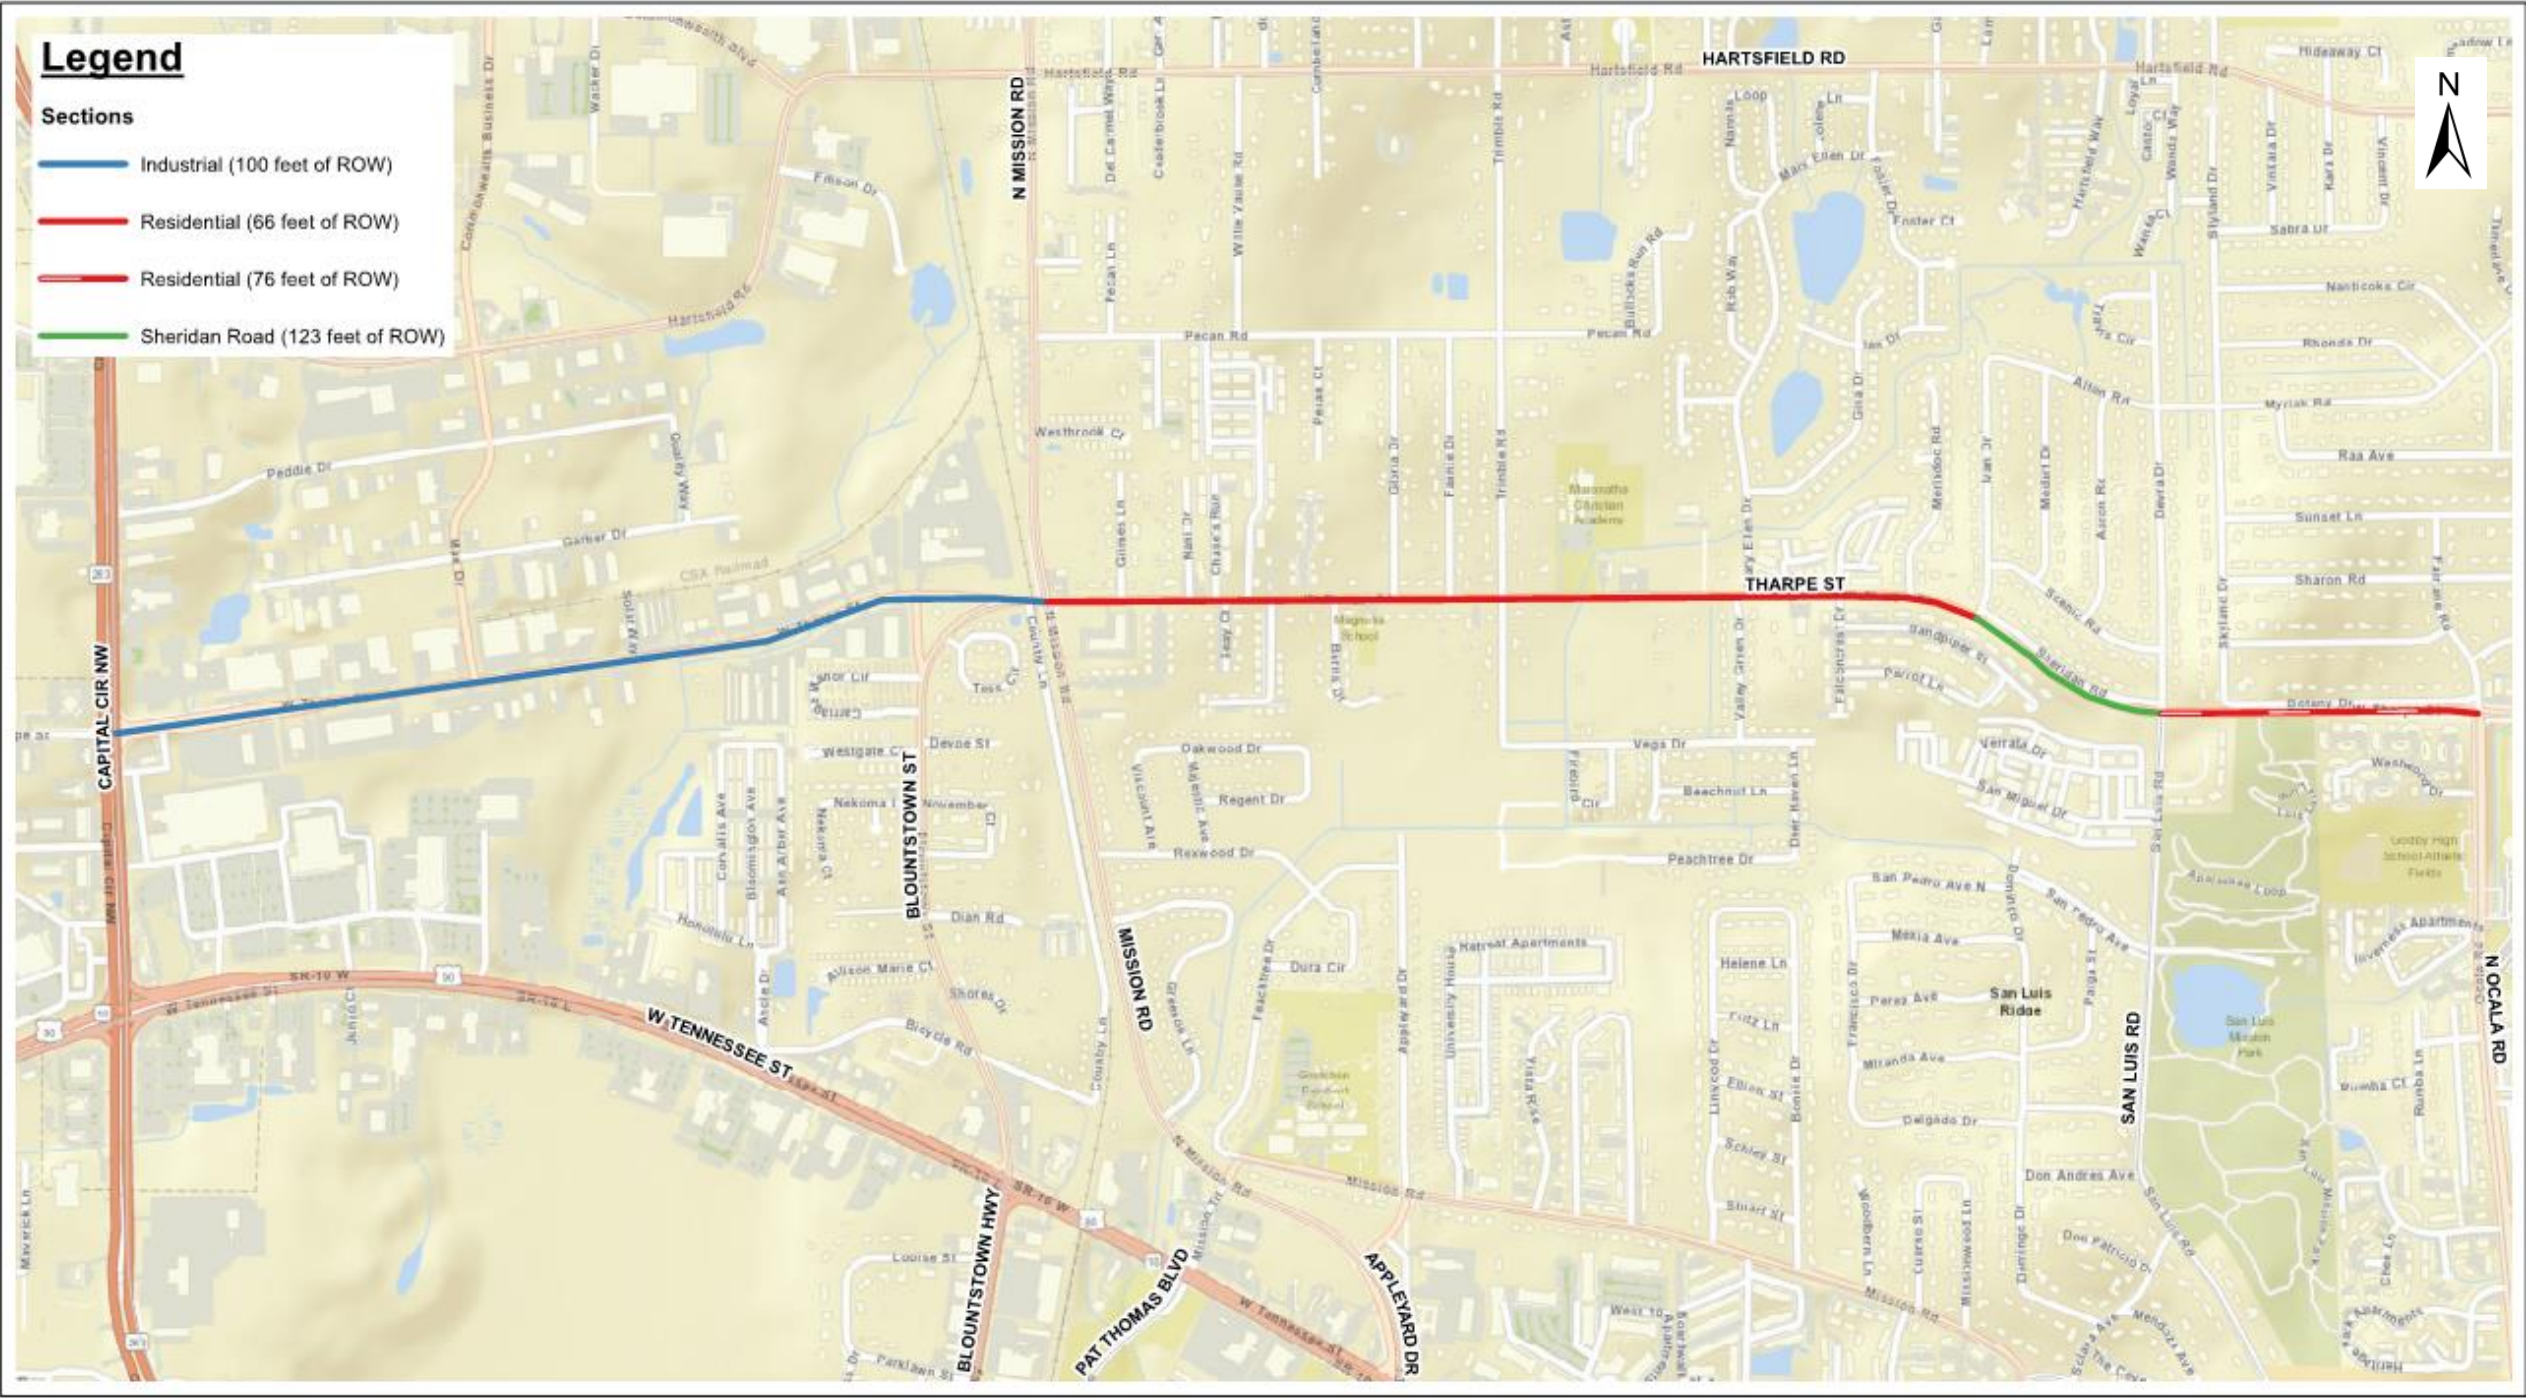
Figure 1. Project Overview

The corridor exhibits three distinct sections based on character and land use. These sections are identified as the Industrial Section, the Residential Section, and the Sheridan Road Section (see Figure 1). The Residential Section is divided into two sections: Mission Road to Ivan Drive and Devra Drive to west of Ocala Road. Number of lanes, travel lanes widths, and right-of-way (ROW) widths are shown in Table 2. The review of the existing conditions within the corridor resulted in the identification of five major issues and are discussed in the following sections.

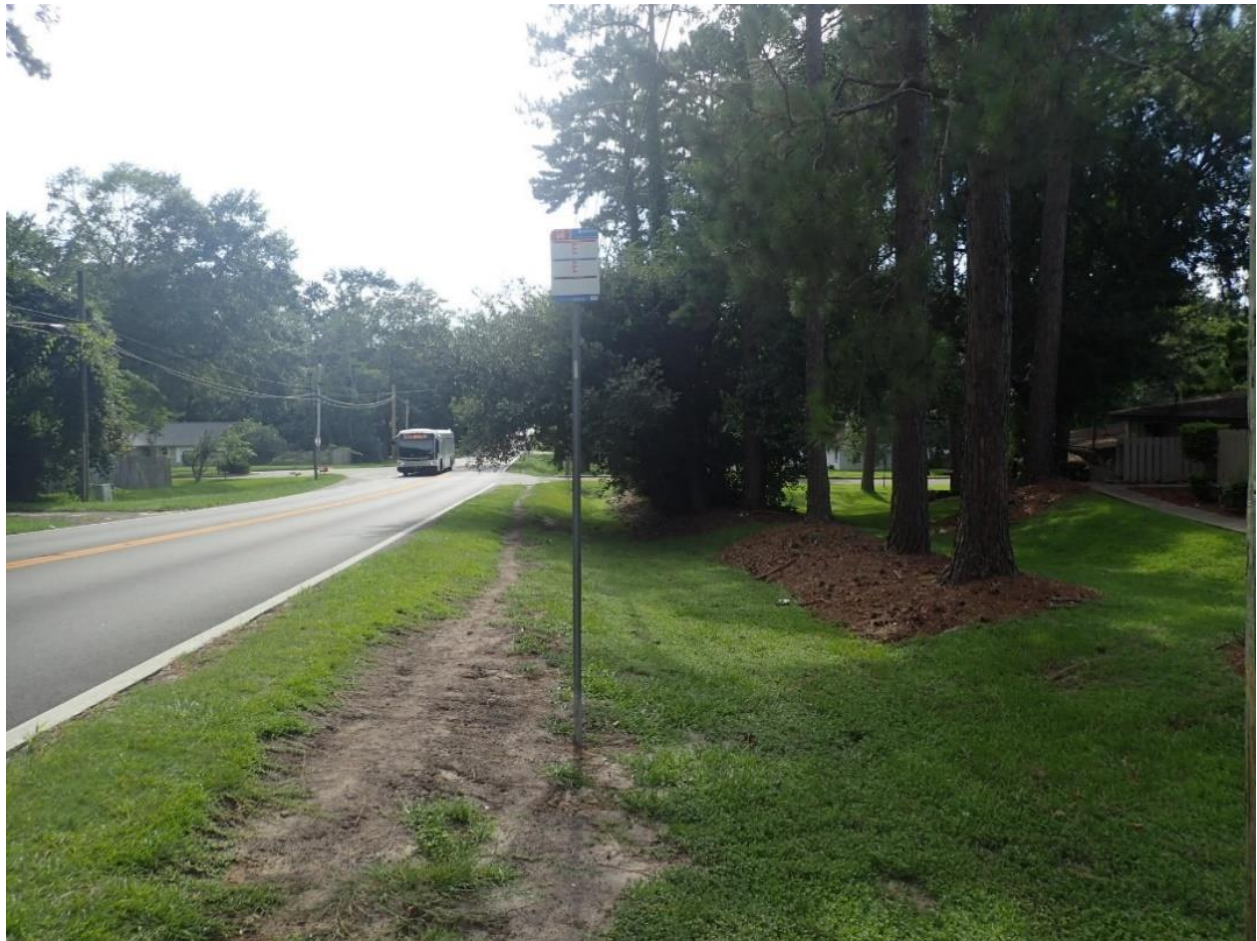
**Figure 2. Typical Bus Stop Along Tharpe Street**

StarMetro serves as the public transit agency for the City of Tallahassee and Florida State University. Currently, bus stops along Tharpe Street are not compliant with the Americans with Disabilities Act (ADA) and offer limited information to passengers (see Figure 2). Current ADA compliance is only required when bus shelters and sidewalks already exist. StarMetro desires to make all public transit links adhere to current ADA standards and to provide schedule and route information, making the system more accessible and safer for all riders.

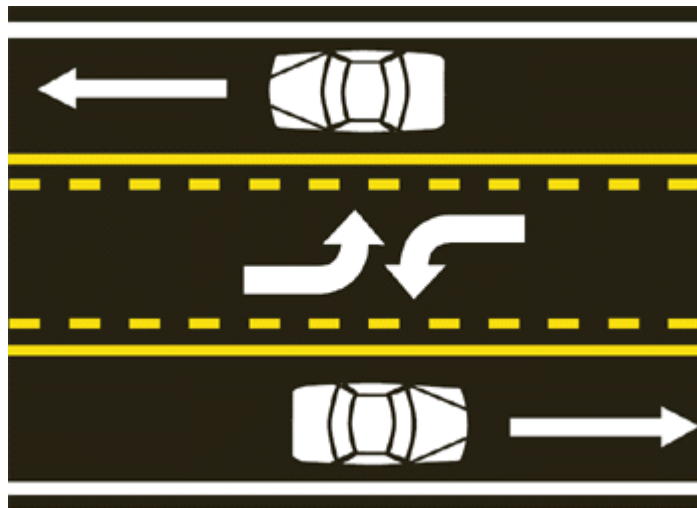
**Figure 3. Existing Lane Design**

Spot congestion along Tharpe Street is primarily caused by routine traffic events such as bus pick up/drop off, trash collections, and left turn traffic. Some portions of the corridor have one through lane in each direction that is separated by a dual left turn lane (see Figure 3). Left turn traffic is especially common in the residential section of Tharpe Street where minor streets are clustered together. During routine bus stops, motorists often travel over painted medians due to the lack of maneuvering space provided by the current two-lane design as shown in Figure 4. With these left turn movements, spot congestion is especially prevalent in the residential section of Tharpe Street during peak AM/PM hours.

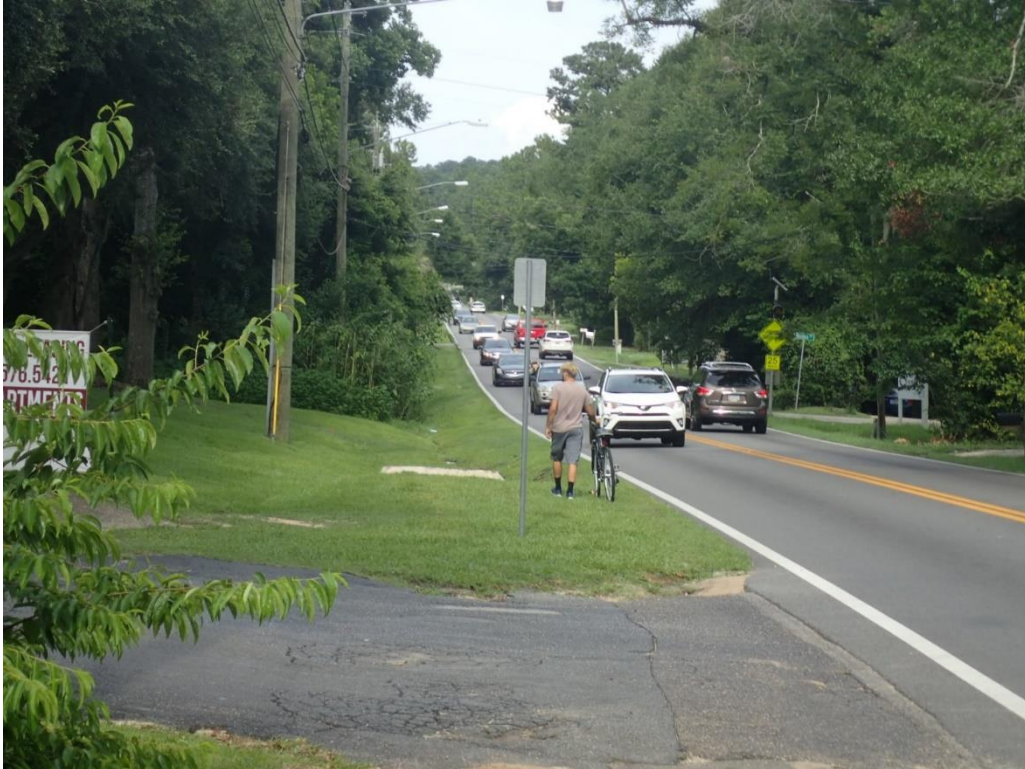
**Figure 5. Pedestrian Travel Pattern**

Presently 90% of the land parcels along Tharpe Street have no access to sidewalks or bicycle facilities. For this reason, cyclists and pedestrians have no choice but to travel along grassed ditches to avoid interaction with motorists (see Figure 5). However, grassed ditches are not always made available. One area in particular, located 500 feet east of Trimble Road, poses a high-risk area for pedestrians as they are given no choice but to travel on the roadway with vehicular traffic (see Figure 6).

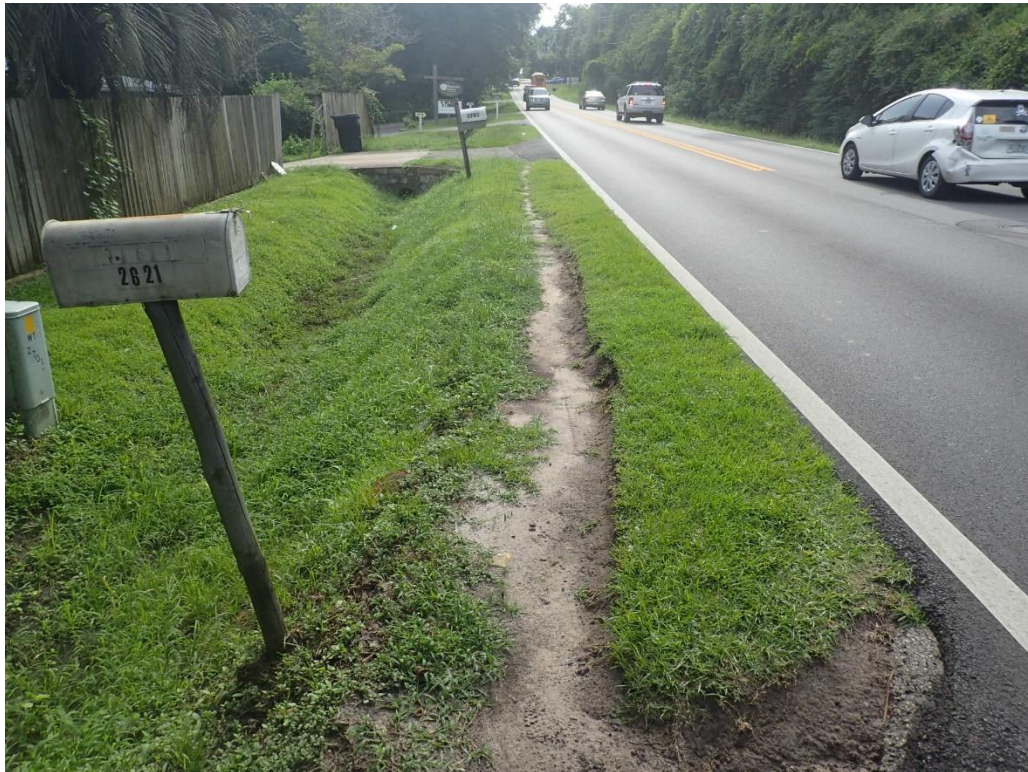
**Figure 7. Desire Lanes along Tharpe Street**

Desire lanes are paths that result from on-going pedestrian foot traffic and can be found at multiple locations along Tharpe Street. This not only lacks pedestrian safety benefits but also uniformity throughout the corridor. Prevalence of desire lanes signify the need for sidewalks (see Figure 7).

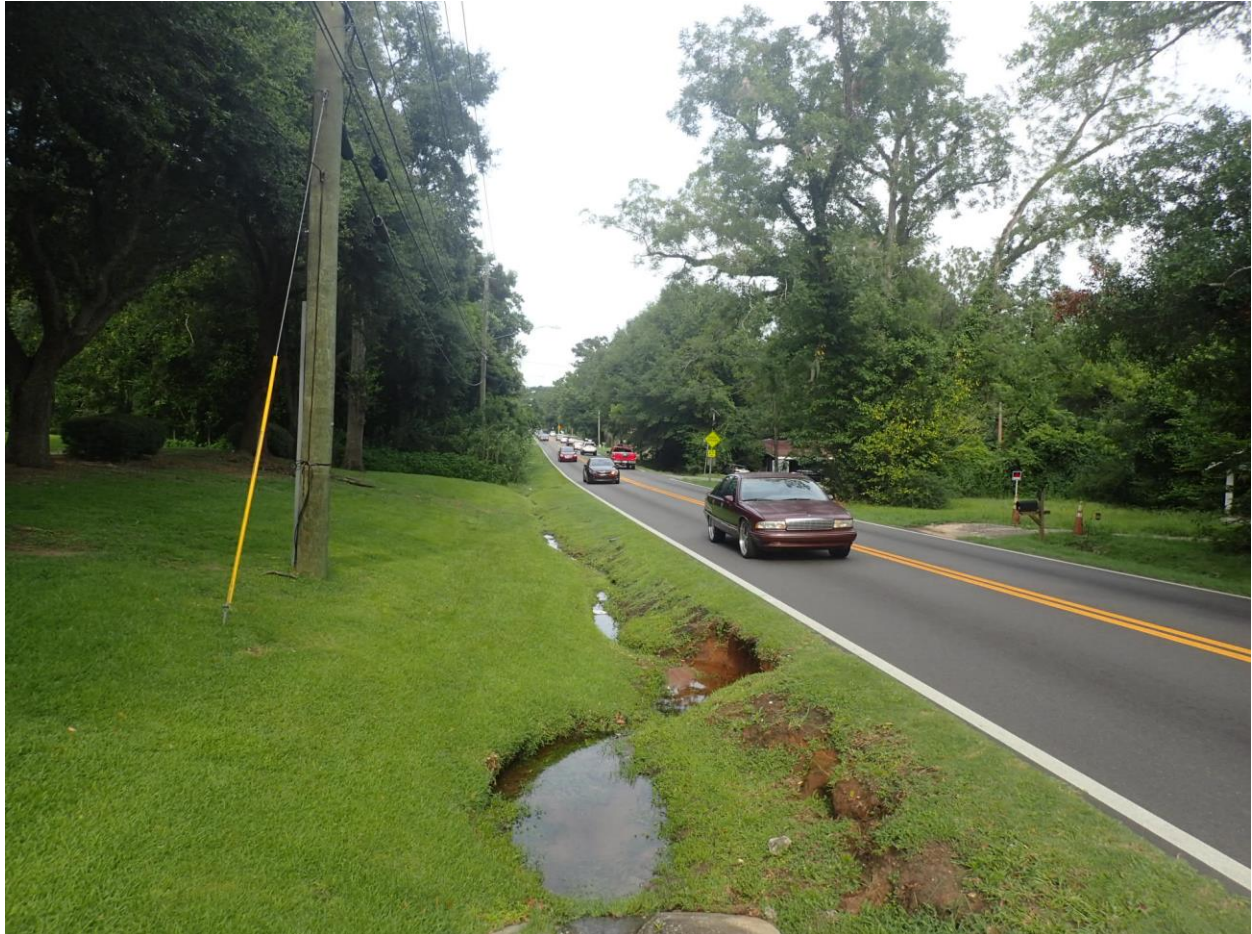
**Figure 8. Slope Erosion Caused by Stormwater Runoff along Tharpe Street**

Evidence of roadside erosion can be observed throughout the corridor. Existing conditions show roadway drainage traveling to nearby roadside ditches that transports water runoff to the nearest outfall point (see Figure 8). Presently, no stormwater treatment is provided for the roadway other than the flow time in grassed ditches.

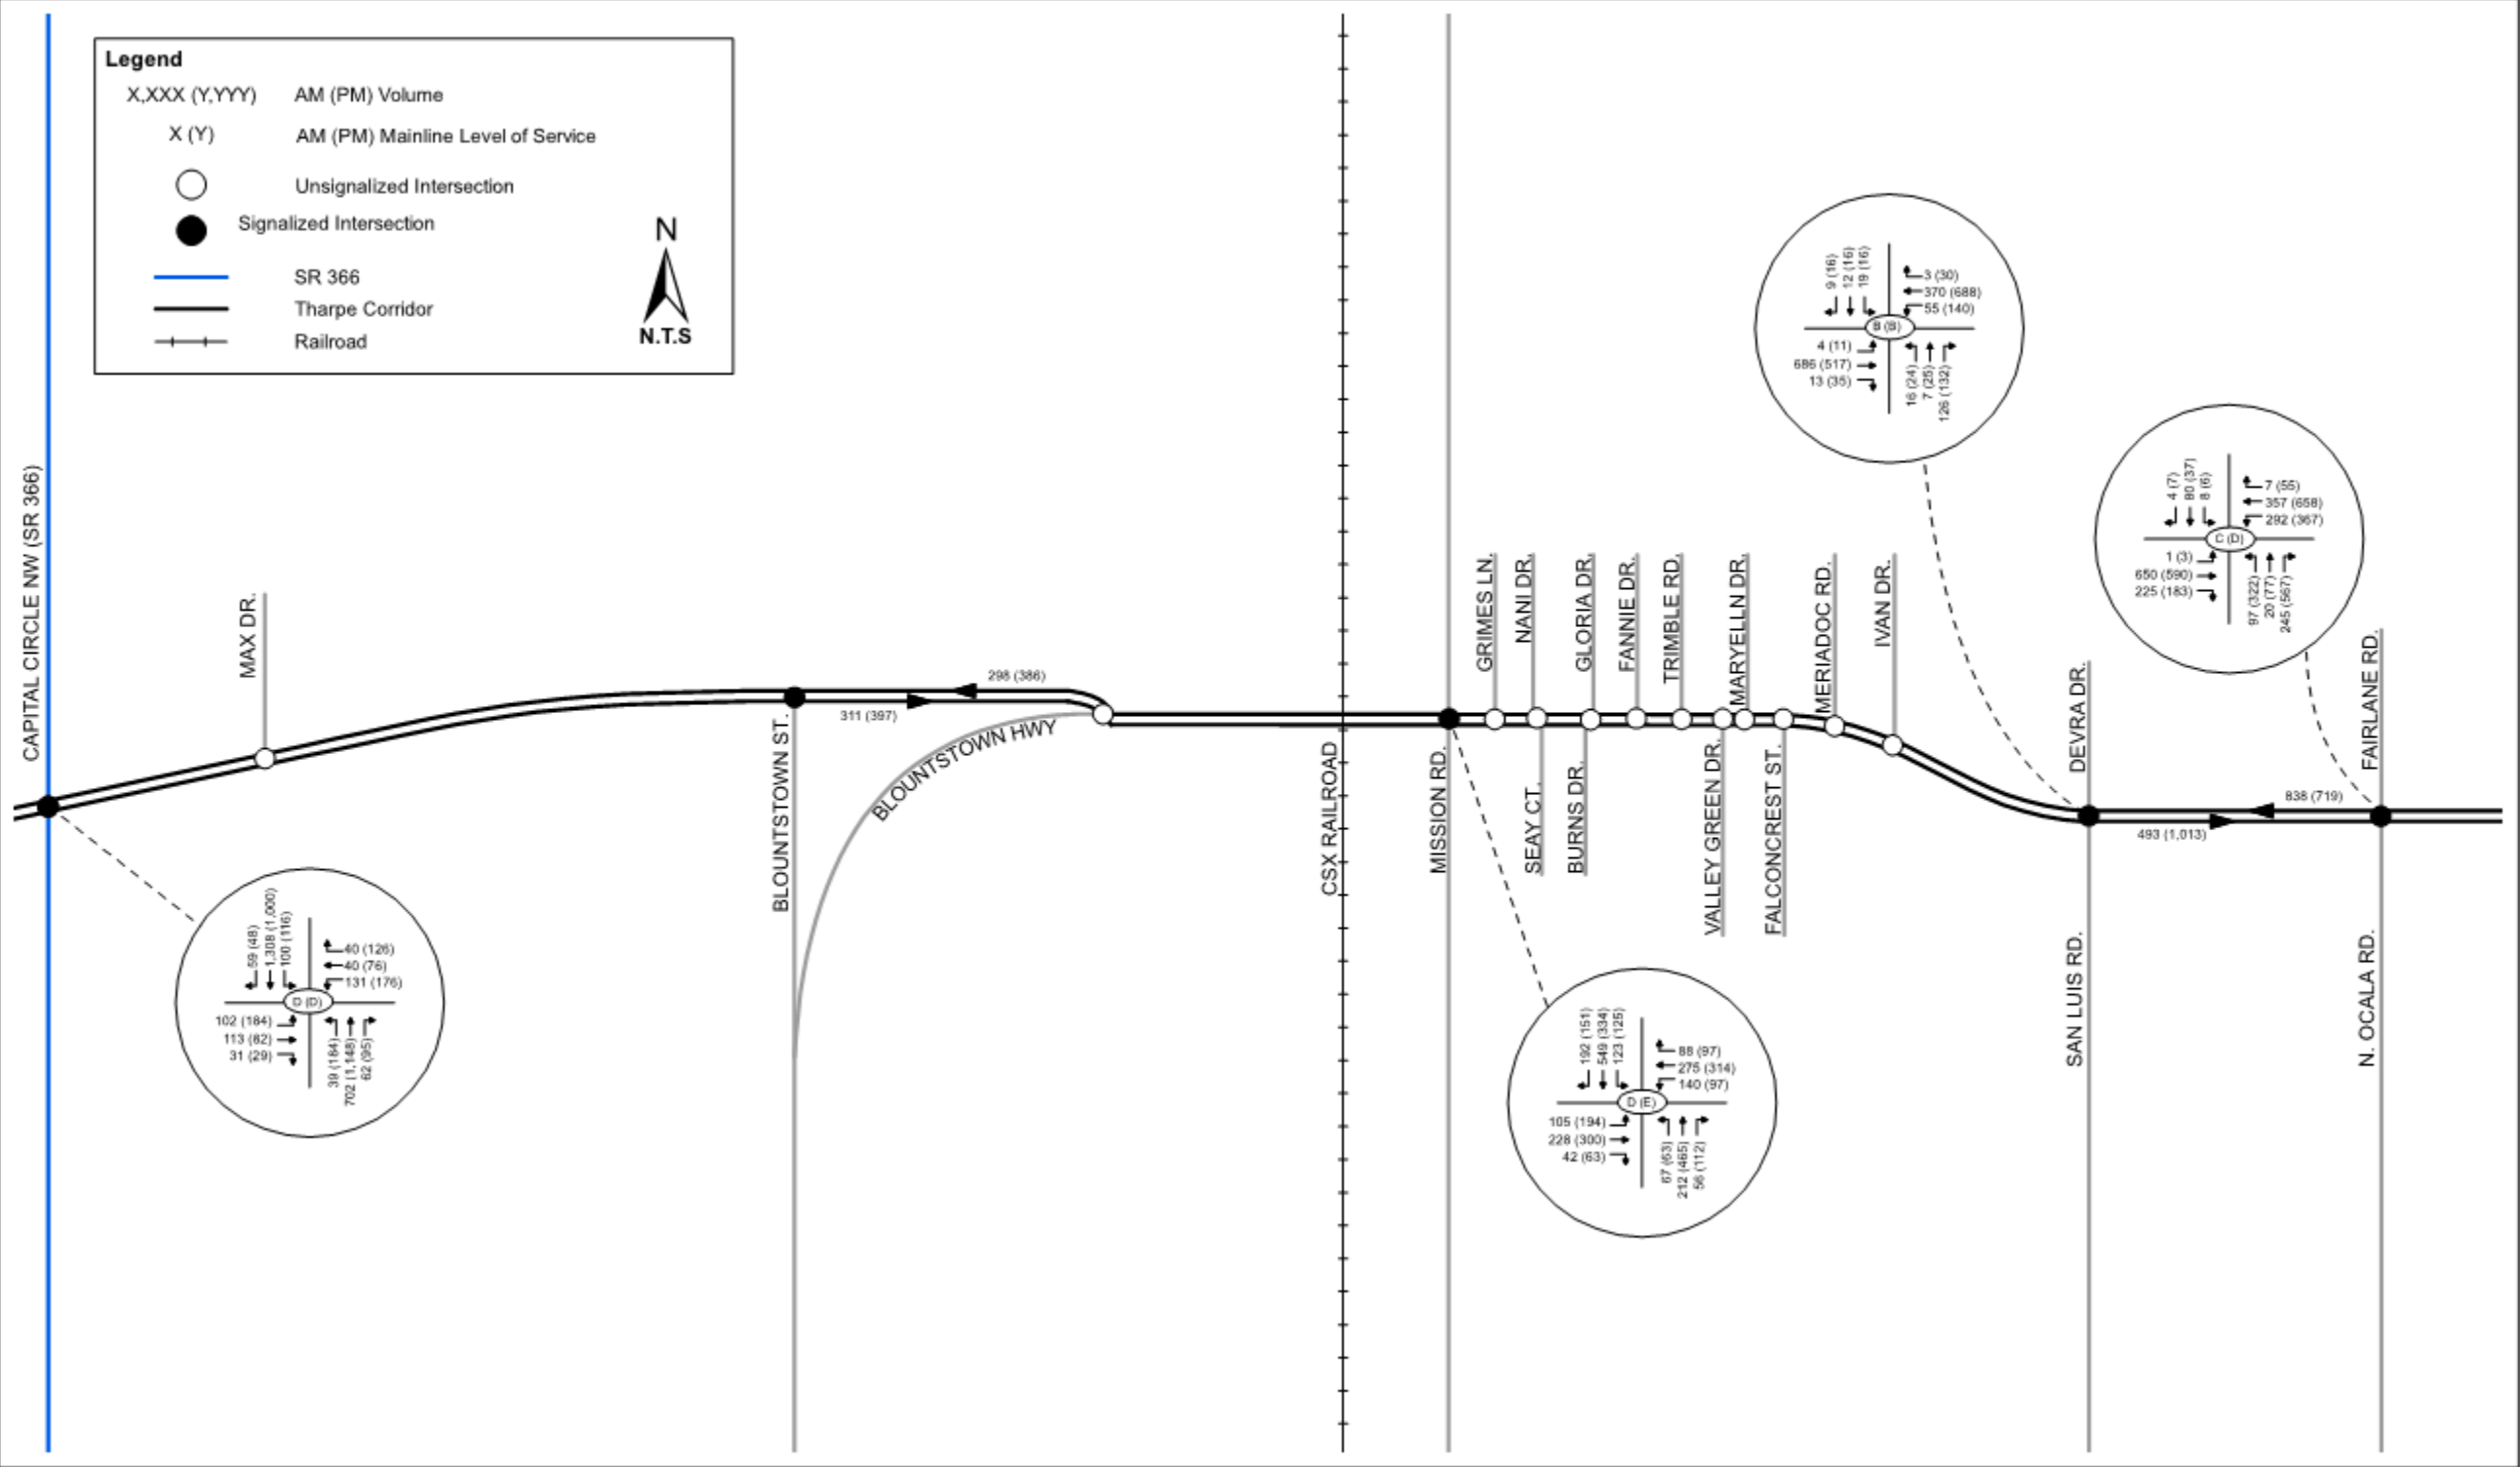
Figure 9. Existing Peak Hour Volumes and Level of Service

Historical and county traffic sites provided the source of existing traffic for the Tharpe Street study area. Existing intersection analysis is summarized in Table 3 and shown in Figure 9. Under current conditions, the Mission Road intersection is not operating at an acceptable LOS for the peak hour. Mission Road operates at LOS E under existing traffic conditions, which does not meet established standards and identifies the need for capacity improvements.

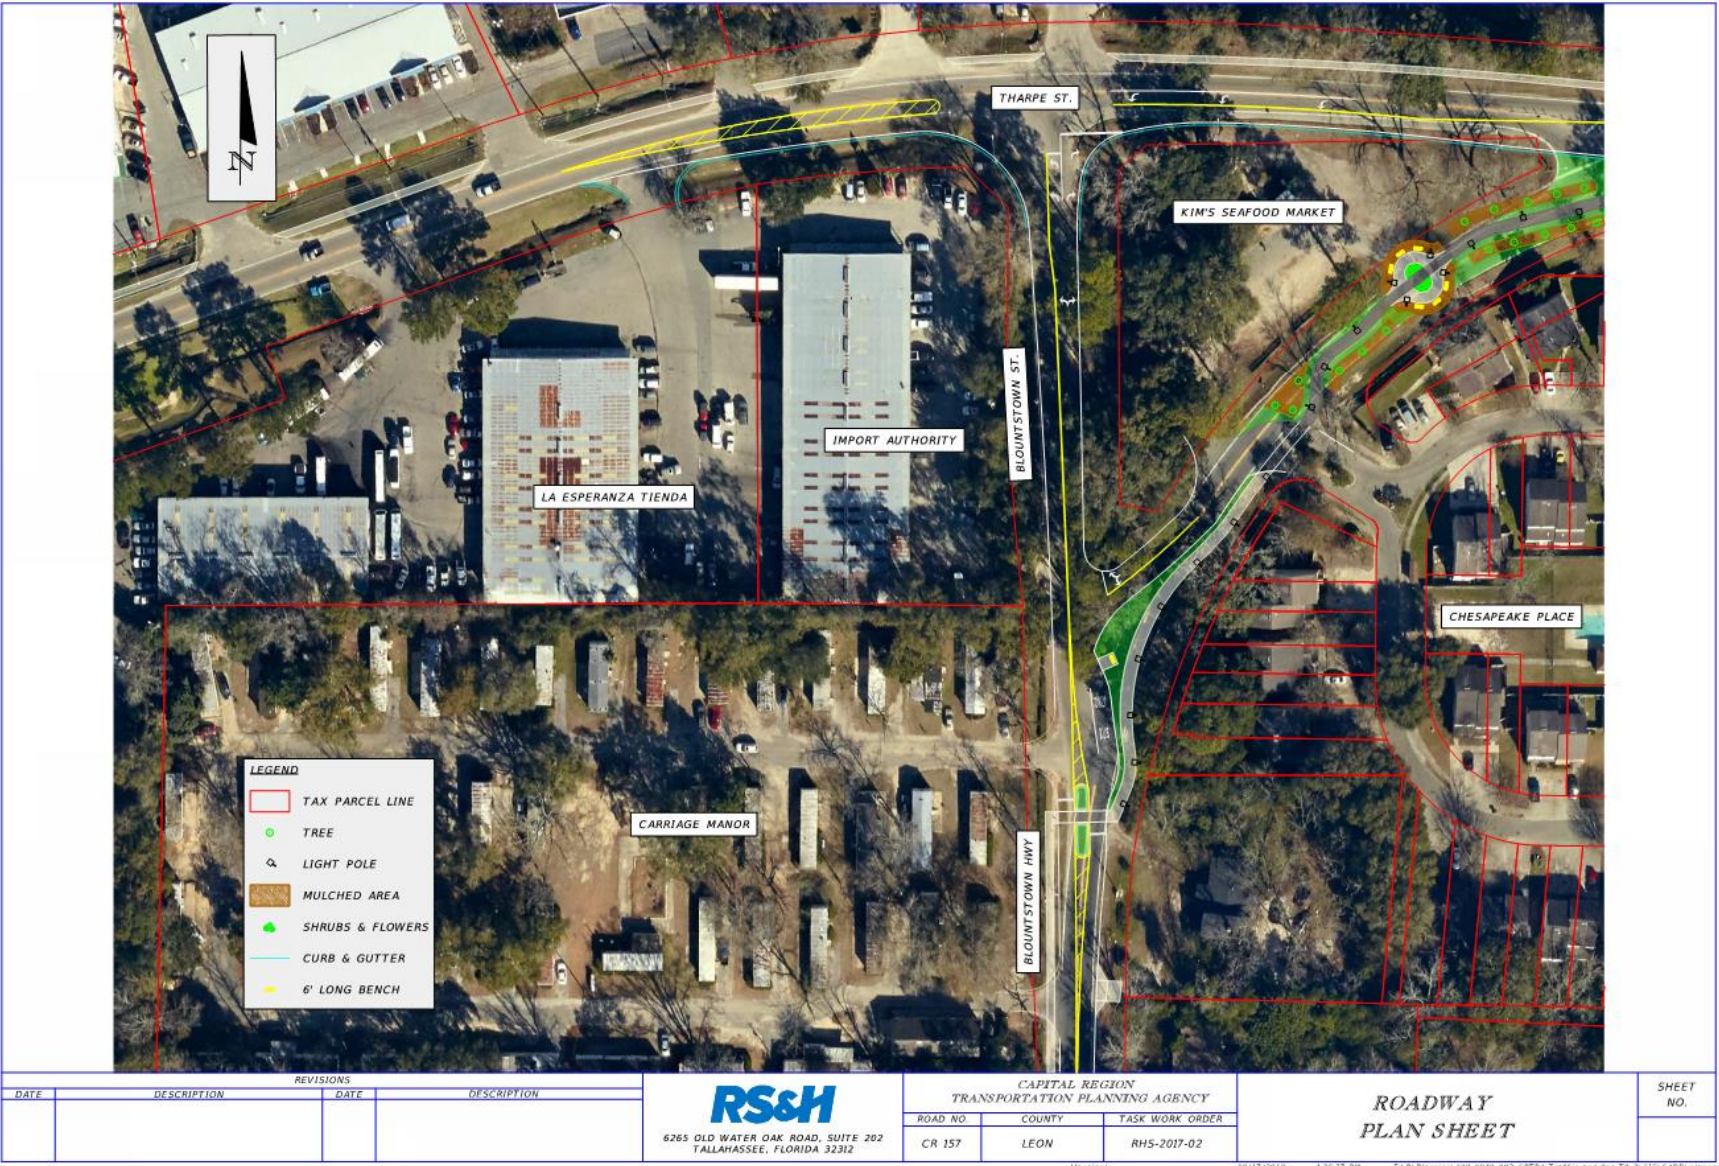
Figure 11. Blountstown Highway and Tharpe Street Intersection

Figure 11 displays the recommended conversion of the Blountstown Highway and Tharpe Street intersection.

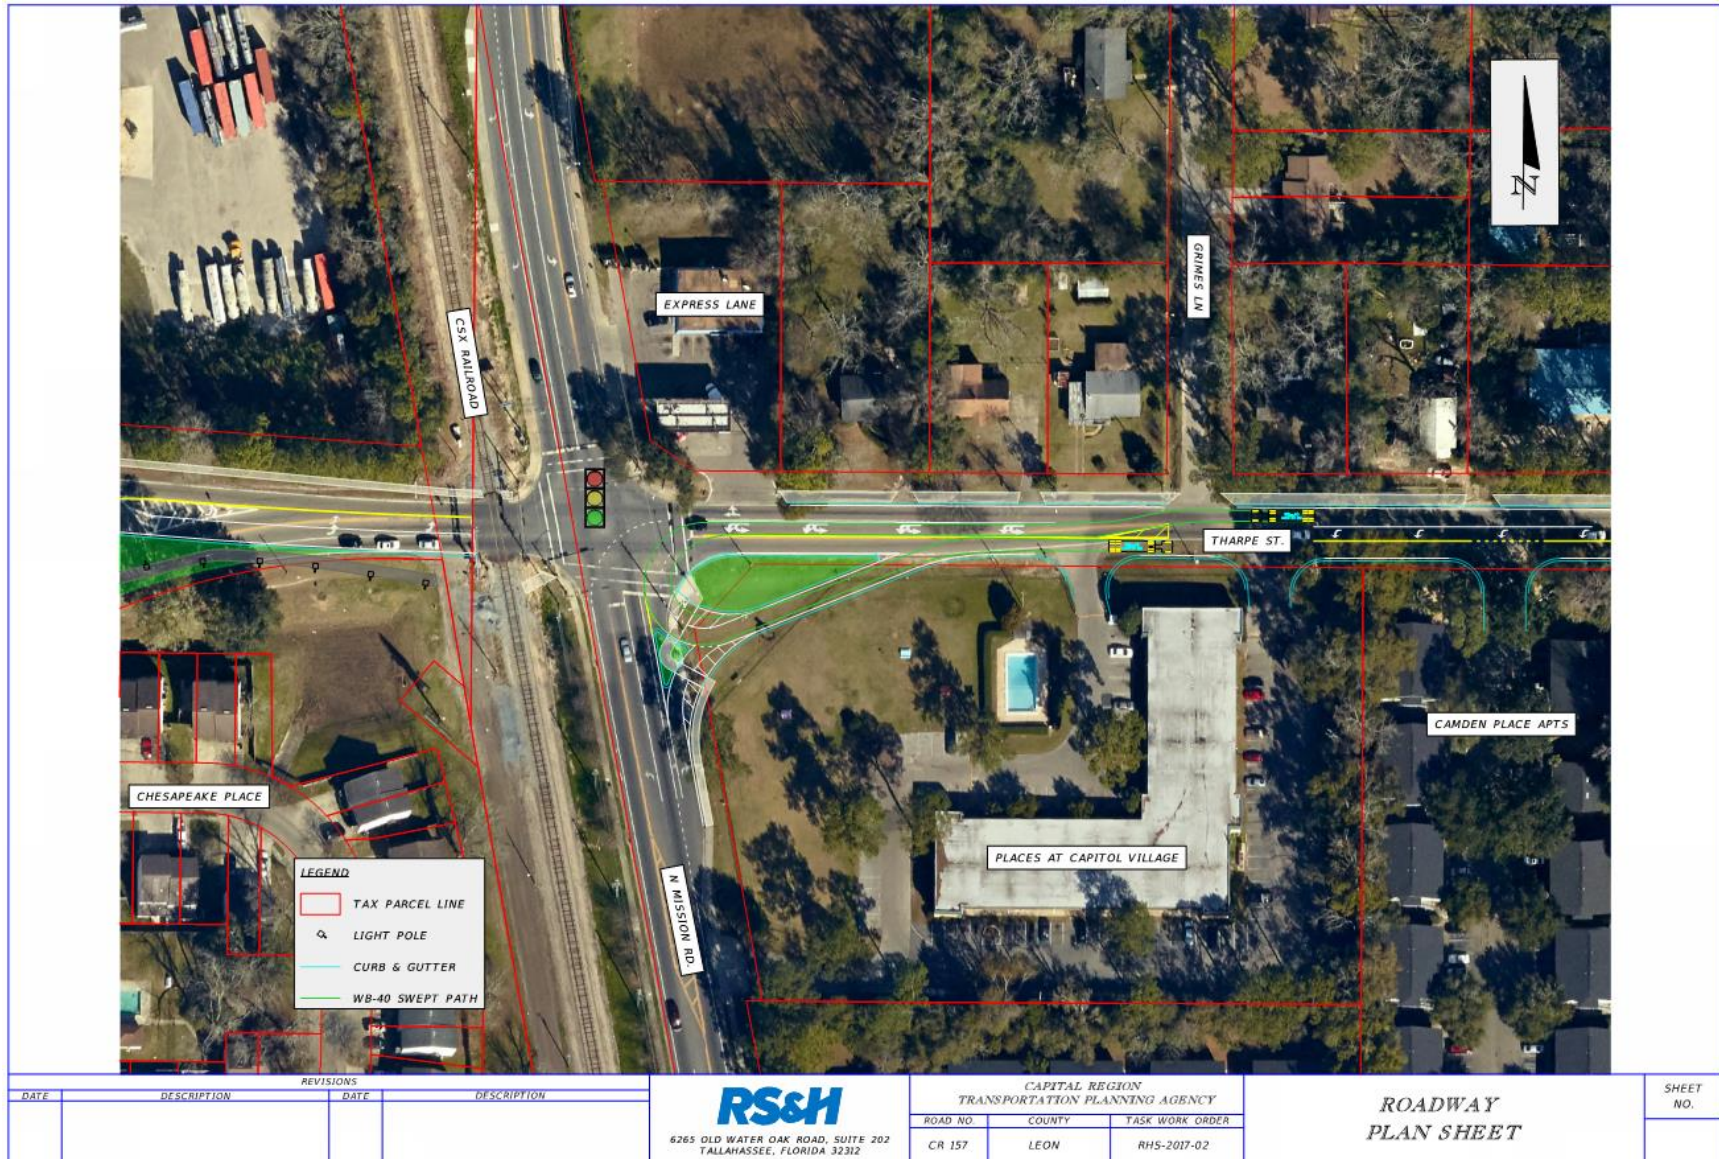
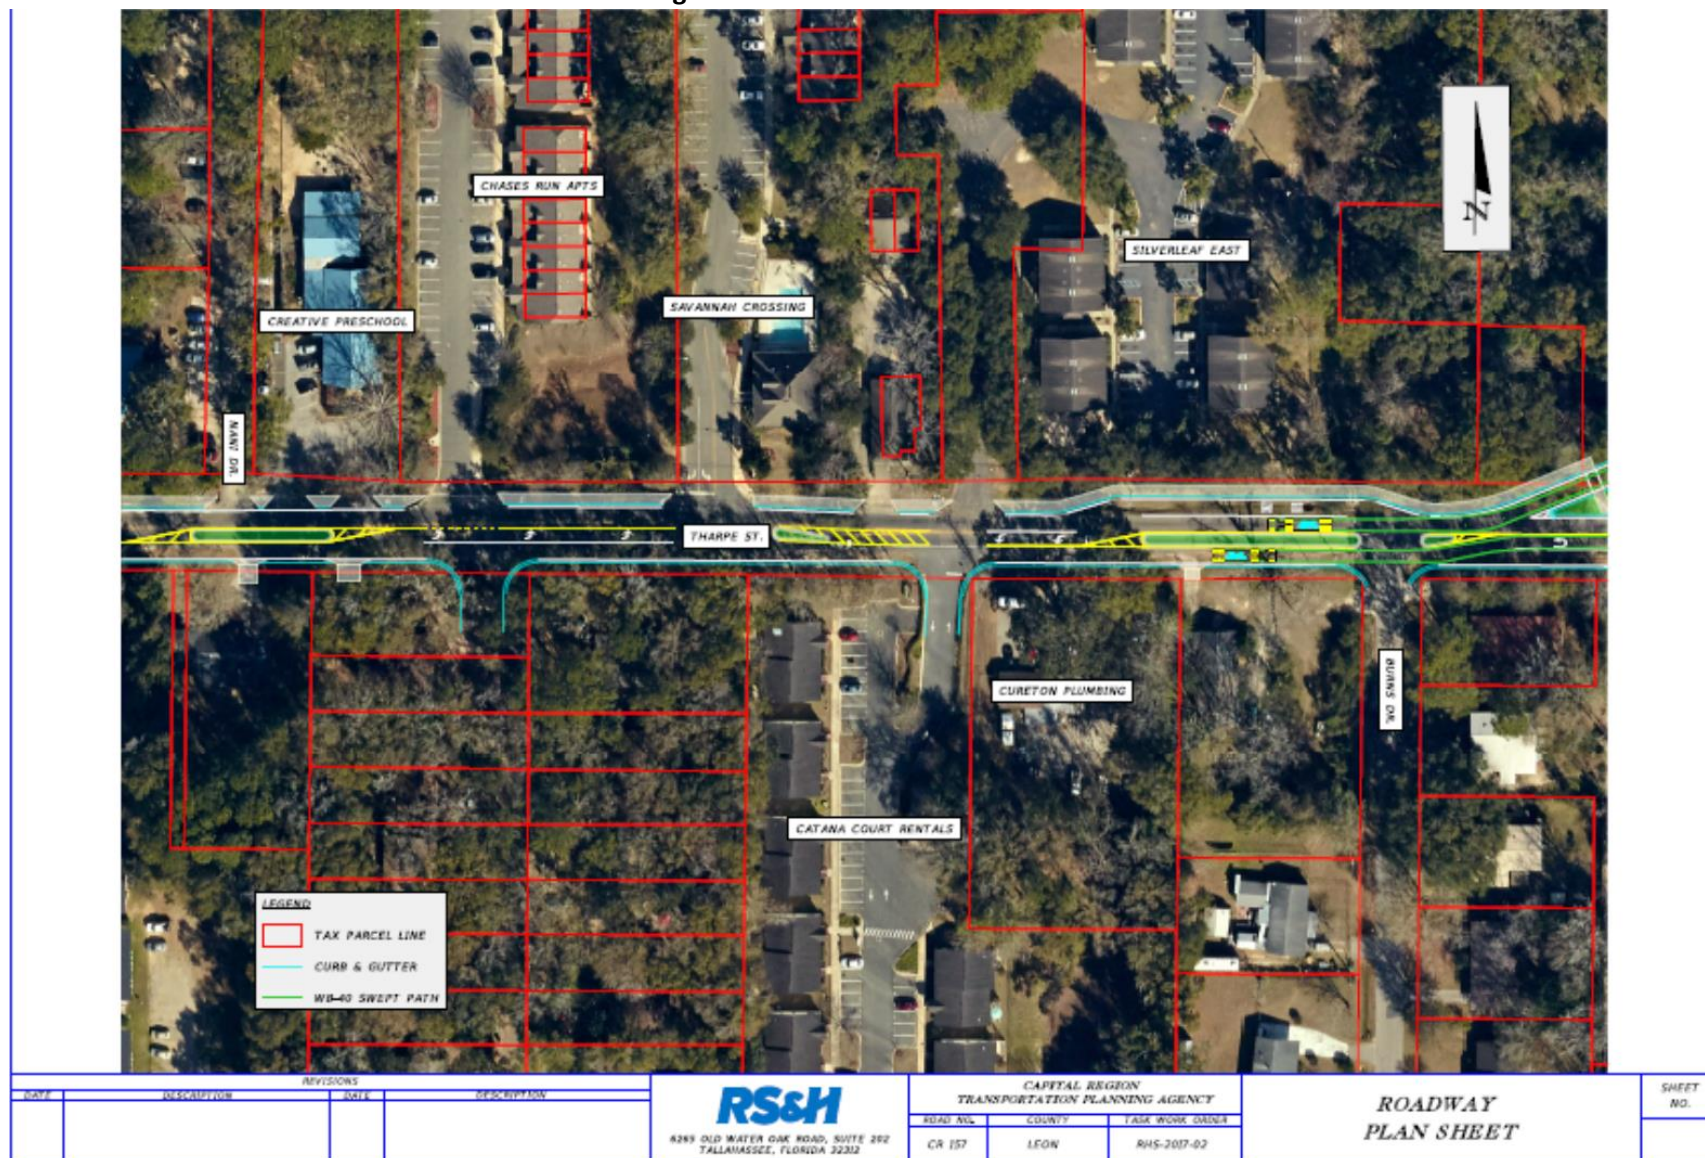
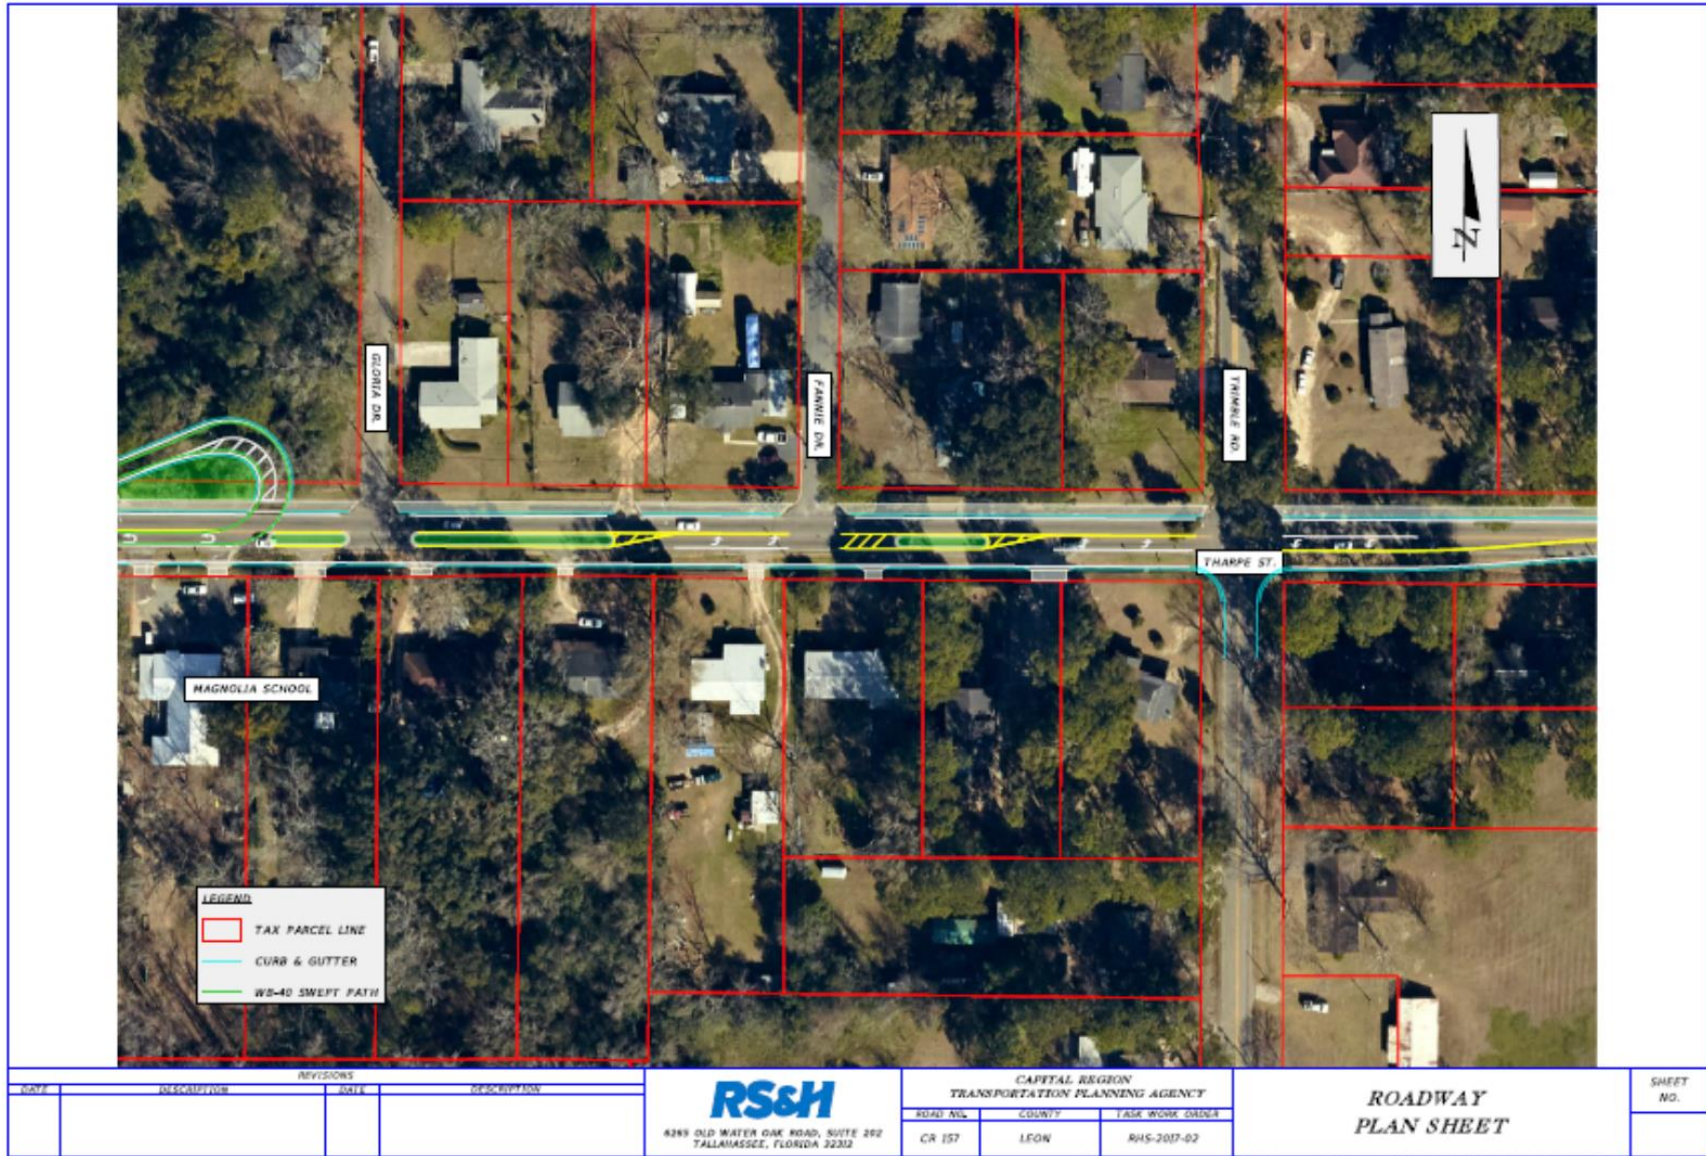
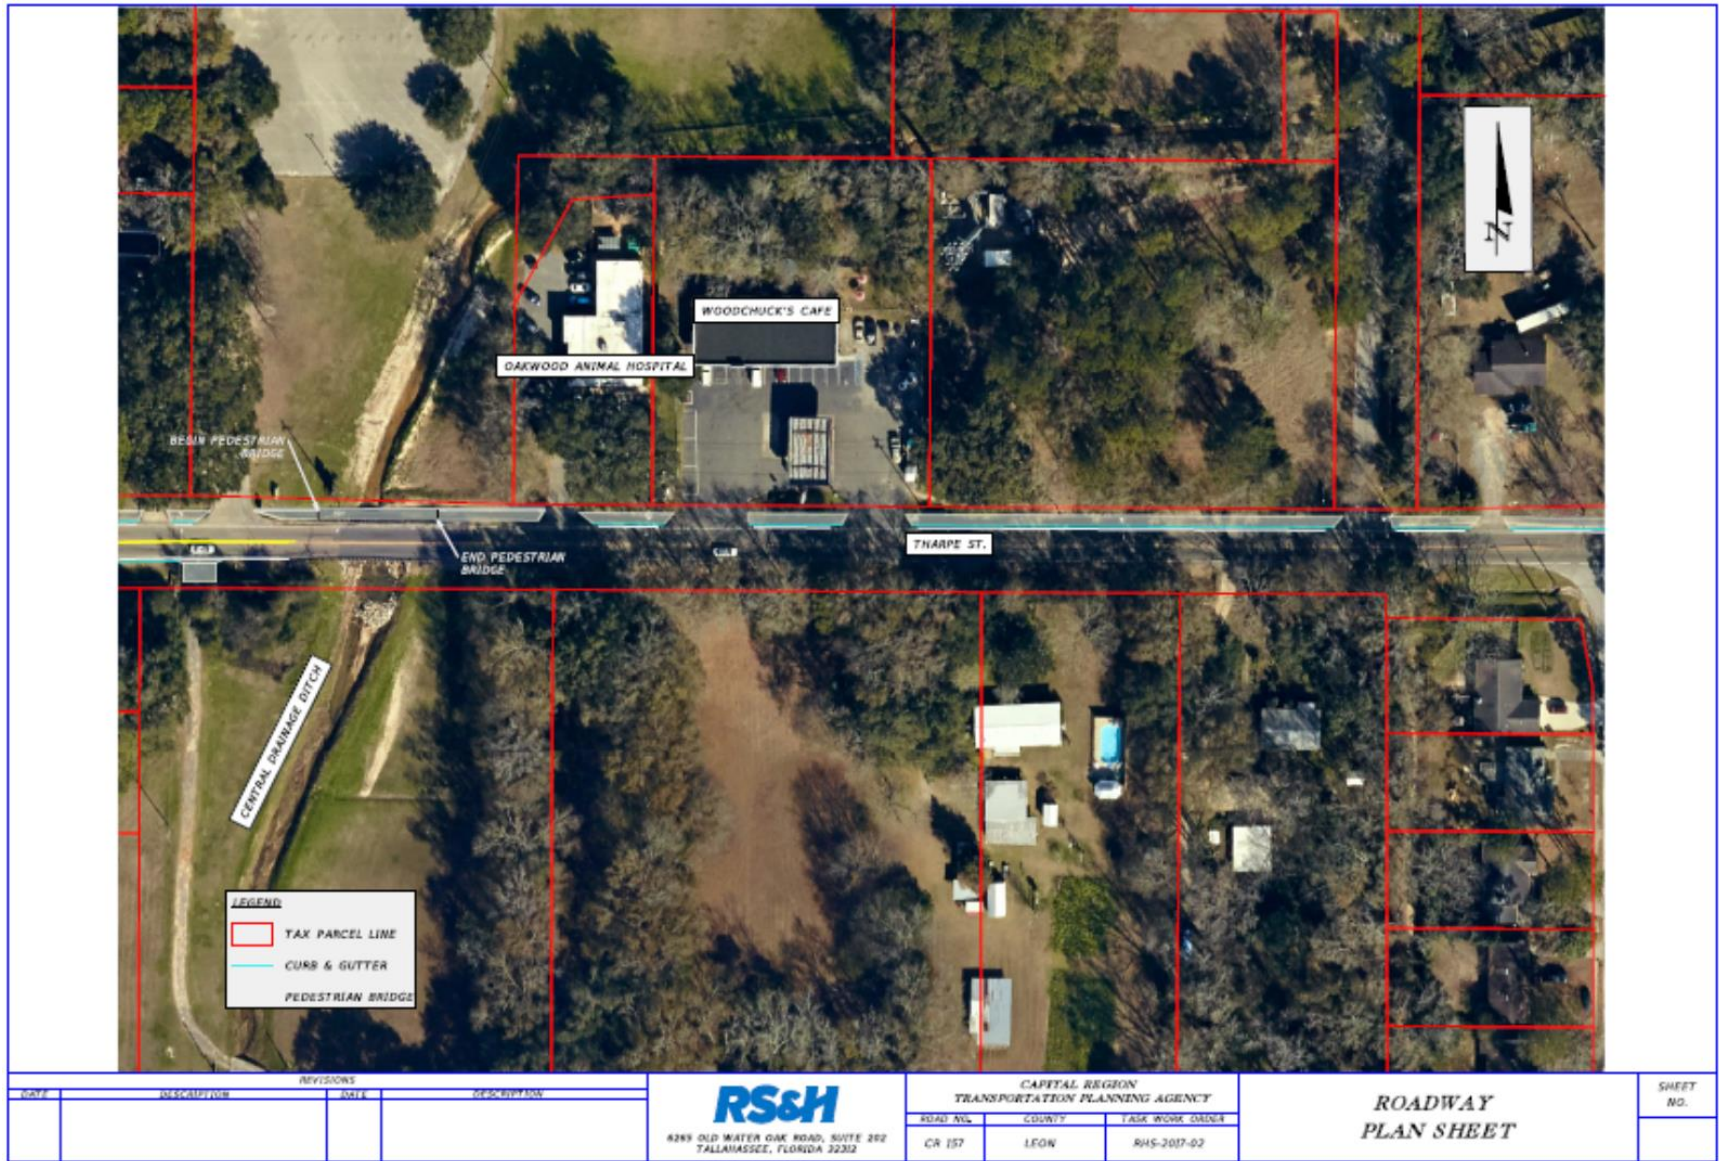
Figures 12 through 16 display the recommendations identified for this section.
