**CITIZENS MULTIMODAL  
ADVISORY COMMITTEE**

**February 5, 2019**

#### **B. Tharpe Street and Pensacola Street Operational Analyses**

In February of 2018, the CRTPA directed its general consultant, RS&H, to initiate corridor studies for Tharpe Street and Pensacola Street, both of which are within Leon County. These corridors were identified as needing additional capacity improvements (roadway widening) in the currently adopted 2040 Regional Mobility Plan (RMP). The corridor studies were initiated to identify existing and projected future conditions along the corridor limits for Pensacola Street (Appleyard Drive to Capital Circle SW) and Tharpe Street (Ocala Road to Capital Circle, NW) and to identify potential projects to improve mobility and efficiency without major capacity expansions.

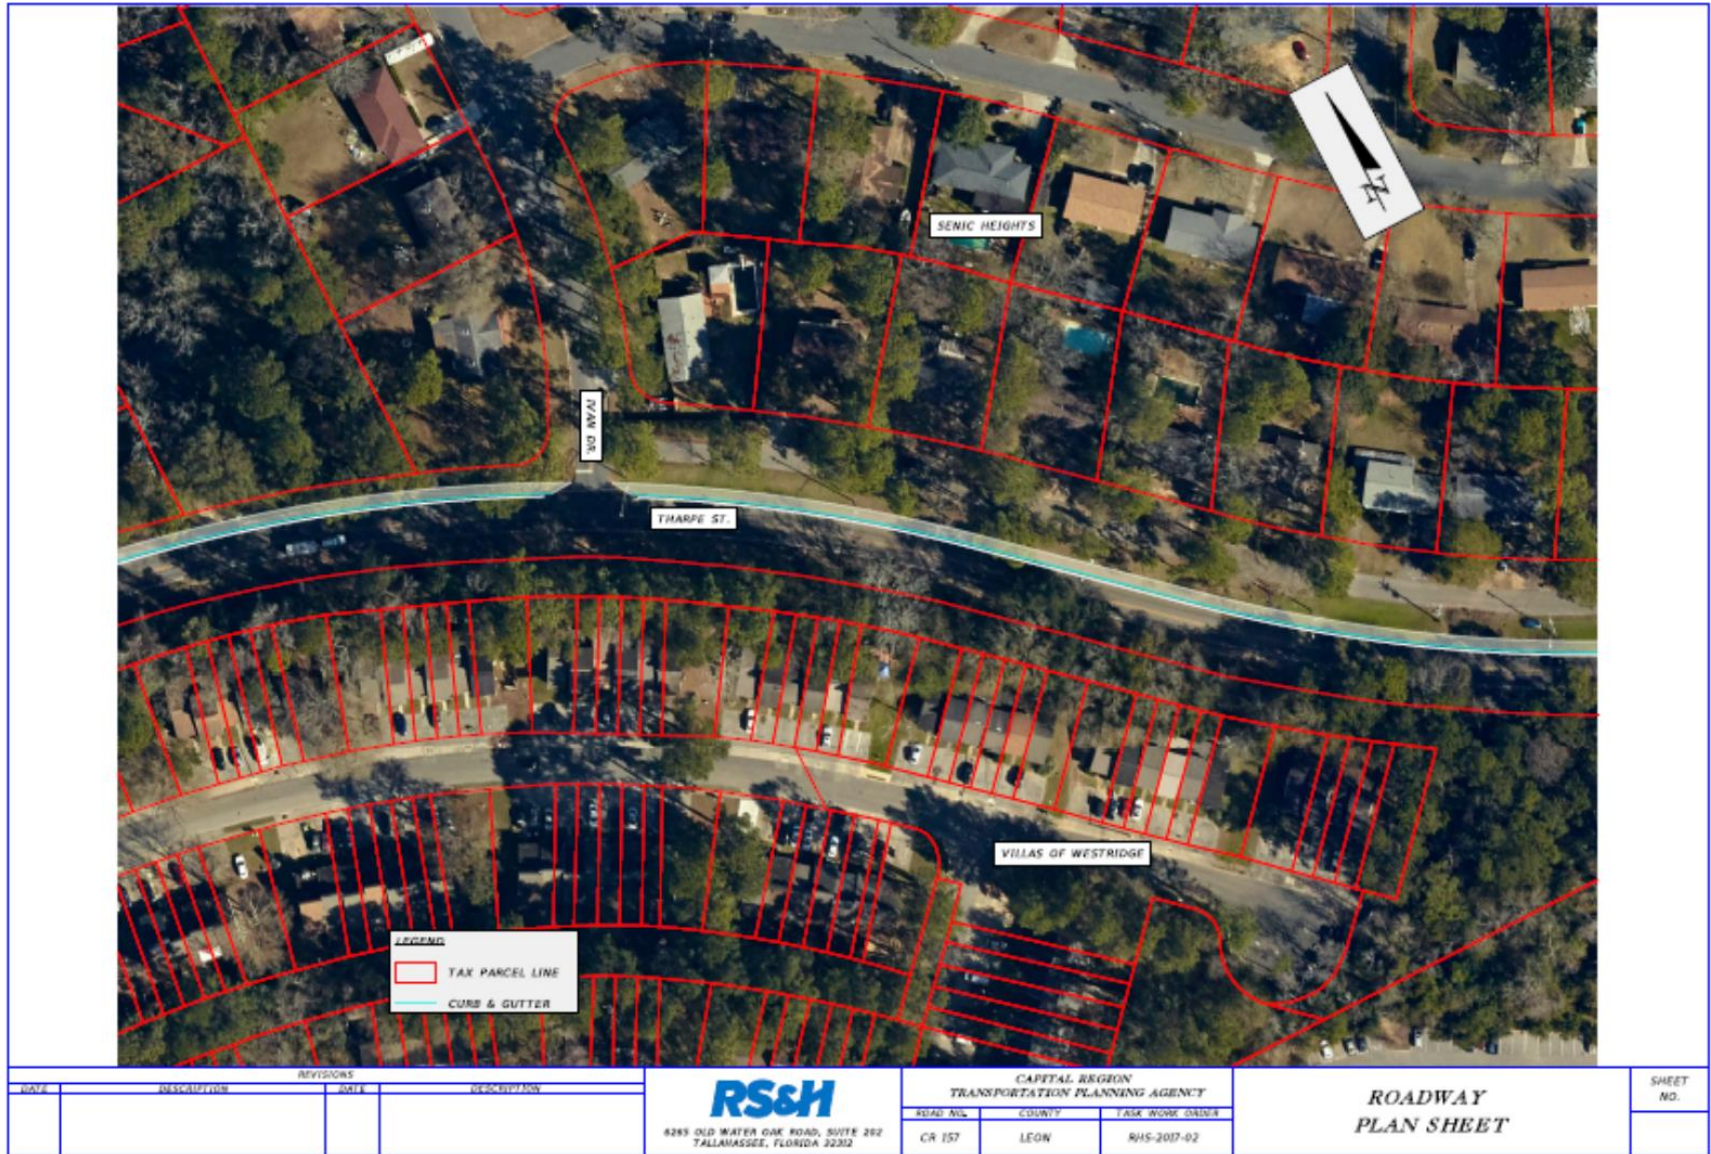
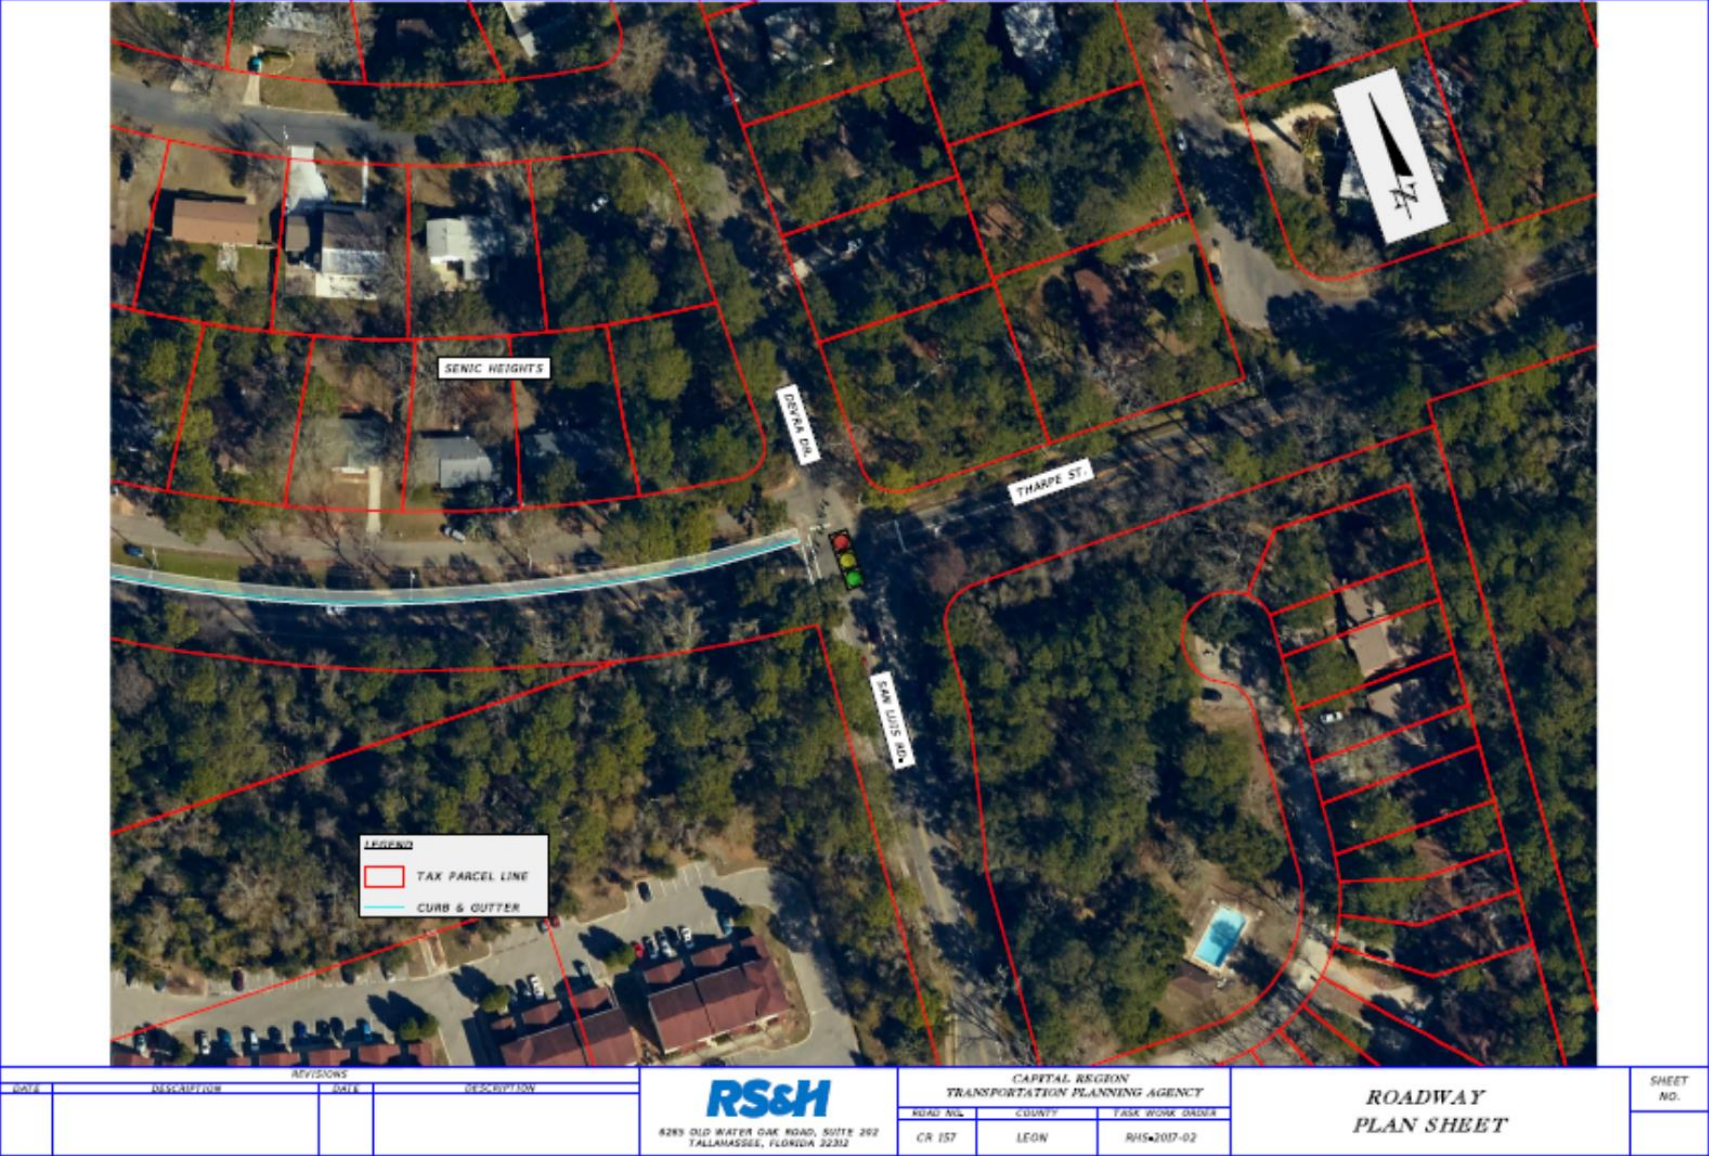
- Addition of 8-foot wide concrete sidewalk, culvert system, and curb and gutter along north side of Tharpe Street.

Figures 17 and 18 display the Ivan Drive and Devra Drive areas.

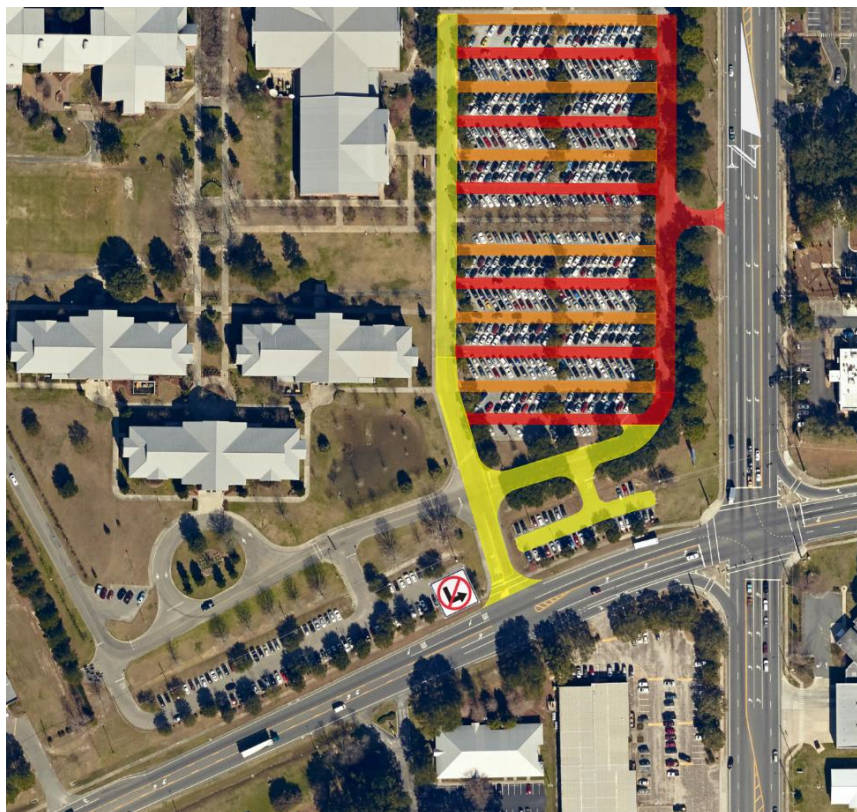
**Figure 2. Typical Congestion from TCC Campus**

Figure 2 illustrates typical congestion conditions from high (red) to low (yellow). Field observations report drivers located in the southeast – Learning Commons - parking lot egress exit to the south onto Pensacola Street. Left turn movements are restricted at this location due to its proximity to the intersection at West Pensacola Street and Appleyard Drive. Despite left turn restrictions, motorists often make illegal left turns, crossing double yellow lane lines in U-turn maneuvers, utilizing private driveways to turn around. These traffic patterns exacerbate spot congestion during AM/PM peak hours.

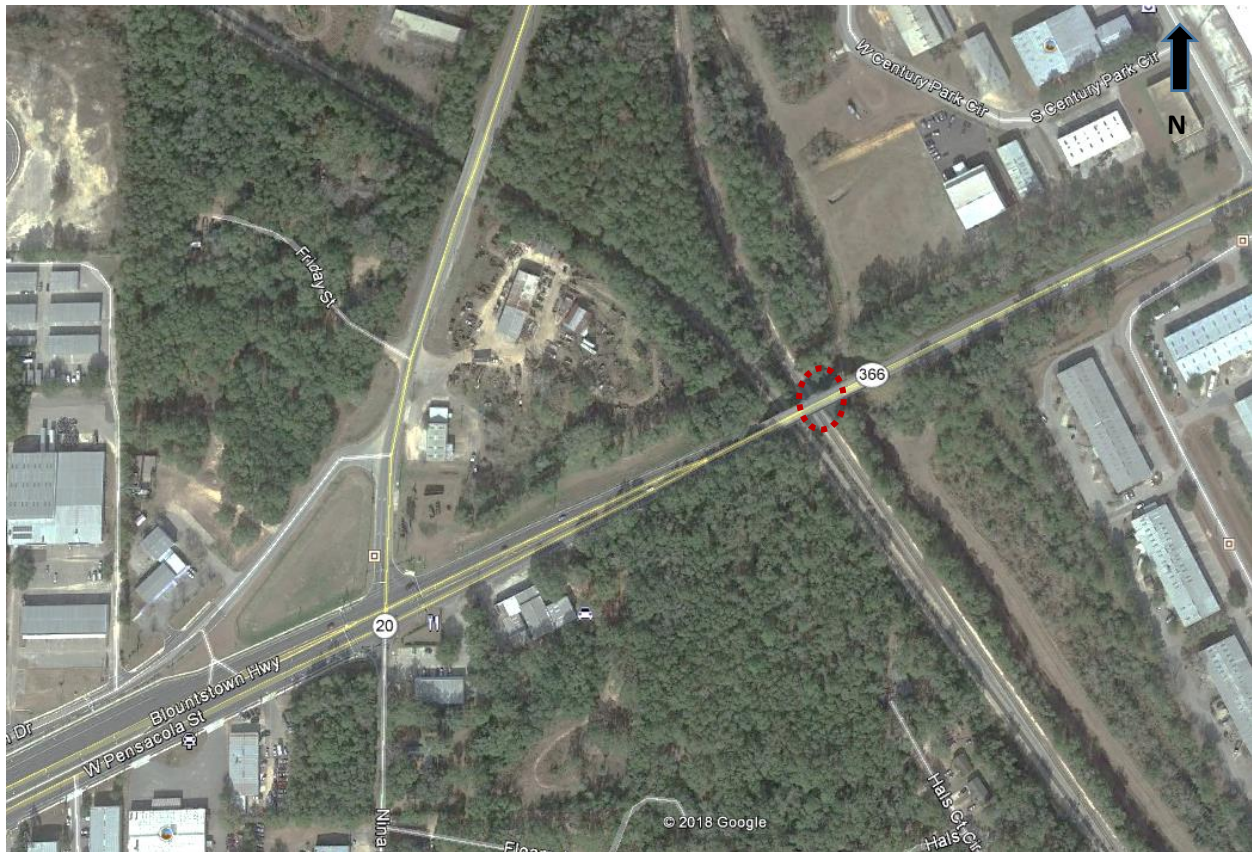
**Figure 3. Bottleneck along Pensacola Street**

When a road has limited physical capacity (i.e., bottlenecks), it contributes to recurring congestion according to the Federal Highway Administration (FHWA). Recent road widening has developed the section of Pensacola Street from Capital Circle SW to Blountstown Highway as a six-lane section. As Pensacola Street continues east, it narrows to a two-lane section at the bridge over the railroad, shown in Figure 3, consequently creating a bottleneck. Pensacola Street continues as a two-lane roadway transitioning into a four-lane roadway at TCC's access point.

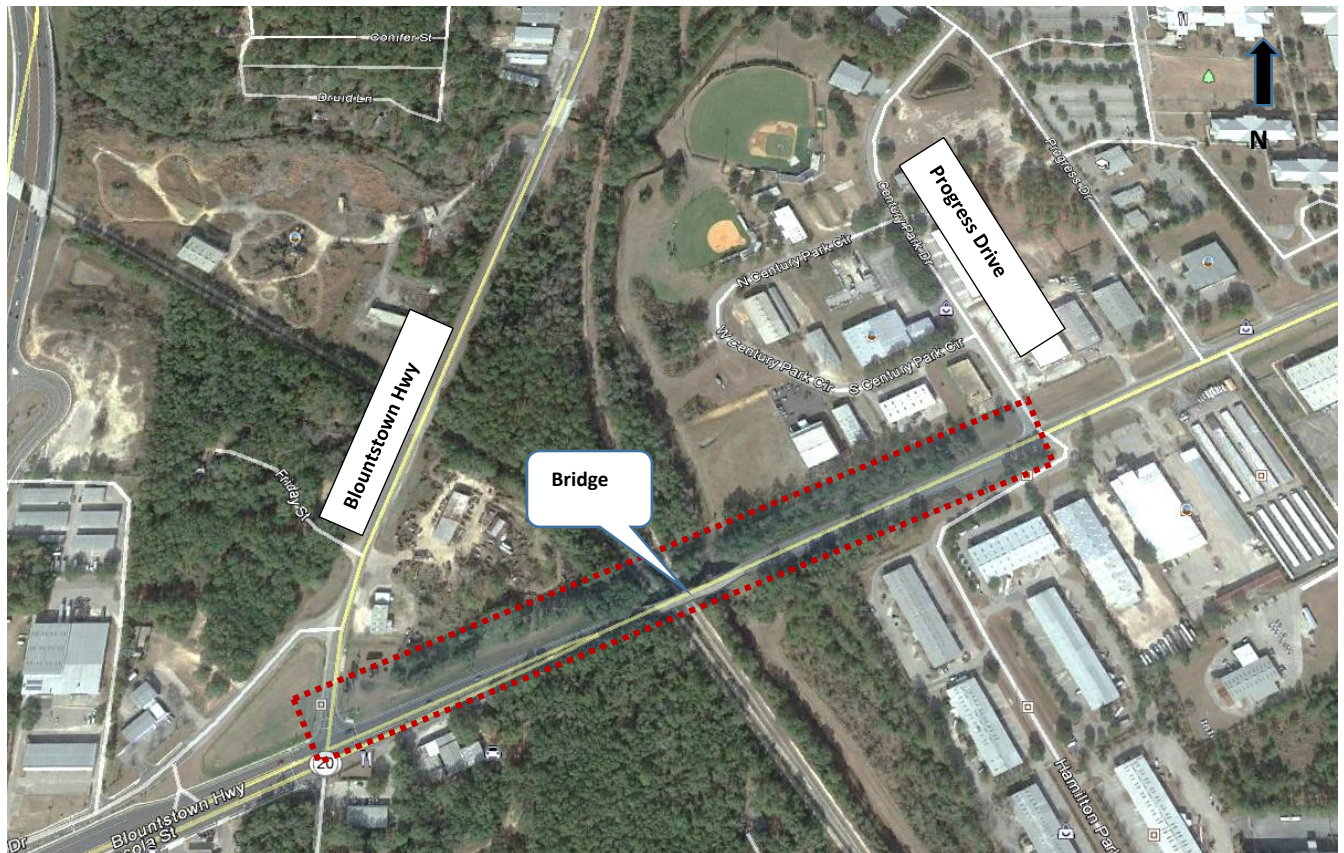
**Figure 4. Lack of Bicycle/Pedestrian Facilities Along Pensacola Street**

Currently, the two-lane section between Blountstown Highway and Progress Drive lacks bicycle and pedestrian facilities (see Figure 4). For this reason, bicyclists and pedestrians are given no choice but to travel along grassed areas to avoid interaction with motorists. However, grassed shoulders and/or ditches are not present throughout the corridor, particularly at the bridge. The lack of facilities and shoulder refuge in this area poses a high risk area for pedestrians as they are given no choice but to travel on the roadway with vehicular traffic.

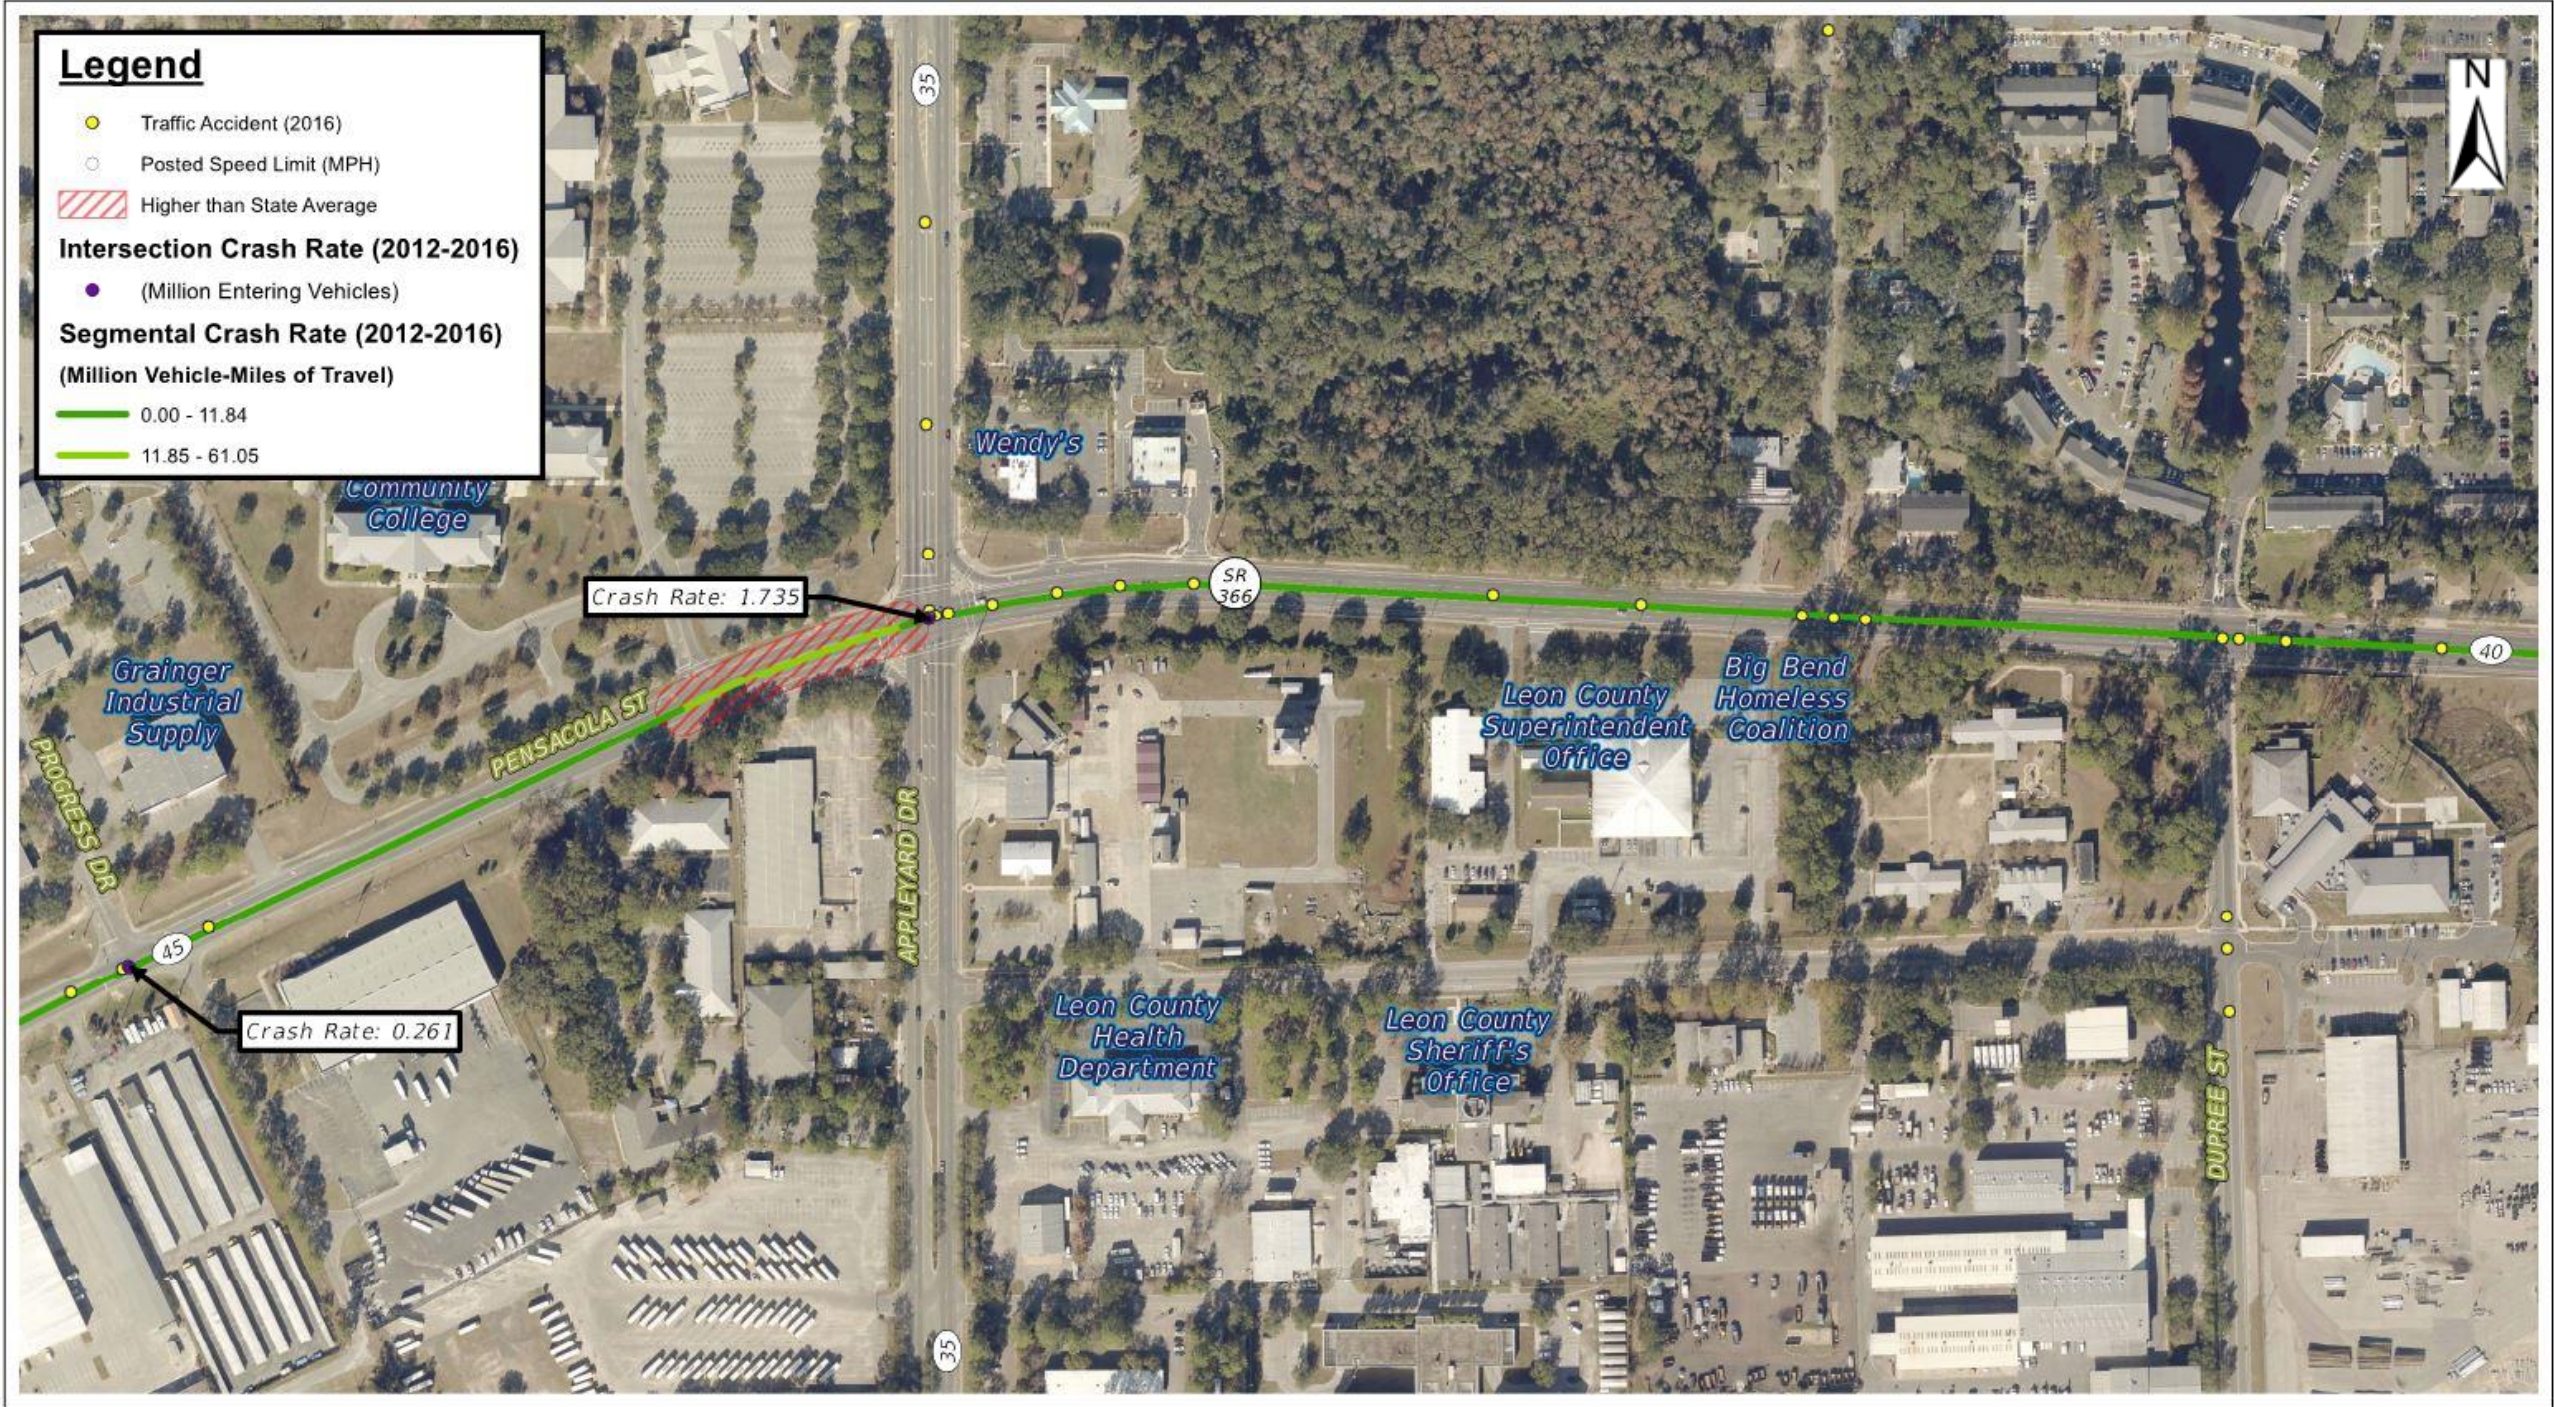
Figure 6. Highest Reported Crash Rate Along Pensacola Street

The crash history along the Pensacola corridor was also assessed to identify deficiencies with respect to existing lighting infrastructure. The analysis of crash data revealed that 17 out of 160 crashes occurred during low visibility hours (dusk, dawn, and nighttime). These incidents comprised 9.4% of total crashes. Additionally, referencing the associated long-form crash reports for these events, none cited low visibility as a primary cause, therefore, no improvements to existing lighting infrastructure are recommended at this time.

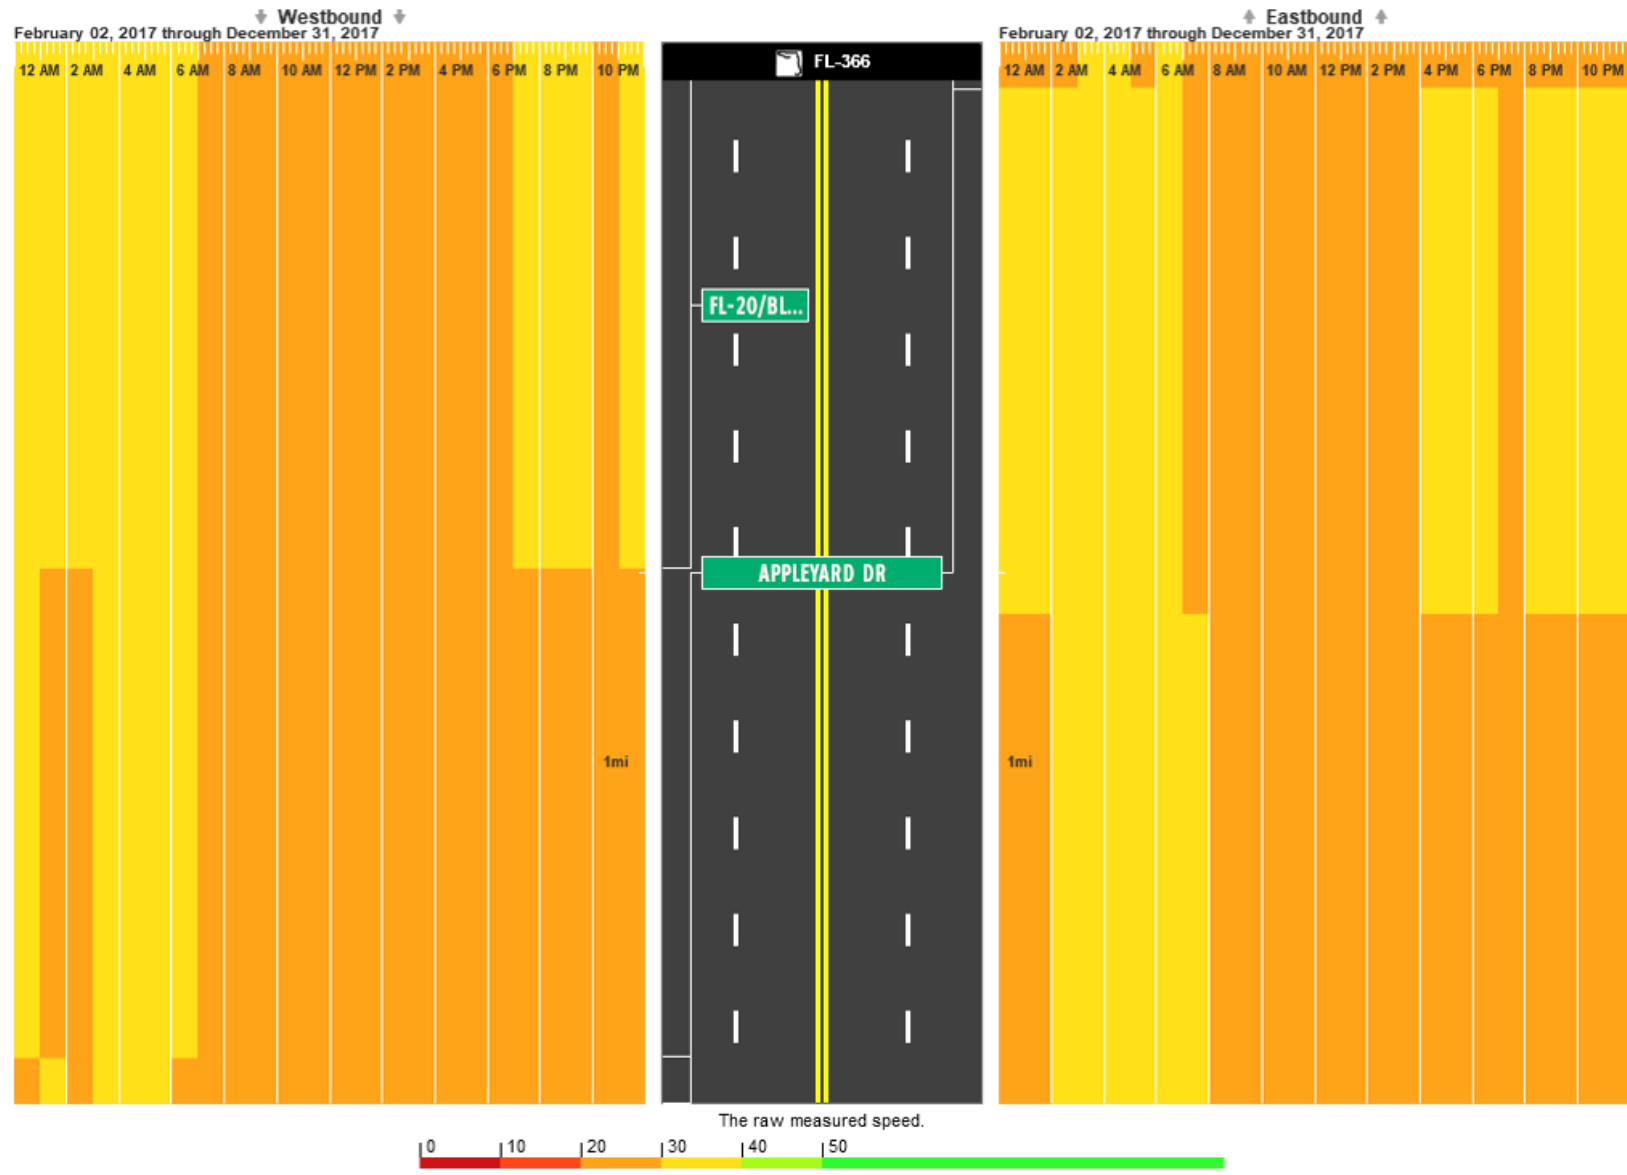
**Figure 8. Pensacola Street NPMRDS Corridor Scan**

The Federal Highway Administration maintains a database of travel information gathered from cellular and GPS units. This database, the National Performance Monitoring Research Data Set (NPMRDS) provides the information for use in network and corridor analyses. The data serves as one analysis tool and can provide insights into the operations of facilities, however, to comprehensively understand the operations of a facility, this data must be combined with other data sources, however it can provide some indication of existing issues.

Averaged by 1 hour for February 02, 2017 through December 31, 2017

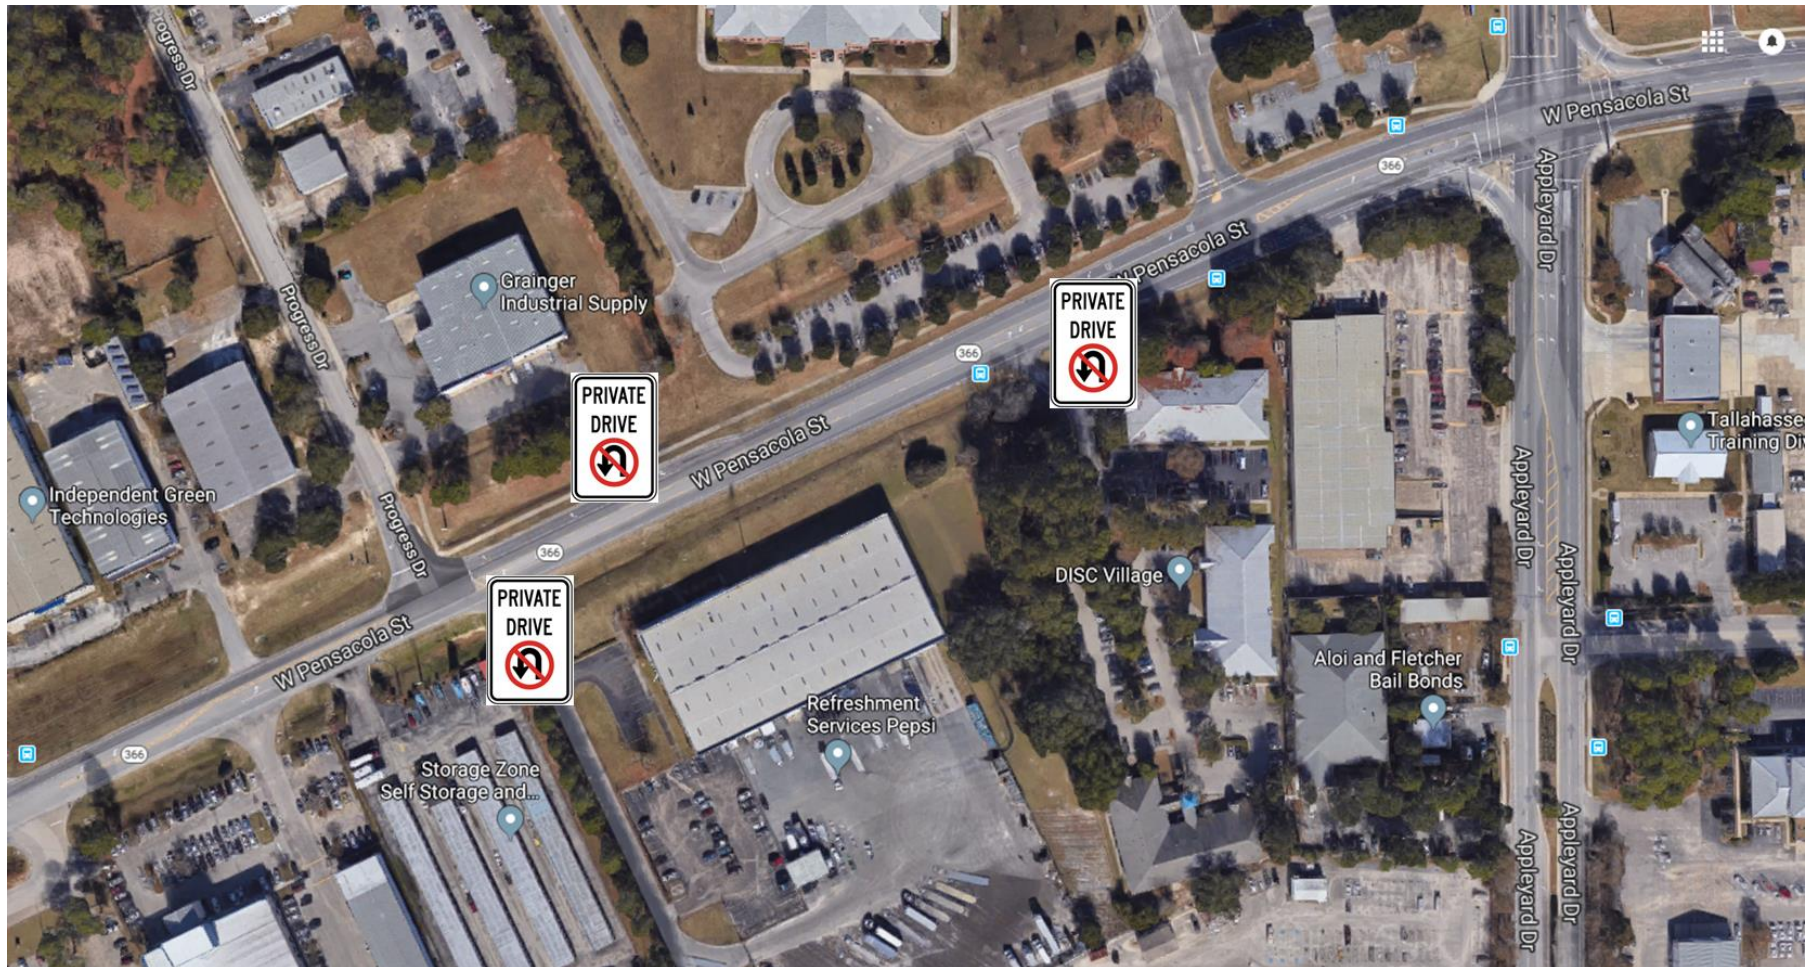
Figure 9. Private Drive Signage and Locations

As a quick fix and low cost improvement to address one of the identified “work around” traffic movements resulting from the spot congestion at TCC, the addition of signage may deter a portion of motorists making the movement. With the consent of all parties, a “Private Drive, No U-Turn” sign is proposed to be placed at the entrances of Disc Village, Grainger, and Pepsico. Figure 9 displays the signage and locations.

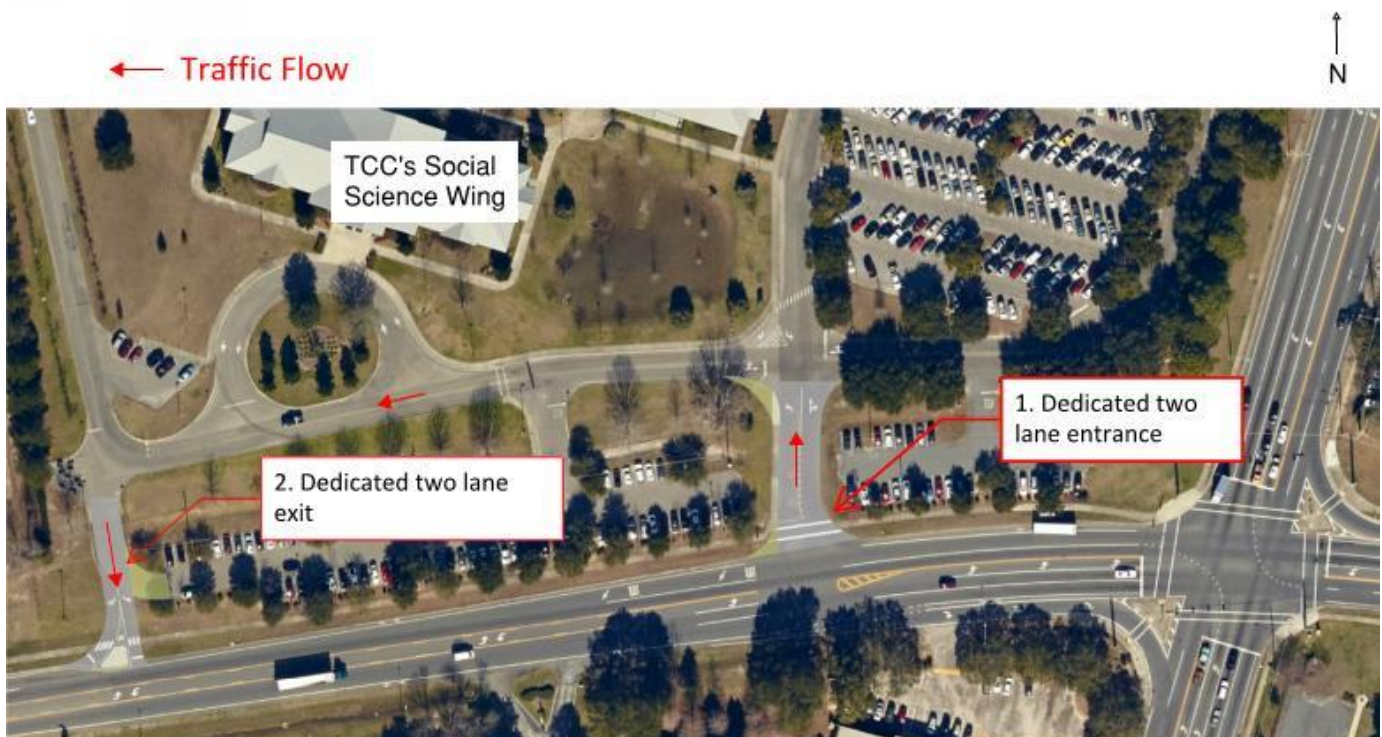
**Figure 10. Spot Congestion – Comprehensive Alternative**

A more comprehensive solution to the issues described regarding spot congestion involves reconfiguring the points of access to TCC from Pensacola. The first element of the proposed approach involves creating a dedicated two-lane entrance for TCC. The entrance will be restriped to create both a left turn and right through lane.

As described earlier, the highest incidence of crashes occurs at the existing two-way access point near the intersection at Appleyard Dr. Managing access and reducing illegal movements will contribute to improved safety conditions along the corridor.
