CRTPA

N. Monroe Safety Implementation

CRTPA  
N. Monroe Safety Implementation

Intersection and Segment Specific Data and Potential Improvements

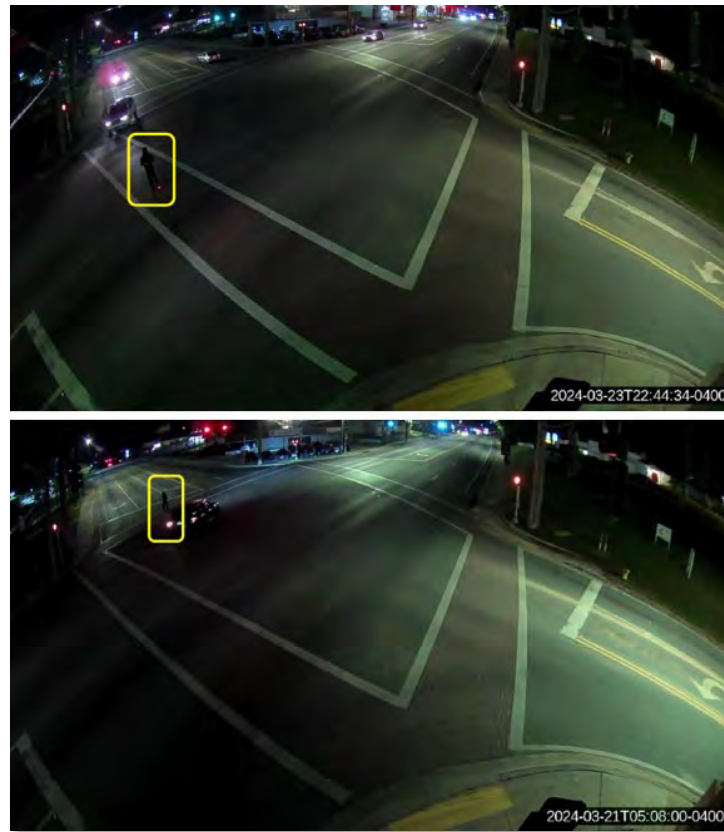
Figure 1: Near Miss Examples in Darkness

Potential improvements for the Tharpe Street intersection include crosswalk improvements, LPI, and lighting enhancements. The crosswalk improvements would create increased visibility of the crosswalk through high emphasis hatch marks, aiming to increase driver awareness of the crossing area. LPI, or leading pedestrian intervals, at this intersection would allow pedestrians who are walking to nearby restaurants, stores, or bus stops to enter the intersection a few seconds before drivers get a green signal, further increasing driver awareness of a pedestrian in this commonly utilized intersection. Currently, there are existing street light poles at this intersection, but additional lighting could improve visibility for both pedestrians and drivers, and it would offer pedestrians a boosted sense of safety. Figure 1 depicts recorded near miss examples at this location at night.

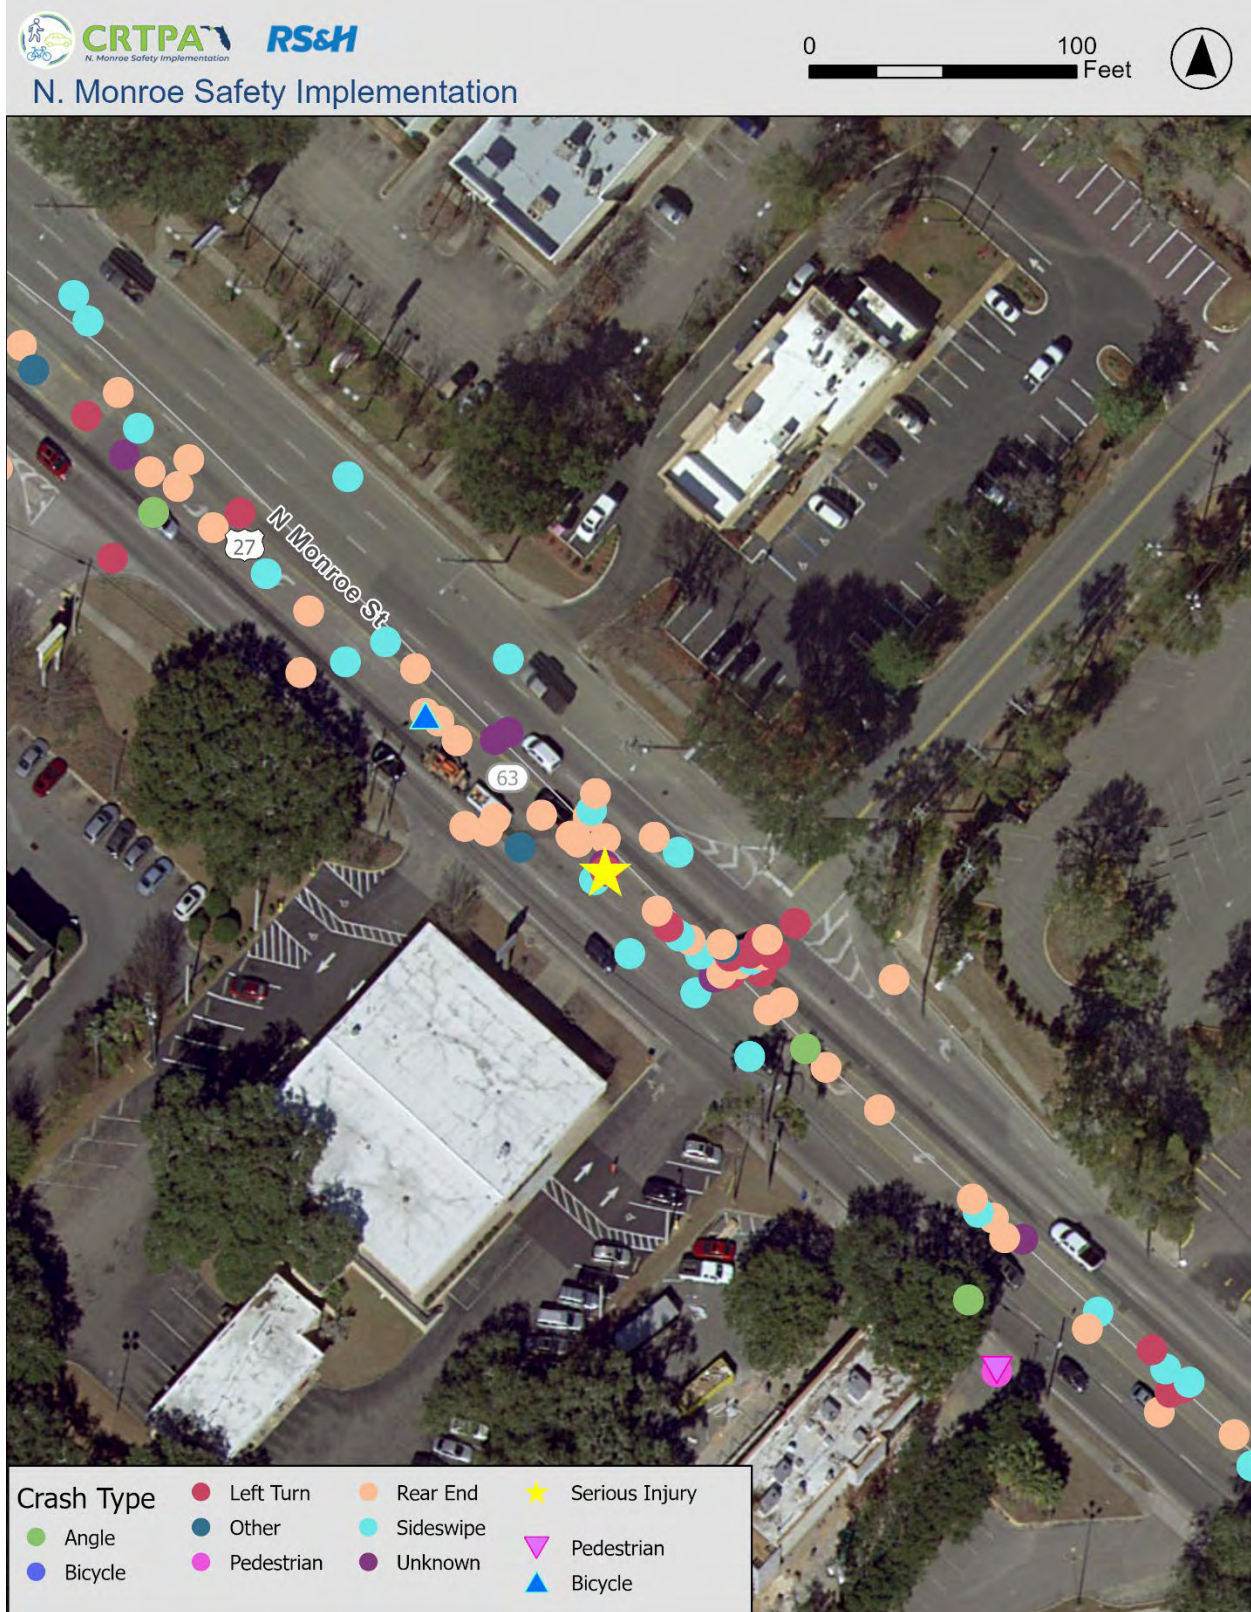
Figure 2: Current Angle Crash and Rear End Clustering at Silver Slipper Lane Intersection

Another potential improvement would be the reconfiguration of the access point at Silver Slipper Lane. This would consist of changing the geometry at this location to have a right turn in, right turn out vehicular flow with hatched pedestrian crossing at the new medians. Figure 2 indicates the current angle crash and rear end clustering at the Silver Slipper Lane intersection.

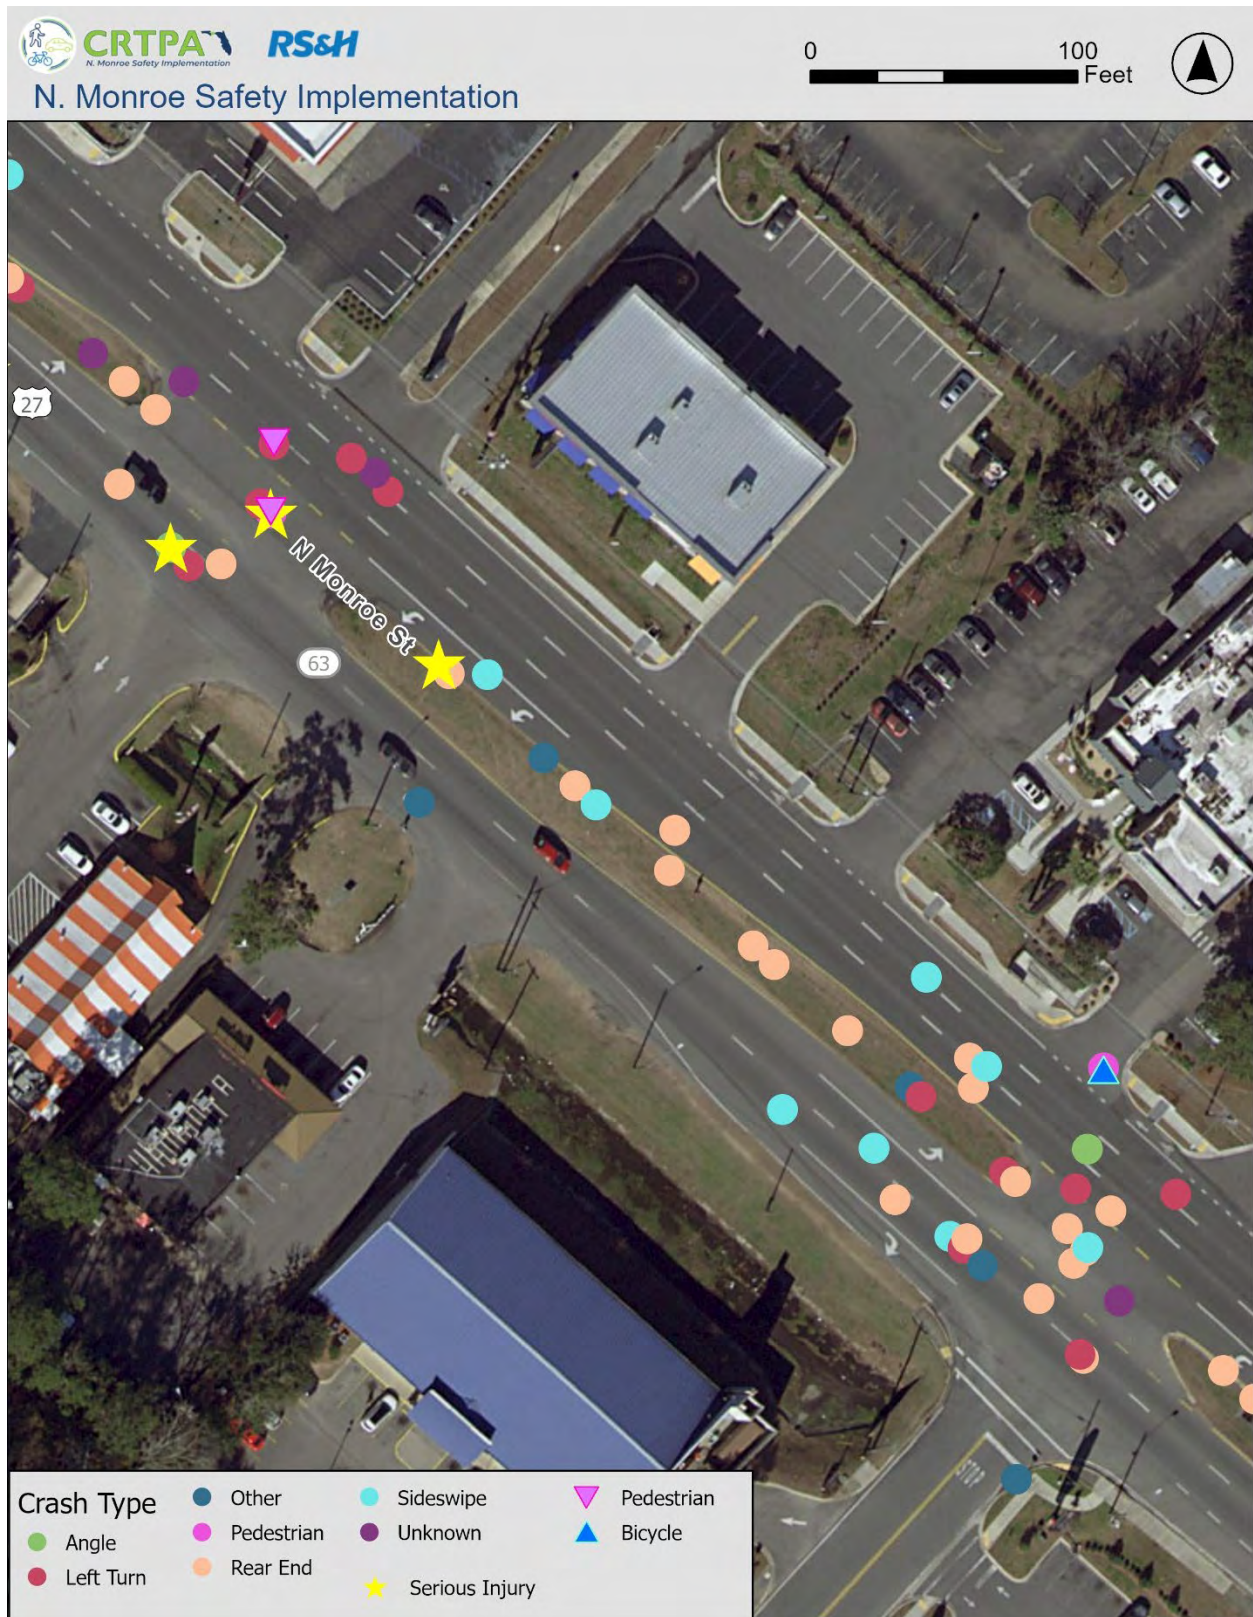
Figure 5: Median Break Crash Clustering Between Allen Road and Sharer Road

From 2017-2023, along the Allen Road to Sharer Road mid-block segment, there was one pedestrian Incapacitating Injury, one Non-Incapacitating Injury, two pedestrian Possible Injuries, and one cyclist No Injury. Potential improvements at this segment include controlled pedestrian crossings and pedestrian fencing to reroute pedestrians to a safer, more identifiable mid-block crossing. Additionally, transitioning to a directional median openings would be a potential improvement to improve driver safety when using median breaks along the segment. Figure 5 depicts clustering in the median areas along this segment.

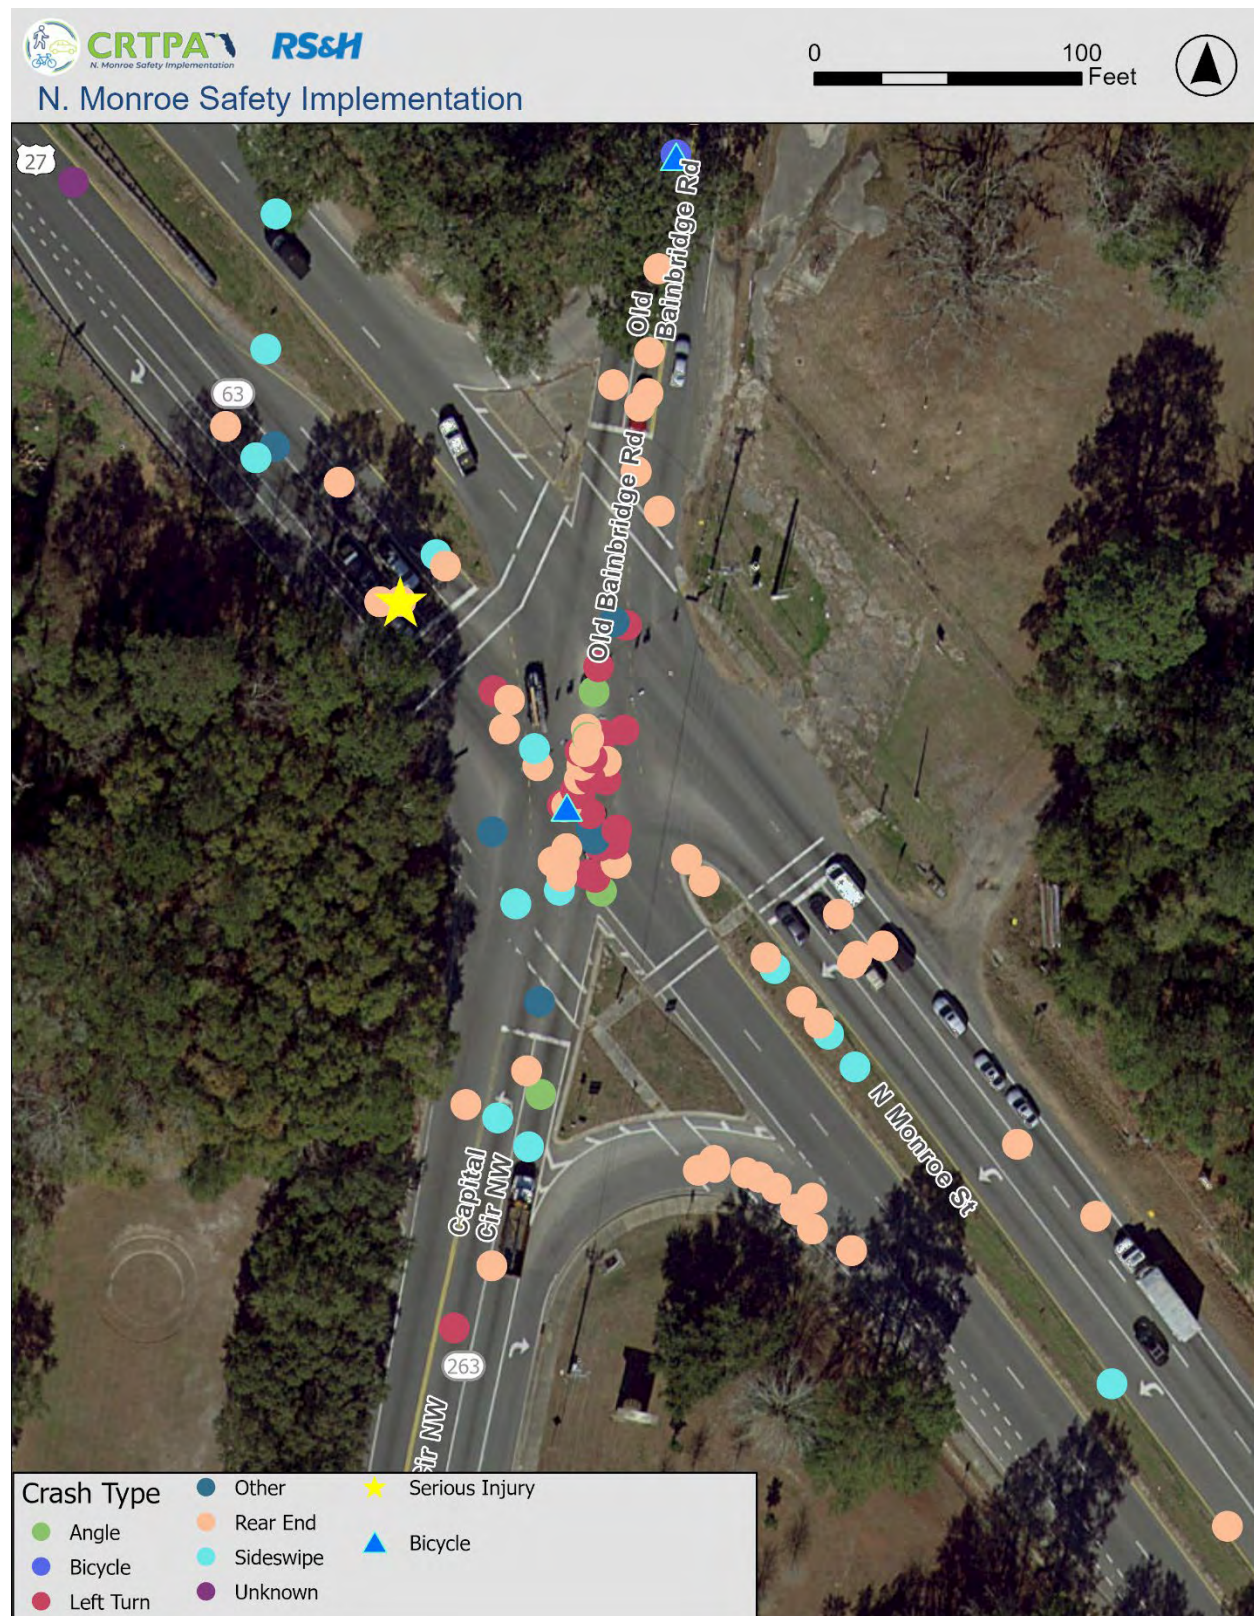
Figure 9: Capital Circle NW / Old Bainbridge Rd Crash Clustering

Potential improvements to address visibility issues are to offset the northbound and southbound left turn lanes and add a blank out sign to restrict turning movements when pedestrians are present. Figure 9 depicts the crash clustering at this intersection.
