March 5, 2024

COMMITTEE AGENDA ITEM 5 B

CRTPA CONGESTION MANAGEMENT PLAN (CMP)

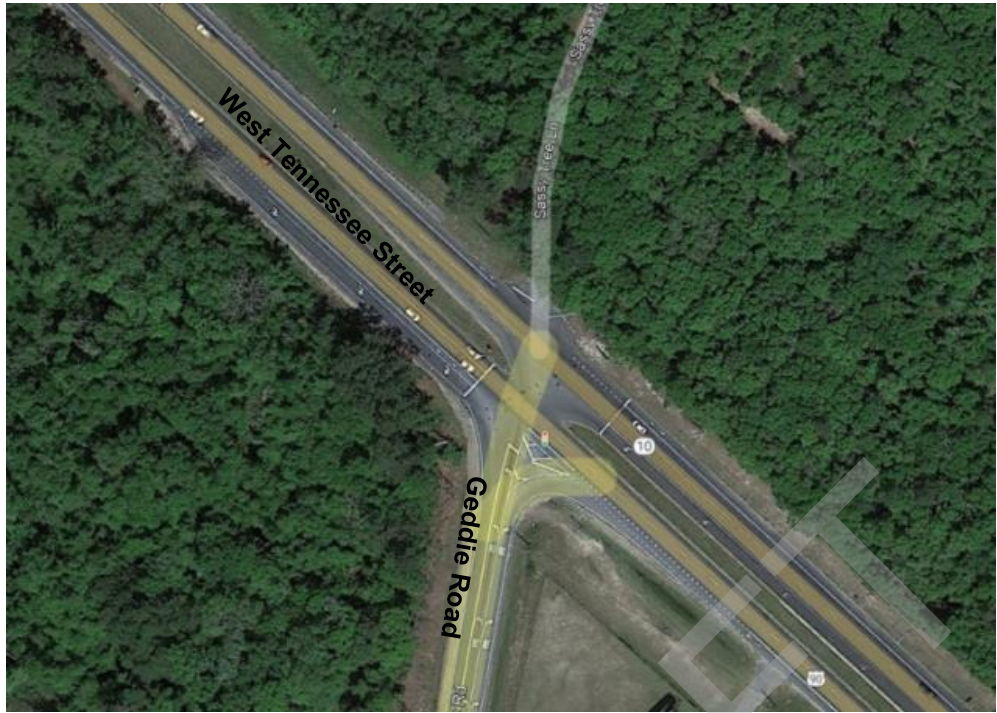
West Tennessee Street and Geddie Road

Year	All Crashes	Rear End	Left Turn
2017	0	0	0
2018	1	1	0
2019	1	0	1
2020	1	1	0
2021	0	0	0
TOTAL	3	2	1

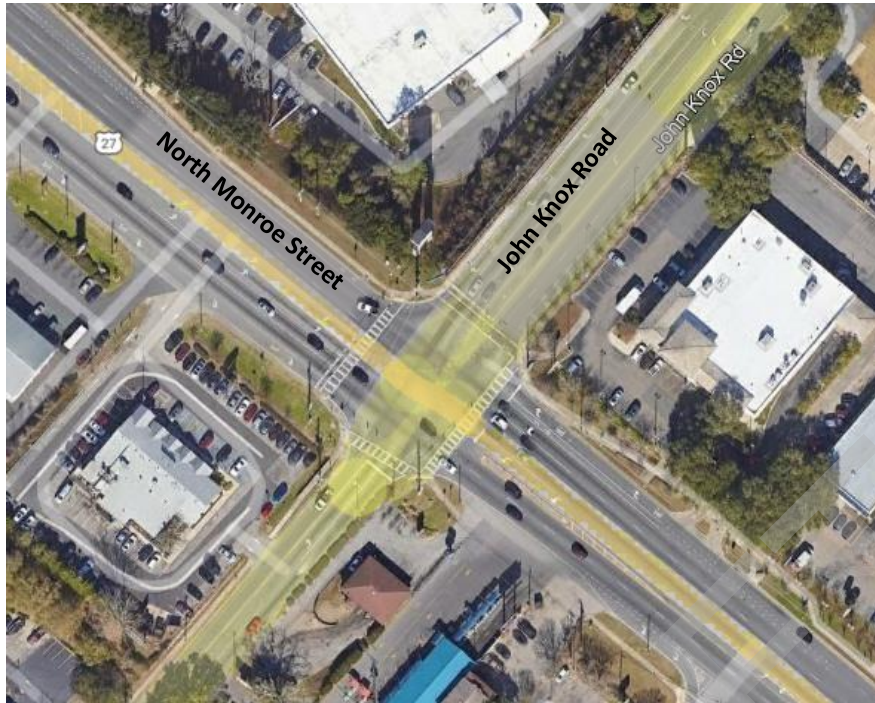
North Monroe and John Knox Road

Year	All Crashes	Left Turn	Rear End
2017	2	1	1
2018	0	0	0
2019	1	1	0
2020	0	0	0
2021	1	0	1
TOTAL	4	2	2

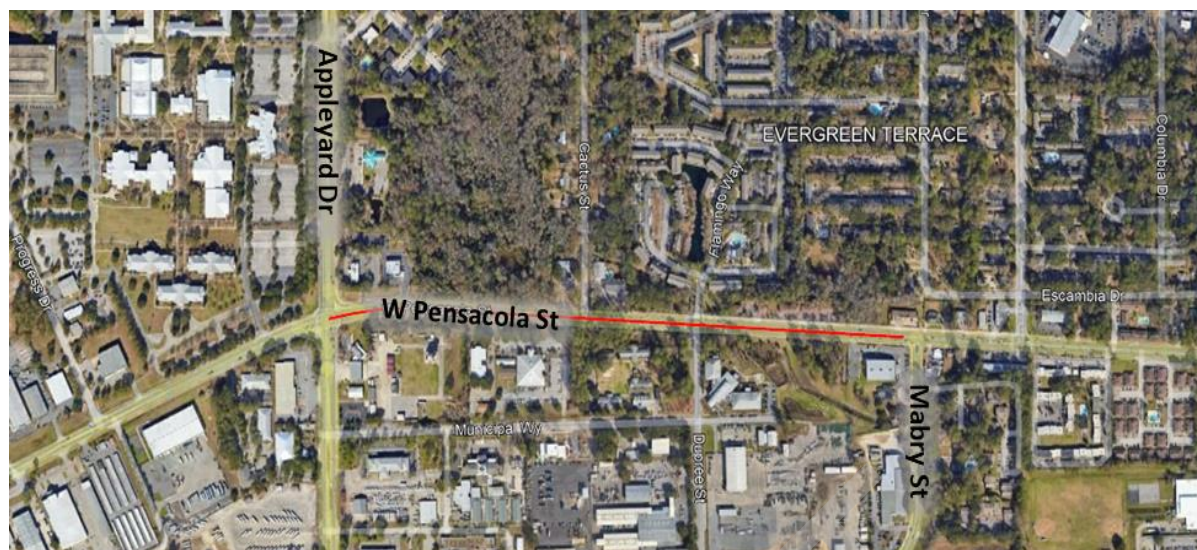
West Pensacola Street between Appleyard Drive and Mabry Street

Year	All Crashes	Pedestrian	Left Turn	Rear End
2017	0	0	0	0
2018	3	2	1	0
2019	2	2	0	0
2020	1	0	0	1
2021	1	1	0	0
TOTAL	7	5	1	1

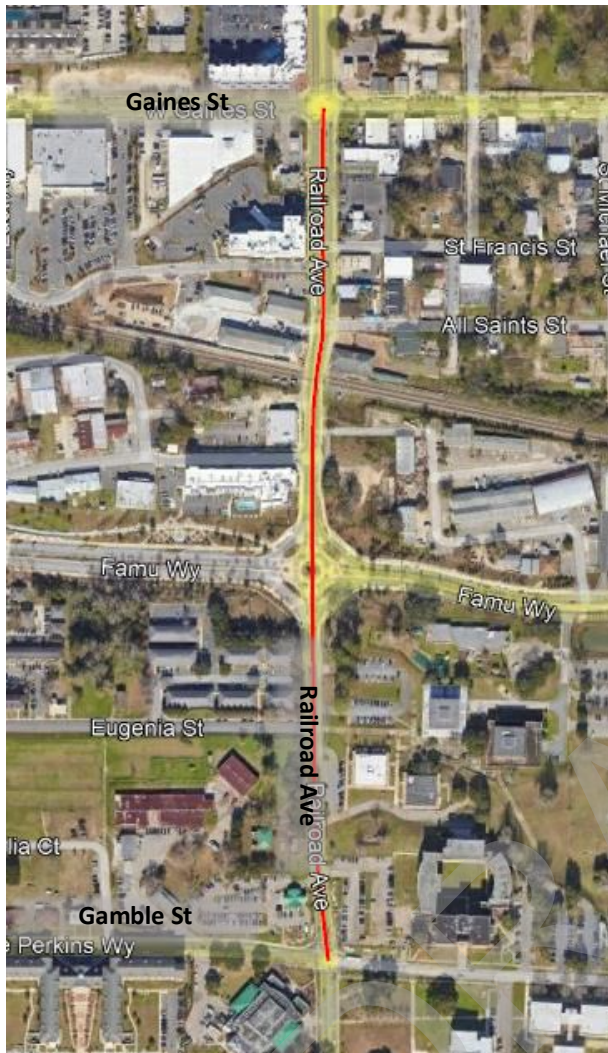
Railroad Avenue between Gaines Street and Robert and Trudie Perkins Way

Year	All Crashes	Off Road	Left Turn
2017	1	0	1
2018	0	0	0
2019	0	0	0
2020	0	0	0
2021	2	2	0
TOTAL	3	2	1

1. Pavement Markings
 - a. Restripe the stop bar and crosswalk on the eastbound approach to Railroad Avenue, south of the Hampton Inn.
2. Pavement/Railroad Condition
 - a. Repair railroad crossing to eliminate uneven (i.e., rough) road conditions.

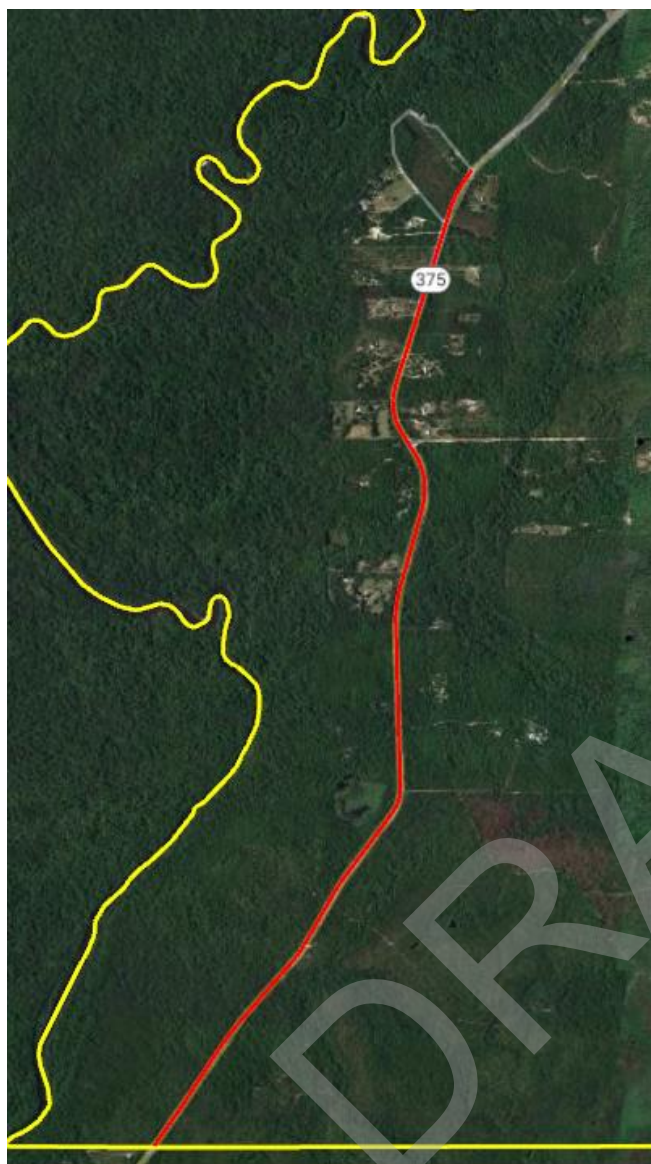
Smith Creek Road (Stoutamire Landing Rd to Leon/Wakulla County Line)

Year	All Crashes	Off Road	Other
2017	1	1	0
2018	1	0	1
2019	0	0	0
2020	1	0	1
2021	0	0	0
TOTAL	3	1	2

1. Pavement Markings
 - a. Replace reflective markers on segment (90% of markers are currently missing).
2. Smith Creek Road near Generation Gap Trail
 - a. Fix rutting on shoulder (Shoulder drop-off).
 - b. Install high visibility horizontal curve advisory features such as reflective pavement markers and chevron alignment signs (including reflective post).

Leon	*Smith Creek Road	<p>1. Pavement Markings a. Replace reflective markers on segment (90% of markers are currently missing).</p> <p>2. Smith Creek Road near Generation Gap Trail a. Fix rutting on shoulder (Shoulder drop-off). b. Install high visibility horizontal curve advisory features such as reflective pavement markers and chevron alignment signs (including reflective post)</p>	600/Three Crashes: One Fatality and Two Serious Injury
Leon	*Wakulla Springs Road	<p>1. Pavement Markings a. Install longitudinal rumble strips or profiled pavement markings on centerline and edge of travel lane line</p>	7,700/Four Crashes: Zero Fatalities and Four Serious Injury (One Bicycle Related Crash)
