CRTPA  
N. Monroe Safety Implementation

RS&H

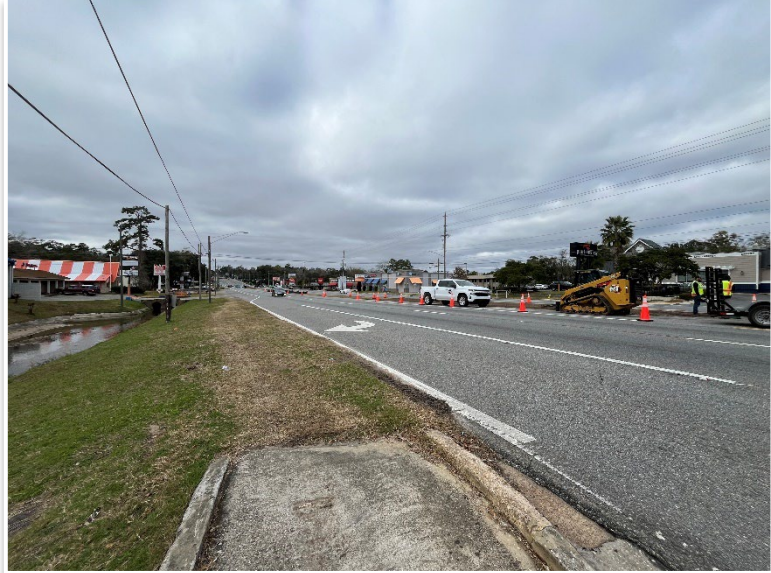
Figure 2: Pedestrian Gap Area

Implementation Grant Program. In coordination with the Florida Department of Transportation (FDOT), the Blueprint Intergovernmental Agency (BPIA) has committed to providing the local match for the grant and implementing the safety improvements upon successful award. Figure 2 indicates a sidewalk gap area with clear signs of wear.

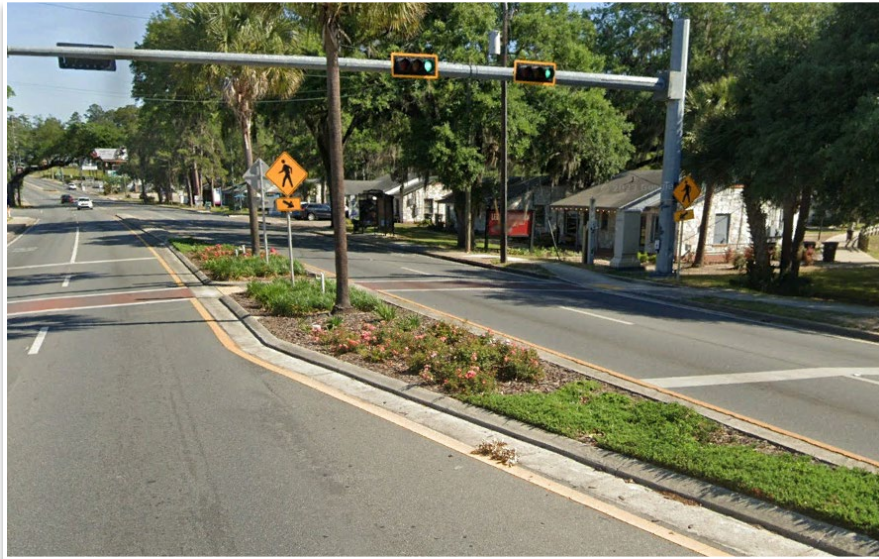
Figure 4: Median and Pedestrian Crosswalk at US 27 Near Lake Ella

- FDOT: Monroe Street Median Construction (2016) – In 2016, construction began on landscaped medians on North Monroe Street from Tharpe Street to Seventh Avenue. A signalized pedestrian crossing (example depicted in Figure 4) was implemented following the construction of the medians.

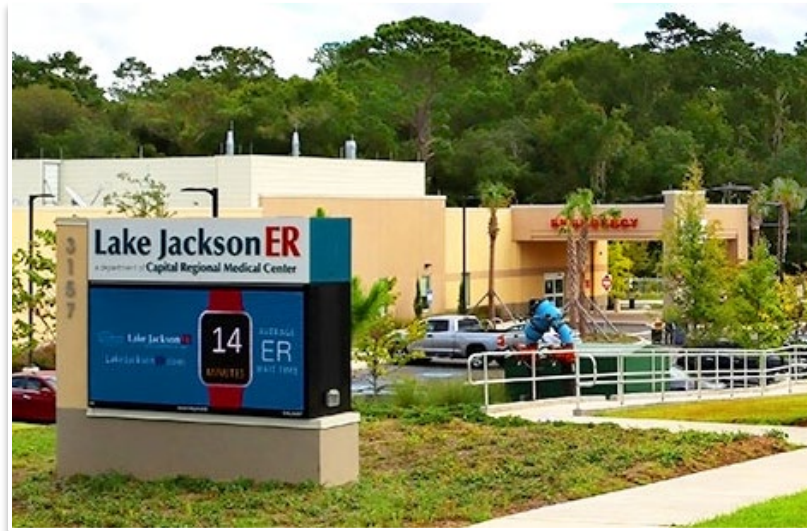
Figure 5: Lake Jackson ER Sidewalk

- of a three-story multi-unit dwelling development located on Tharpe Street focusing on assisted and independent living.
- Lake Jackson Emergency Room (2019)⁴ – A freestanding emergency room located on North Monroe Street (see Figure 5) was opened in 2019. This project included the implementation of a five-foot-wide sidewalk with a landscape buffer and trees from Northmont Drive to Okeeheepkee Road.

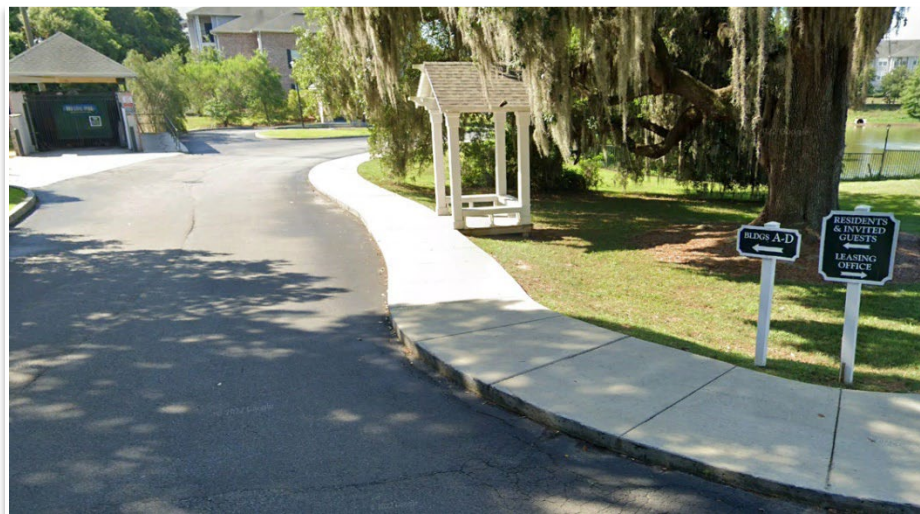
Figure 6: Sidewalk at Arbor Landing

- FDOT; CRTPA; Tallahassee: Safe Routes to Schools (2019-2020) – This FDOT project consisted of various Safe Routes to School projects constructing approximately 0.7 miles of sidewalk in various locations including Canopy Oaks Elementary School and the School of Math and Sciences on North Monroe Street.
- Arbor Landing Development (2020) – This 2020 private investment development located on North Monroe Street (south of Capital Circle NW/Old Bainbridge Road) featured an internal wide sidewalk infrastructure which could create a connection to sidewalks along North Monroe Street. (example shown in Figure 6). Arbor Landing features 120 multi-family units.

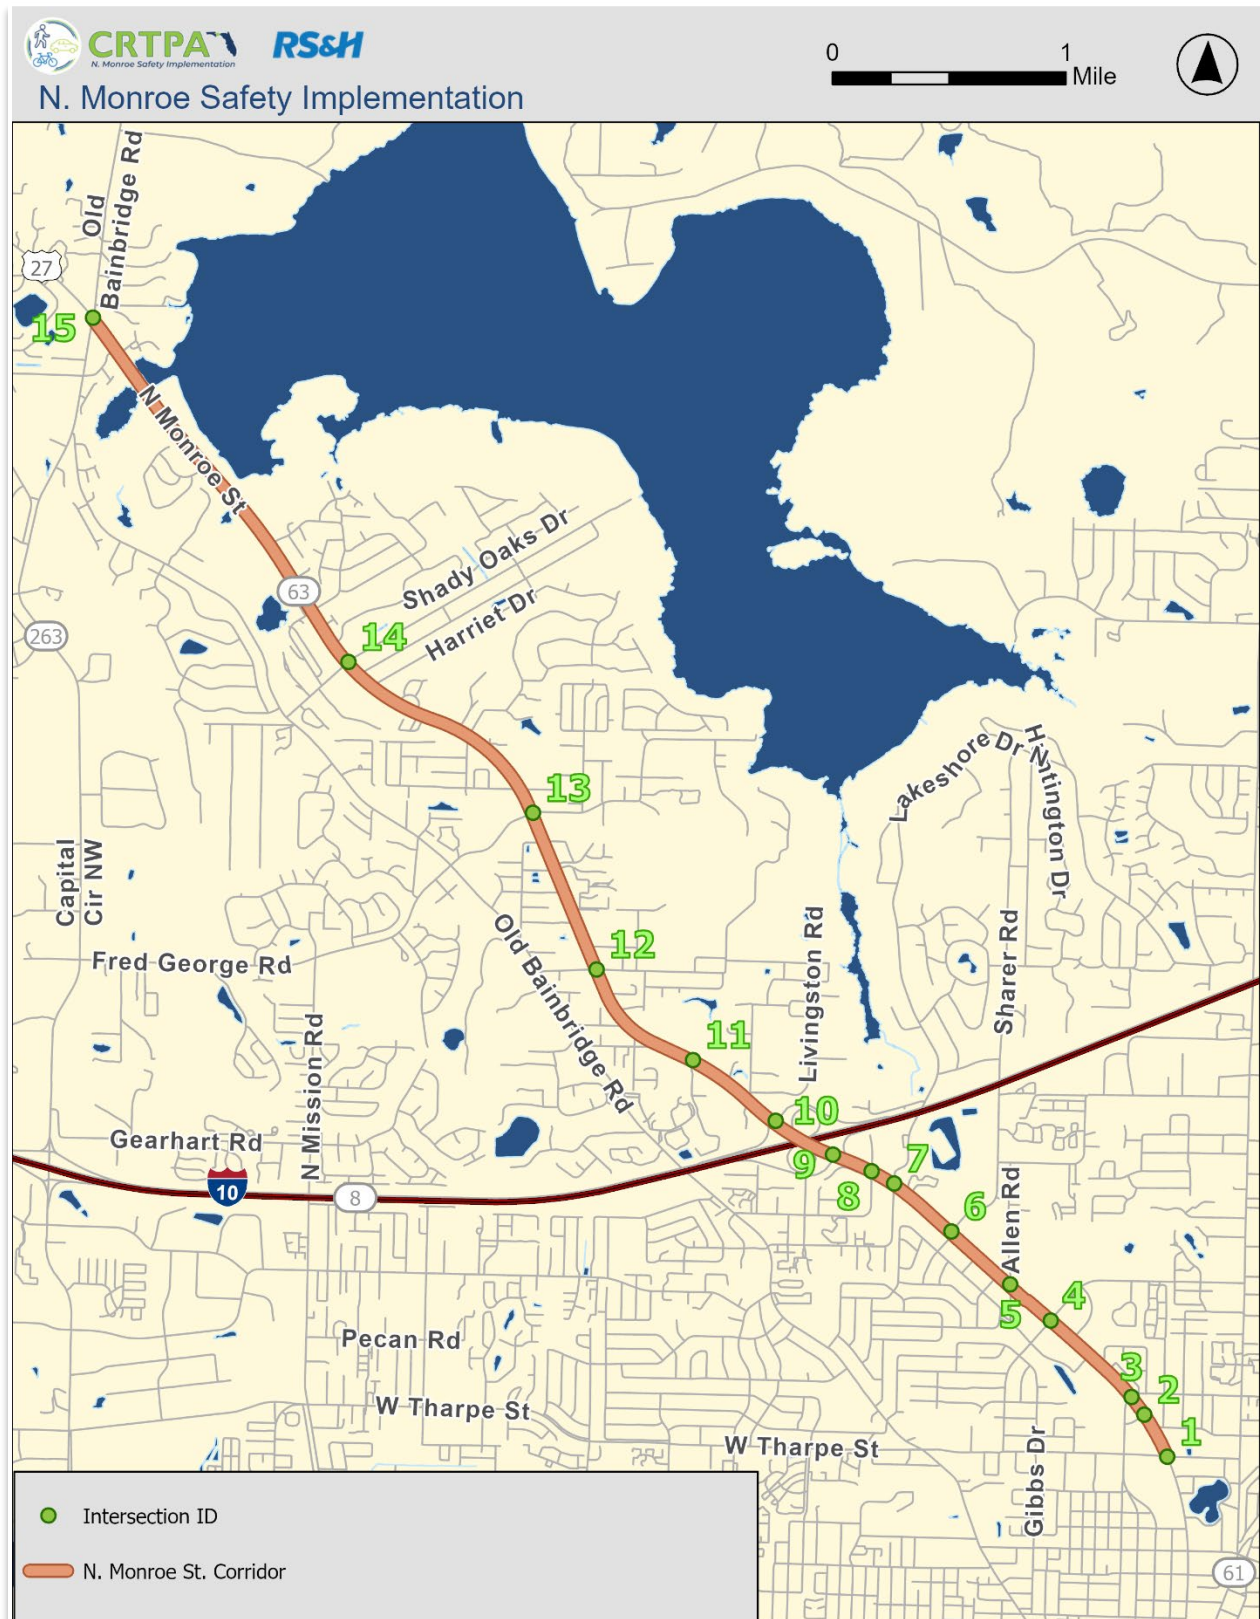
Figure 9: Corridor Intersection Identifiers

Figure 9 Depicts the location of the intersections and their identification number.

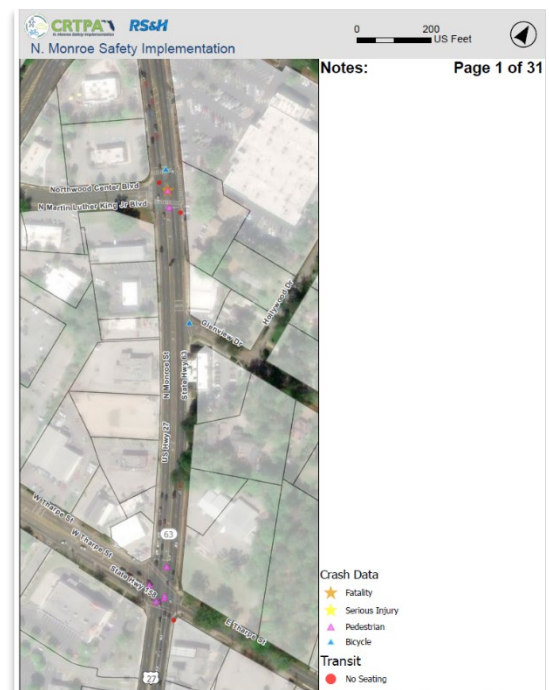
Figure 12: Notes Page Example

The team was also given a map series, showing the corridor locations and known crash locations through the corridor. The crash locations and data enhanced team understanding and was instrumental in the development of potential improvements along the corridor. Figure 12 represents an example of the notes pages provided to the team members.

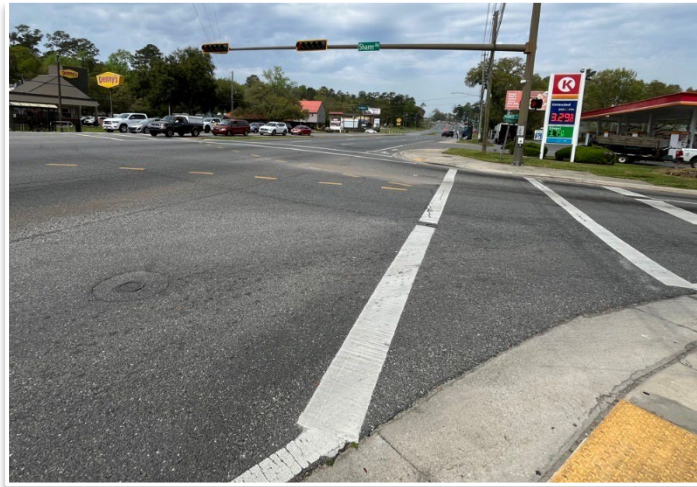
Figure 13: Crosswalk Without High Emphasis Markings

This audit was conducted to confirm conditions along the corridor and to identify additional areas of concern that were not readily identified through desktop analysis. As depicted in Figure 13, Figure 14, and Figure 15, this multidisciplinary team identified key infrastructure and conditions of the corridor, taking a collaborative approach that helped generate coordinated and integrated potential improvements.

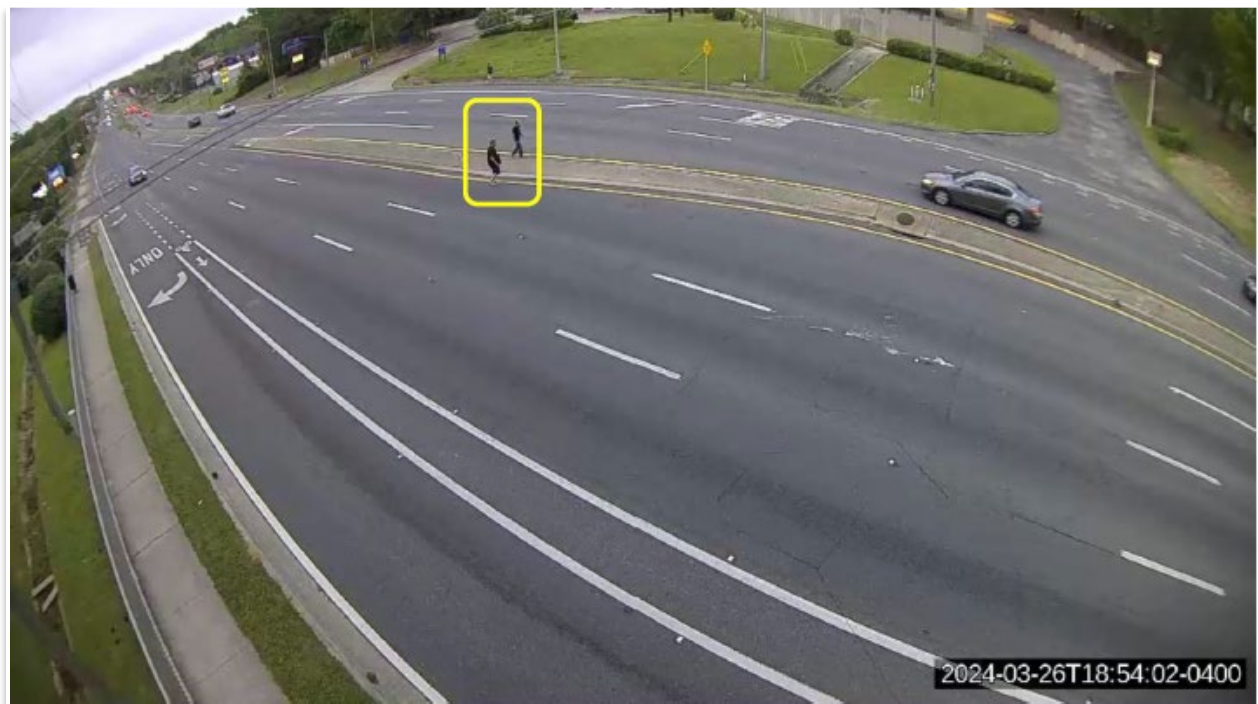
Figure 29: North Midblock between Lakeshore Drive and Sharer Road Pedestrian Crossing Midblock

Figure 28 and Figure 29 depict near misses recorded at this location.

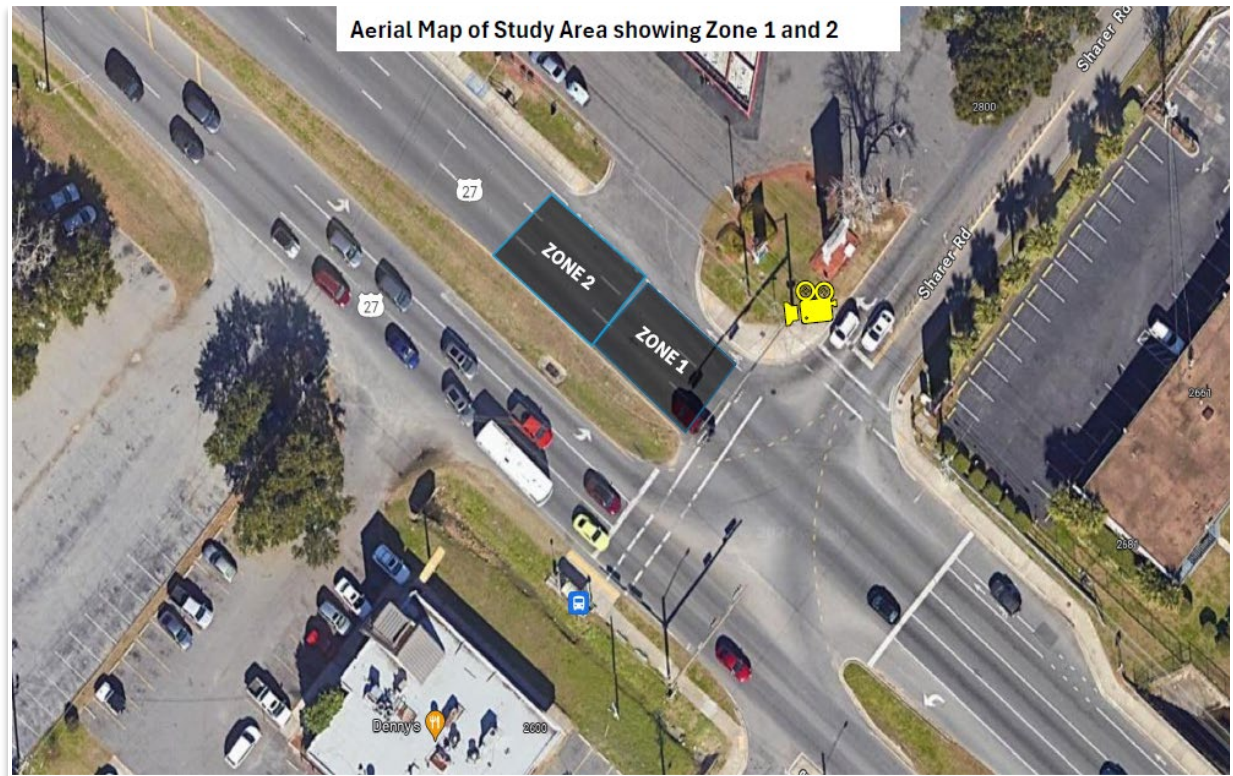
Figure 30: Overview of the South Midblock Camera Coverage

Figure 30 demonstrates the south midblock camera coverage area. The results of the non-motorist near miss analysis are documented in Figure 31.

- Typical weekday: 250 pedestrians observed, 43 midblock crossings, 8 near miss events
- Typical weekend day: 266 pedestrians observed, 91 midblock crossings, 15 near miss events

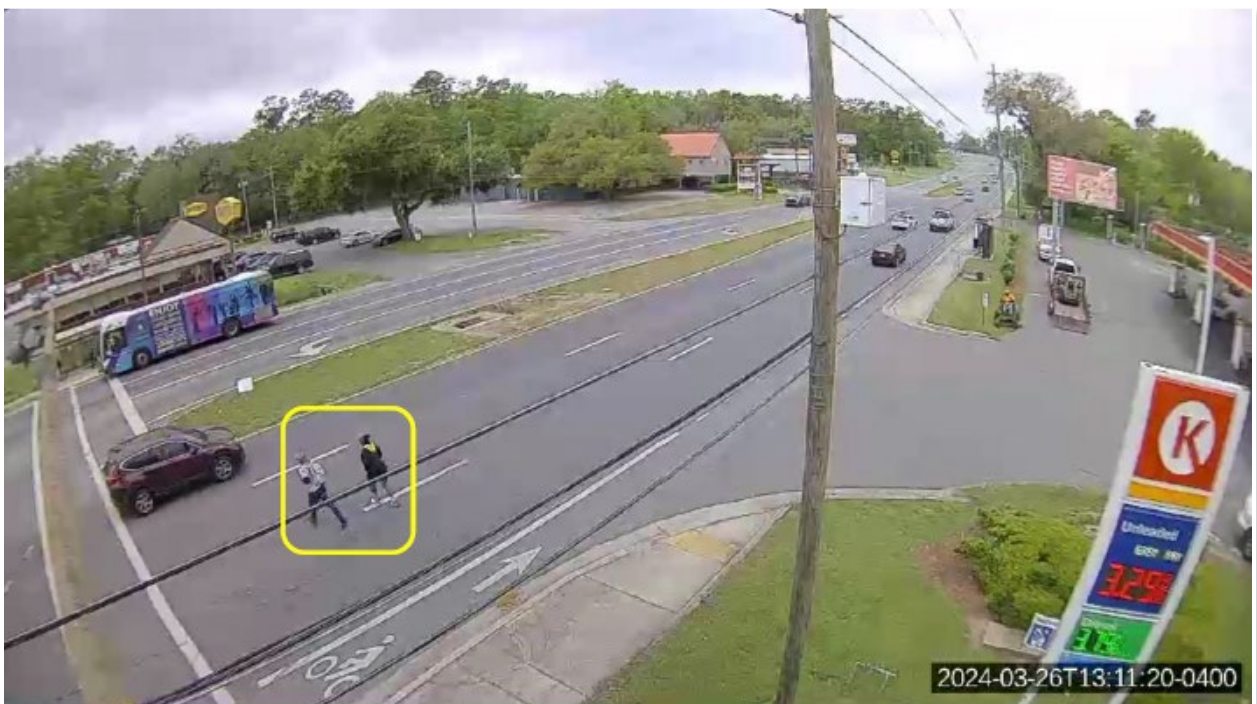
Figure 33: South Midblock between Lakeshore Drive and Sharer Road Pedestrians Crossing between Moving Traffic

The non-motorist routes are shown in Figure 32. Figure 33 and Figure 34 depict near misses recorded at this location.

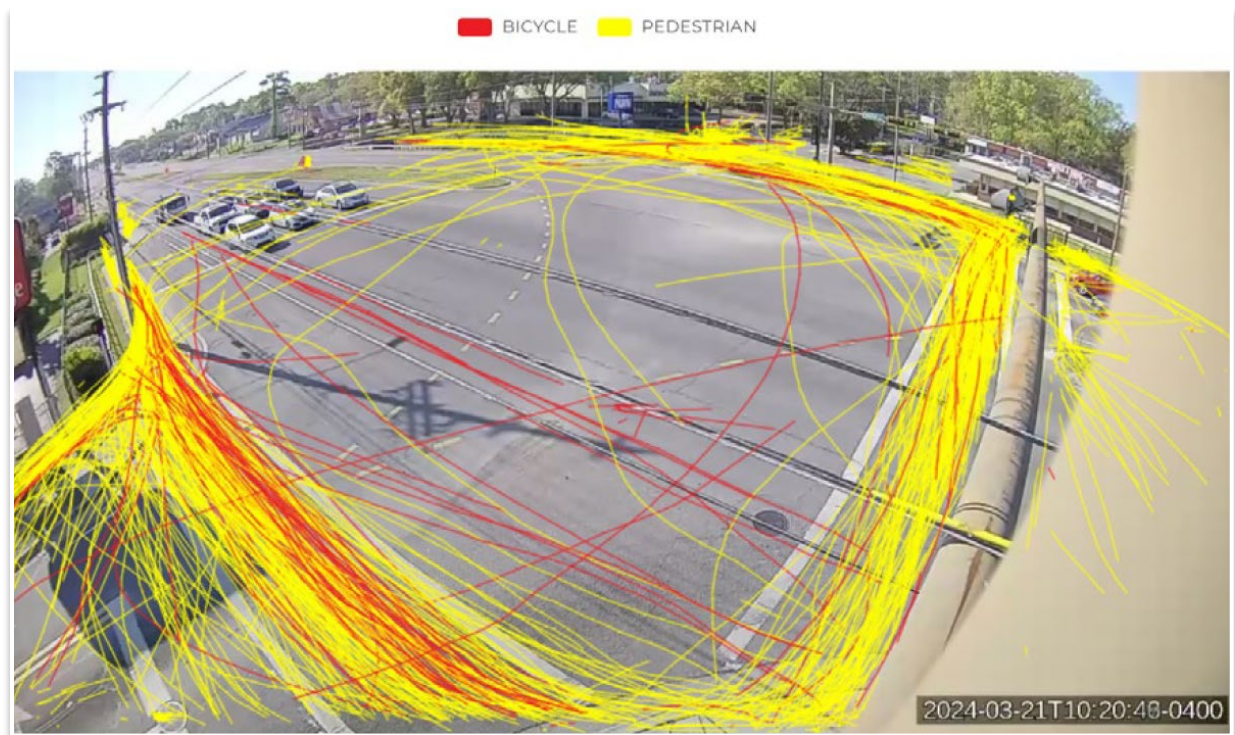
Figure 36: Sharer Road Pedestrian and Bike Pathing

The non-motorist routes are shown in Figure 36. Figure 37 and Figure 38 depict near misses recorded at this location.

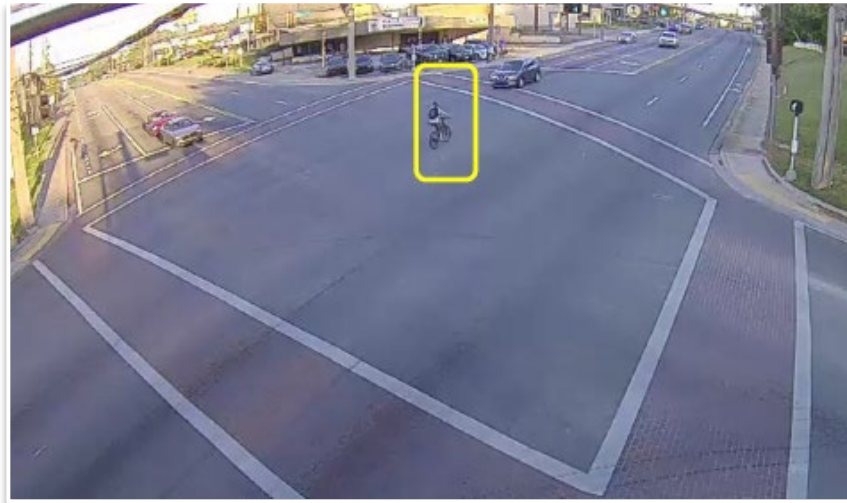
This near miss analysis allowed for the development of proactive recommendations rather than reactive to previous crash data. Figure 45 depicts an example of a recorded near miss where a bicyclist crossed through the center of an intersection with oncoming traffic. *Figure 45: Bicyclist and Vehicle Near Miss*

To reduce the number of unsafe crossings, pedestrian fencing and the implementation of signalized midblock crossings have been recommended. These countermeasures channelize pedestrian crossings to designated and safer locations.
