CRTPA
TRAFFIC AND OPERATIONS ANALYSIS
PENSACOLA STREET

January 2019

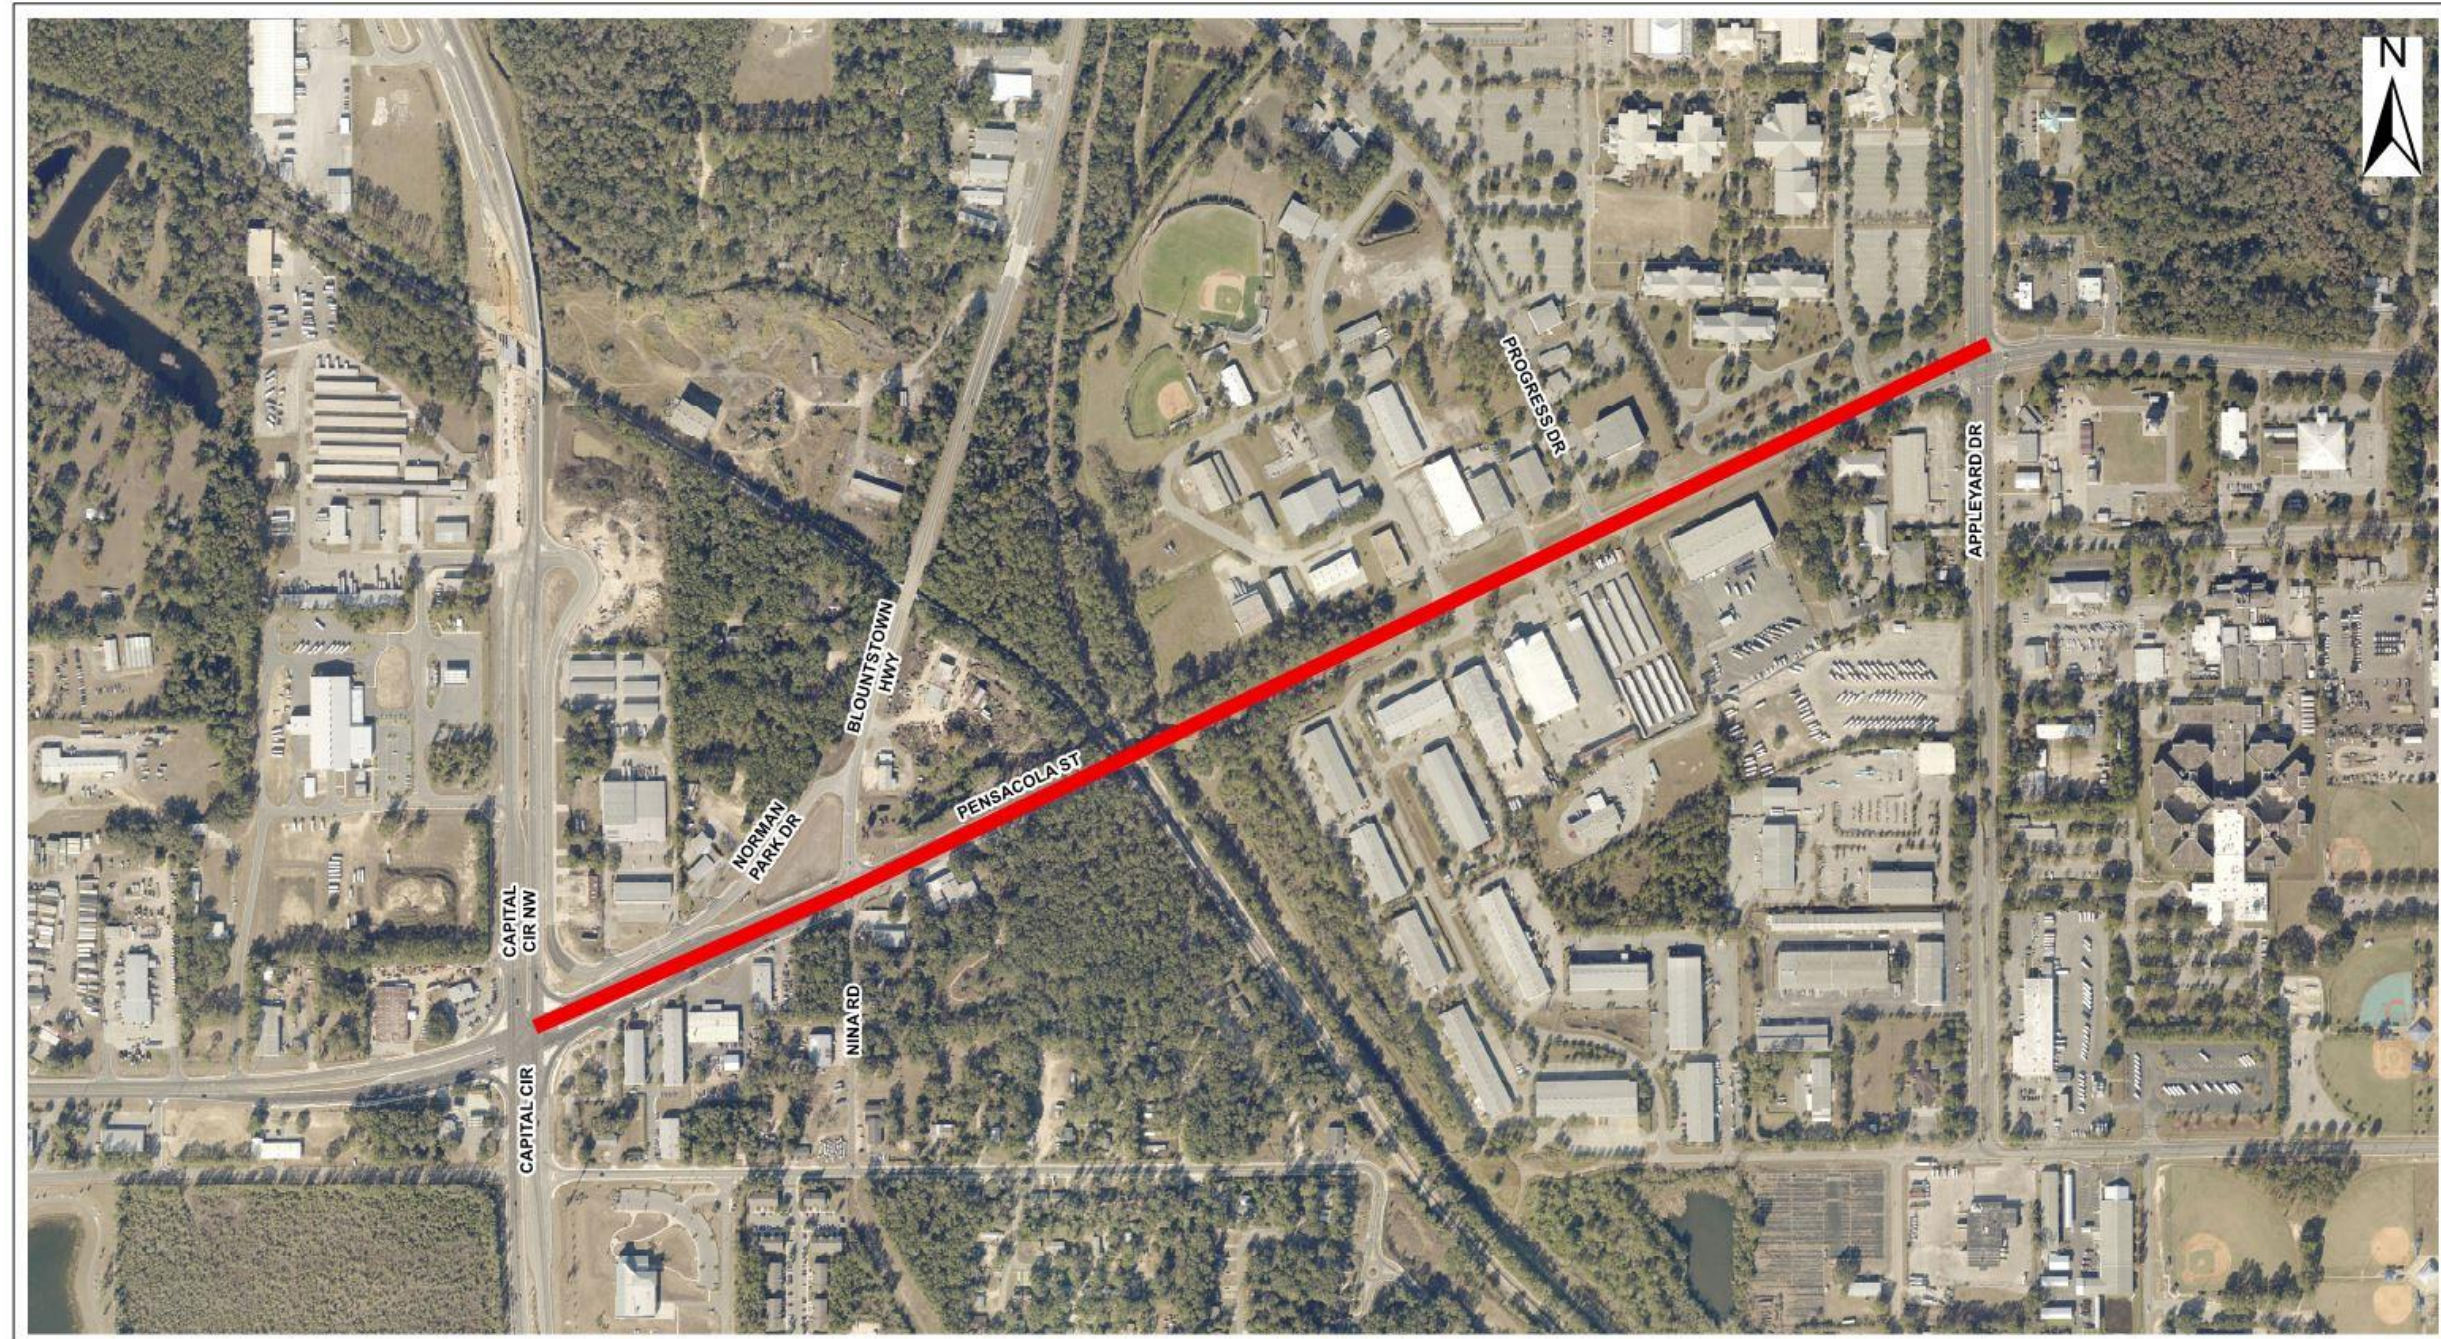
Figure 1. Study Limits

The Capital Region Transportation Planning Agency (CRTPA) identified the need for additional capacity for Pensacola Street in the 2040 Regional Mobility Plan (RMP). The RMP proposes the widening of this corridor. The purpose of this study is to investigate existing and future conditions along Pensacola Street (SR 366) and identify potential projects to improve mobility and efficiency without major capacity expansions. This study will identify potential improvements from Appleyard Drive to Capital Circle (see Figure 1). Existing conditions were established using the following data sources listed in Table 1 below:

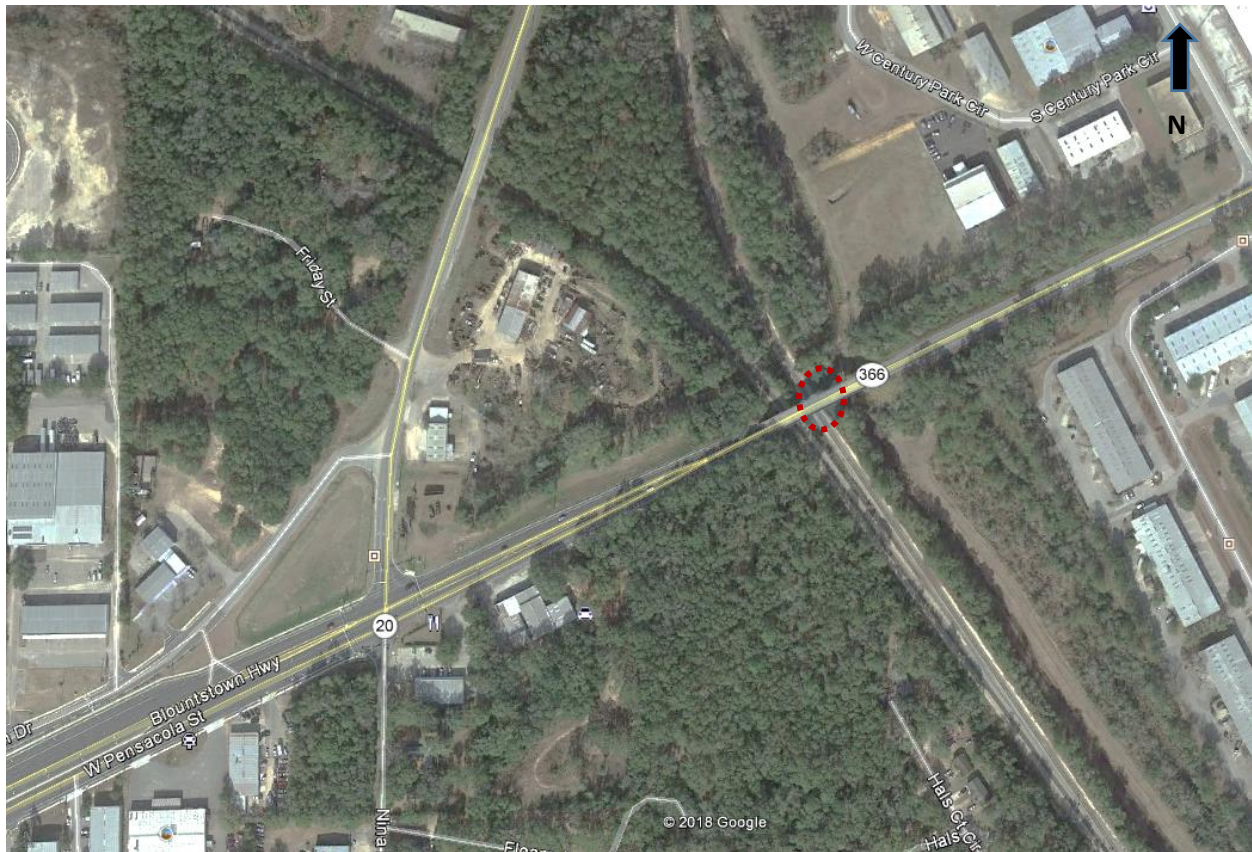
Figure 3. Bottleneck along Pensacola Street

When a road has limited physical capacity (i.e., bottlenecks), it contributes to recurring congestion according to the Federal Highway Administration (FHWA). Recent road widening has developed the section of Pensacola Street from Capital Circle SW to Blountstown Highway as a six-lane section. As Pensacola Street continues east, it narrows to a two-lane section at the bridge over the railroad, shown in Figure 3, consequently creating a bottleneck. Pensacola Street continues as a two-lane roadway transitioning into a four-lane roadway at TCC's access point.

Increased traffic volumes, an effect from the recent widening of Pensacola, will not only further exacerbate the bottleneck situation but also the spot congestion identified near the TCC campus.

In order to address the bottleneck existing at the bridge over the railroad, the bridge and the remaining two-lane section of Pensacola Street should be widened. This widening to four lanes should also incorporate bicycle and pedestrian facilities to address safety concerns for pedestrians and bicyclists on the current bridge. Coordination with CSX railroad will need to be undertaken to facilitate the widening.

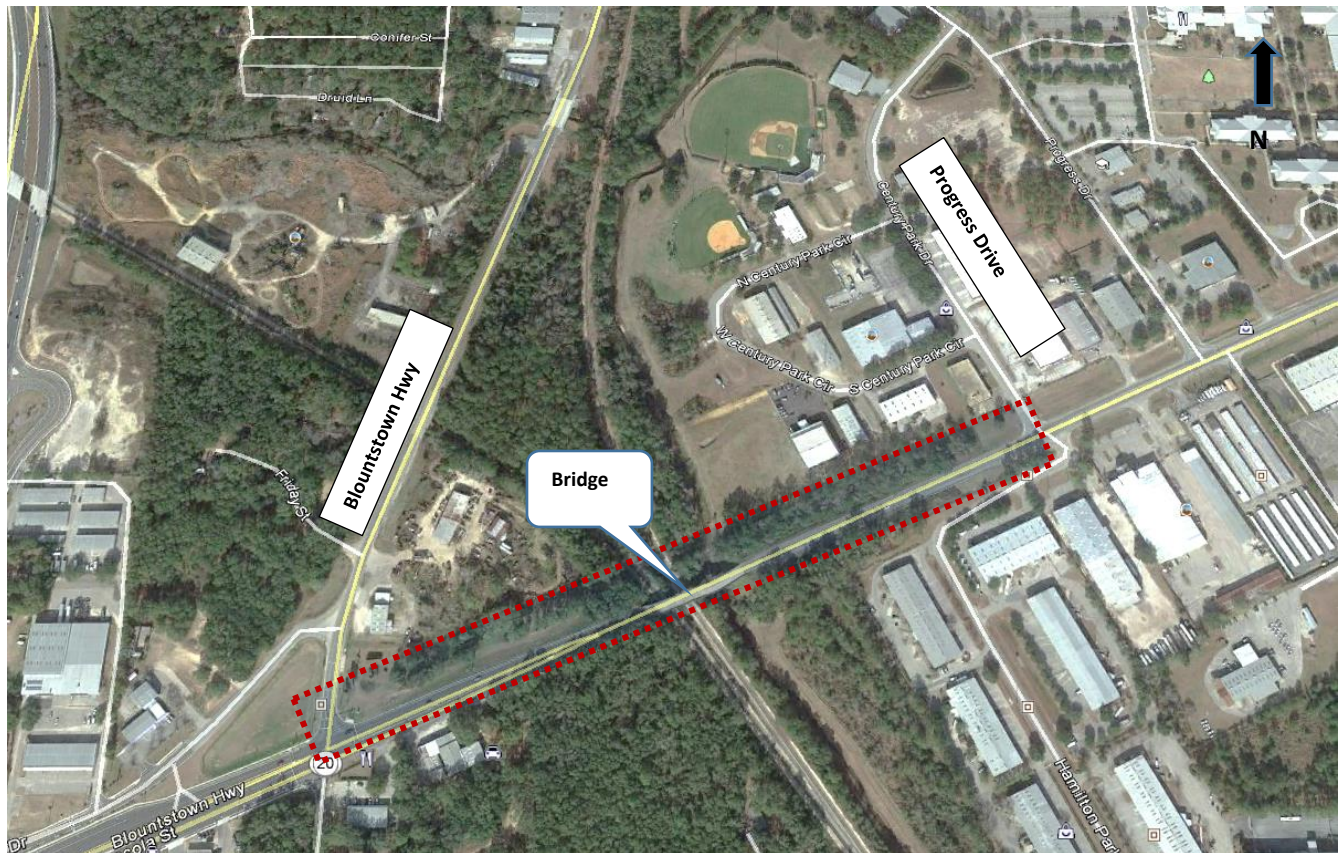
Figure 4. Lack of Bicycle/Pedestrian Facilities Along Pensacola Street

Currently, the two-lane section between Blountstown Highway and Progress Drive lacks bicycle and pedestrian facilities (see Figure 4). For this reason, bicyclists and pedestrians are given no choice but to travel along grassed areas to avoid interaction with motorists. However, grassed shoulders and/or ditches are not present throughout the corridor, particularly at the bridge. The lack of facilities and shoulder refuge in this area poses a high risk area for pedestrians as they are given no choice but to travel on the roadway with vehicular traffic.

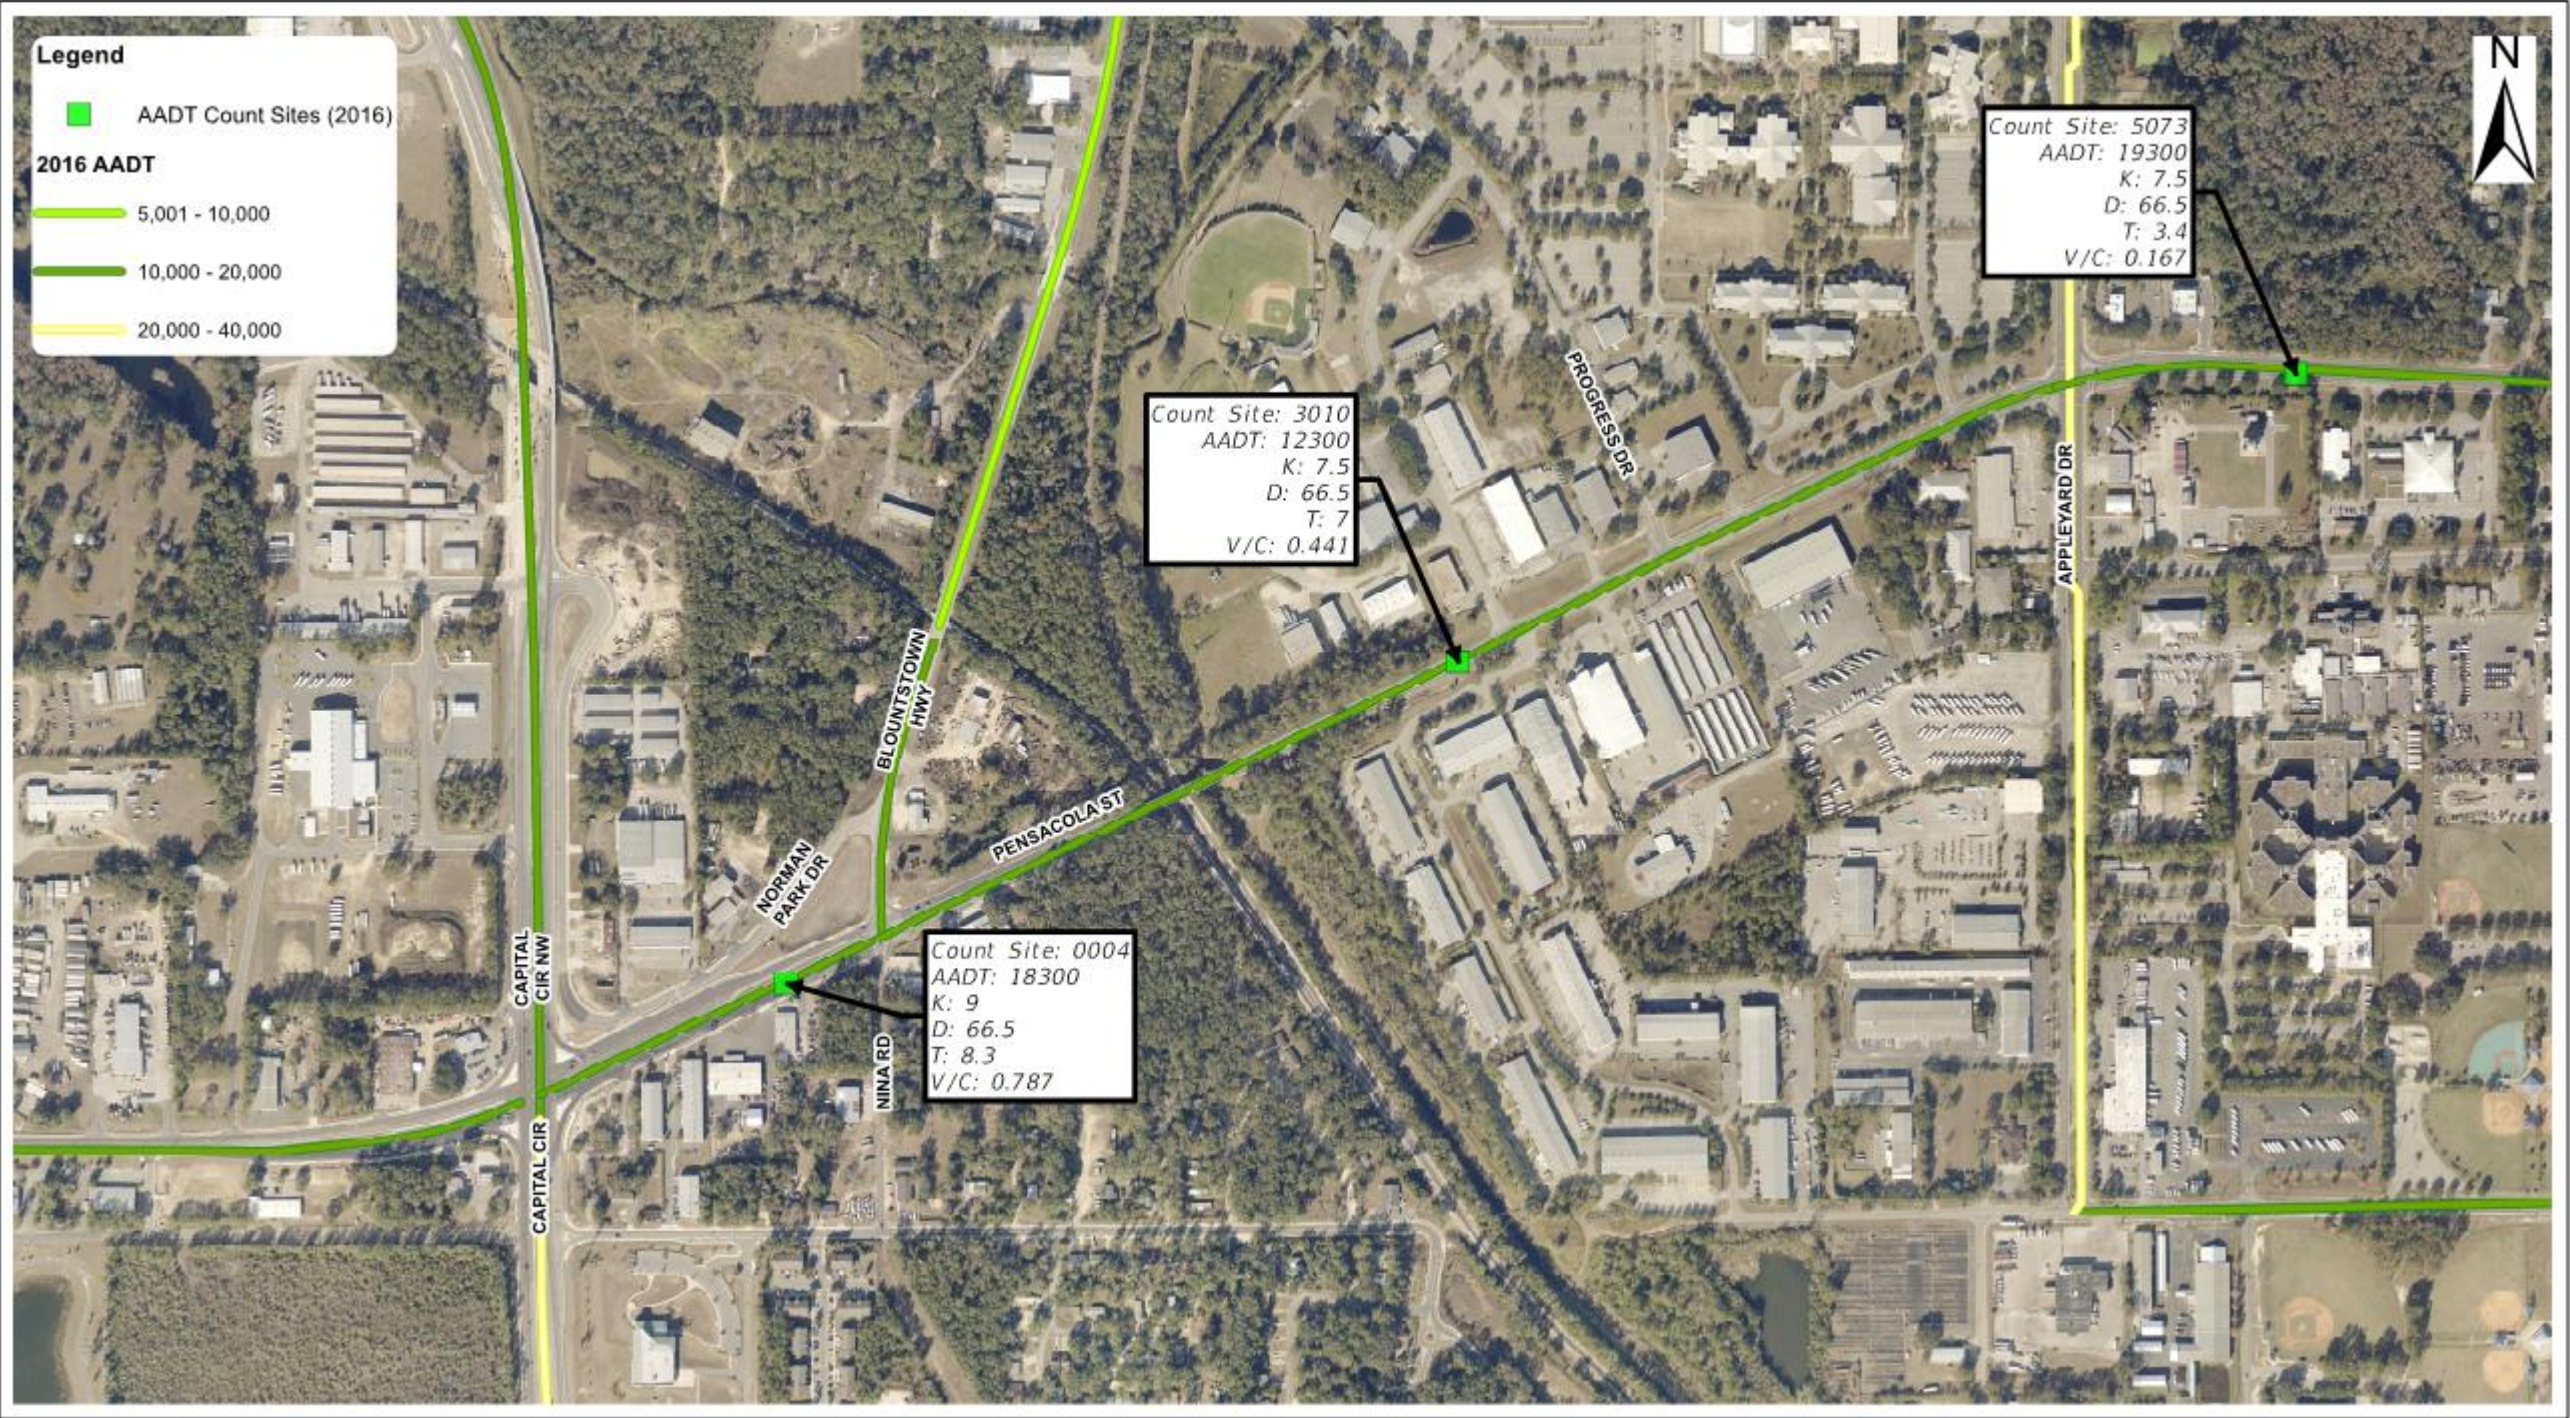
Figure 5. 2016 Traffic Volumes

Historical traffic data and county traffic sites provided the source of existing traffic for the Pensacola Street study area. Figure 5 summarizes Annual Average Daily Traffic (AADT) from the Florida Department of Transportation traffic information. The highest traffic volumes within the study segment in 2016 are found between Blountstown Highway and Capital Circle SW, with an Average Annual Daily Traffic (AADT) of 18,300. The traffic information is displayed in Figure 5.

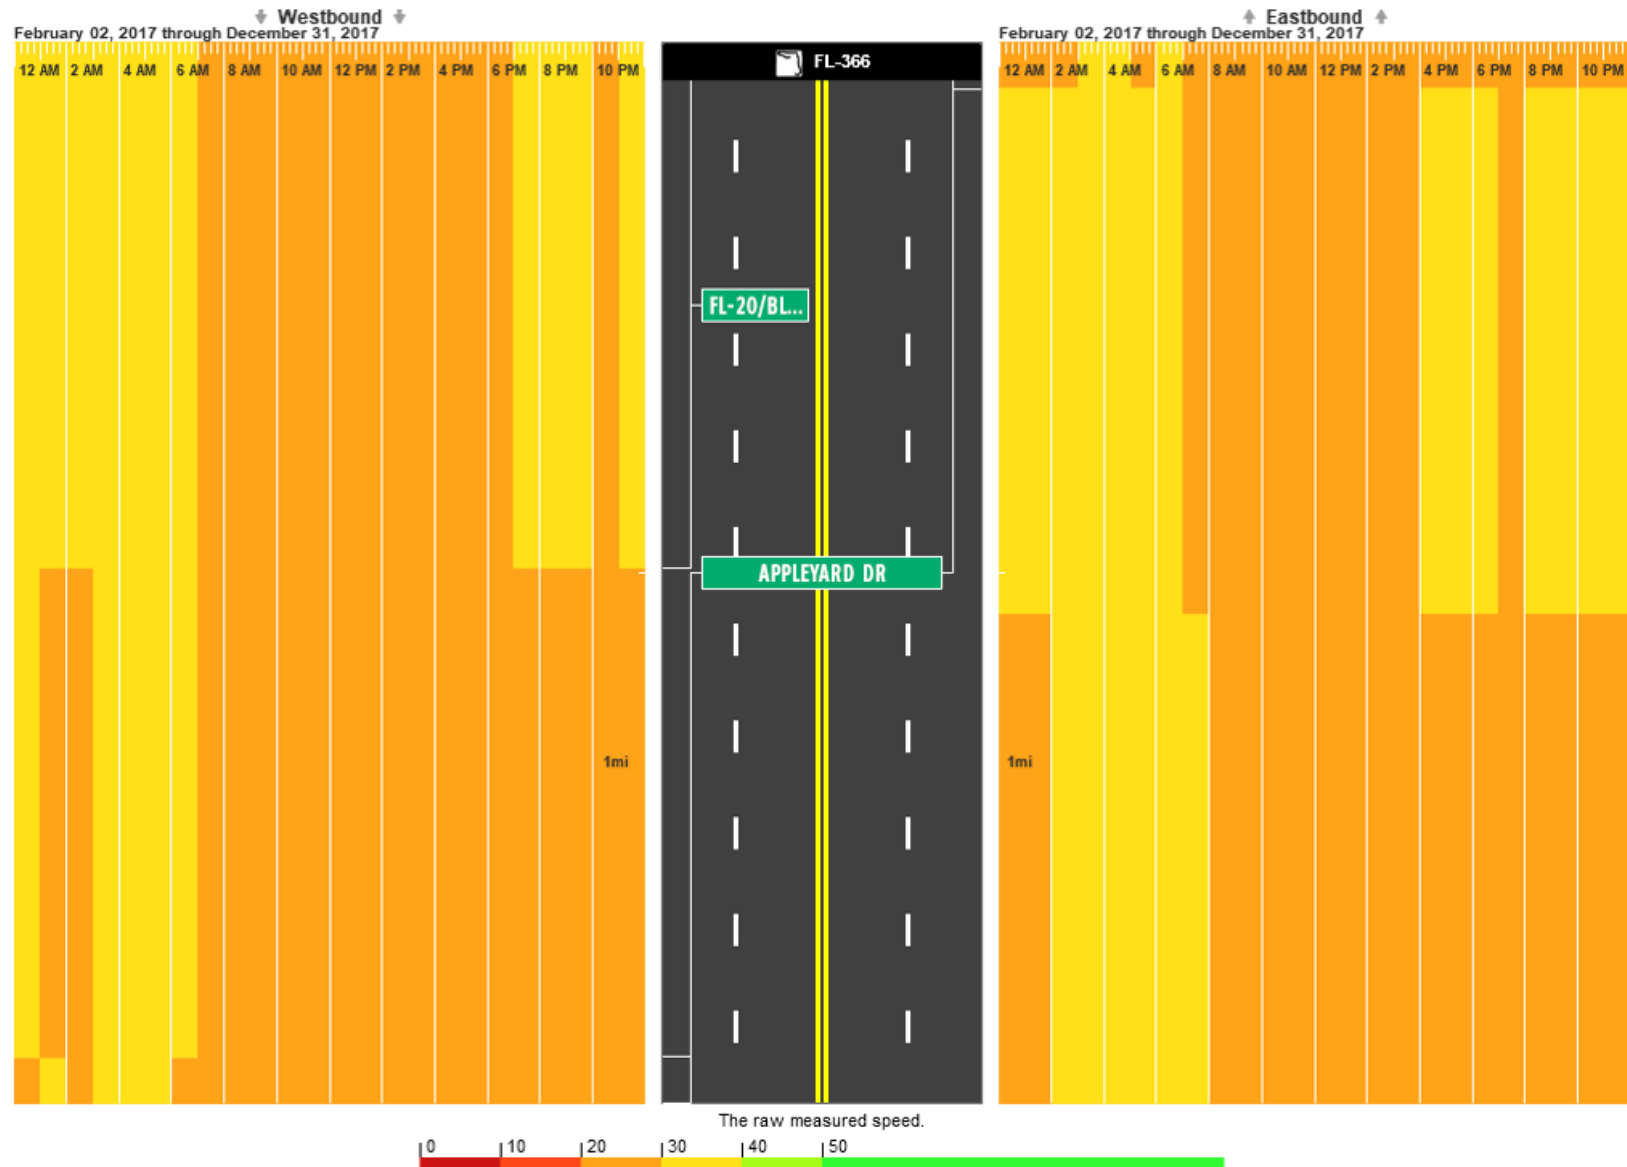
Figure 8. Pensacola Street NPMRDS Corridor Scan

The Federal Highway Administration maintains a database of travel information gathered from cellular and GPS units. This database, the National Performance Monitoring Research Data Set (NPMRDS) provides the information for use in network and corridor analyses. The data serves as one analysis tool and can provide insights into the operations of facilities, however, to comprehensively understand the operations of a facility, this data must be combined with other data sources, however it can provide some indication of existing issues.

Averaged by 1 hour for February 02, 2017 through December 31, 2017
