September 3, 2024

## COMMITTEE AGENDA ITEM 5 A

### **NORTH MONROE STREET SAFETY IMPLEMENTATION PLAN**

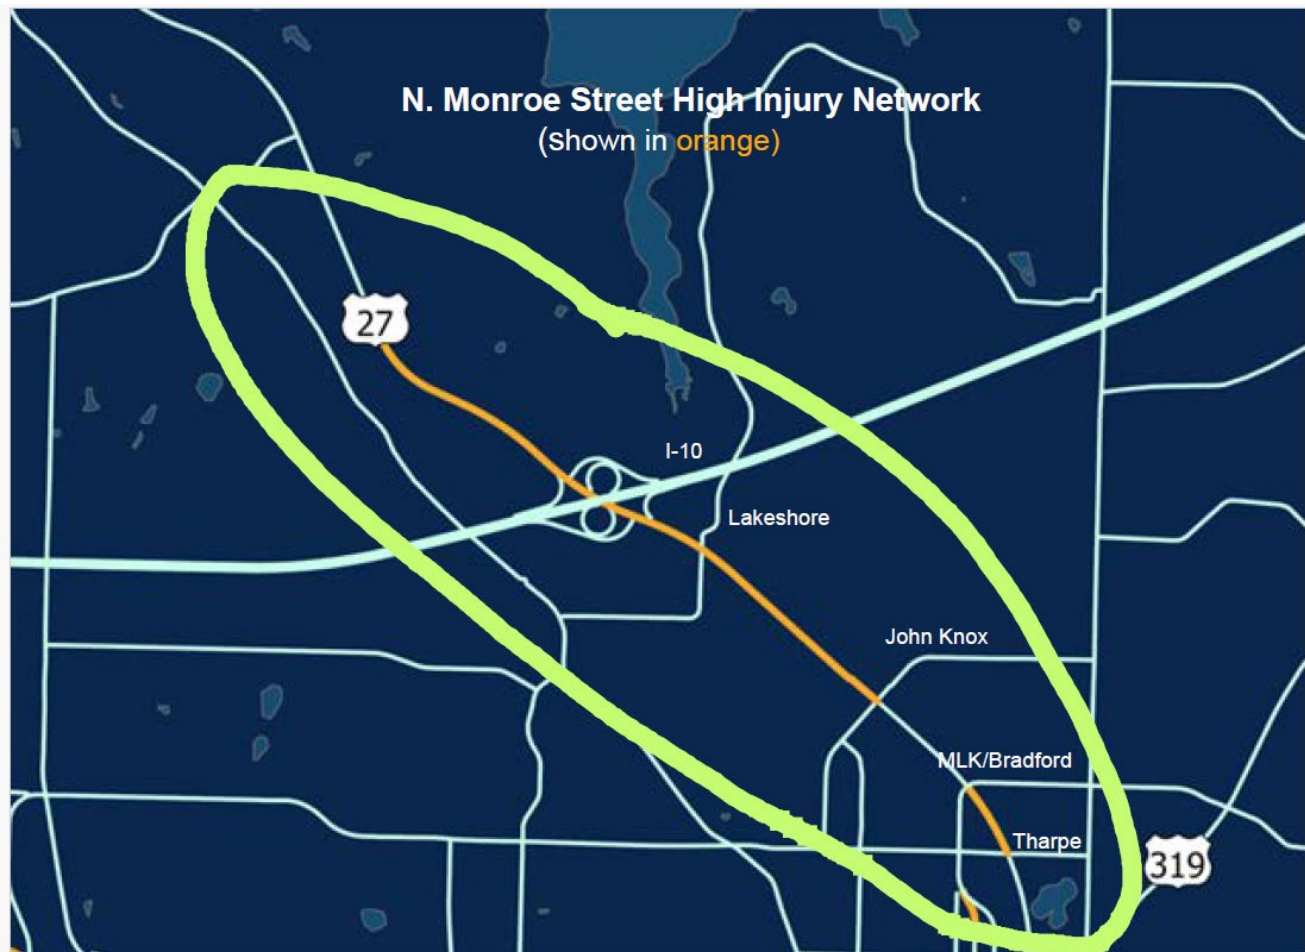
### N. Monroe Street High Injury Network Map

In June 2023, the CRTPA adopted the [Safe Streets and Roads for All \(SS4A\) Safety Action Plan](#), a plan that identified projects and priorities addressing roadway safety in the capital region. Associated with the plan's development was the identification of High Injury Network (HIN) for roadways in the region with safety concerns. The analysis identified North Monroe Street as being on the HIN for *vulnerable road users* (defined as people, including pedestrians and bicyclists, who are not protected by a car or truck while traveling and, as a result, at a higher risk of injury in a crash with a vehicle), ***shown below***.

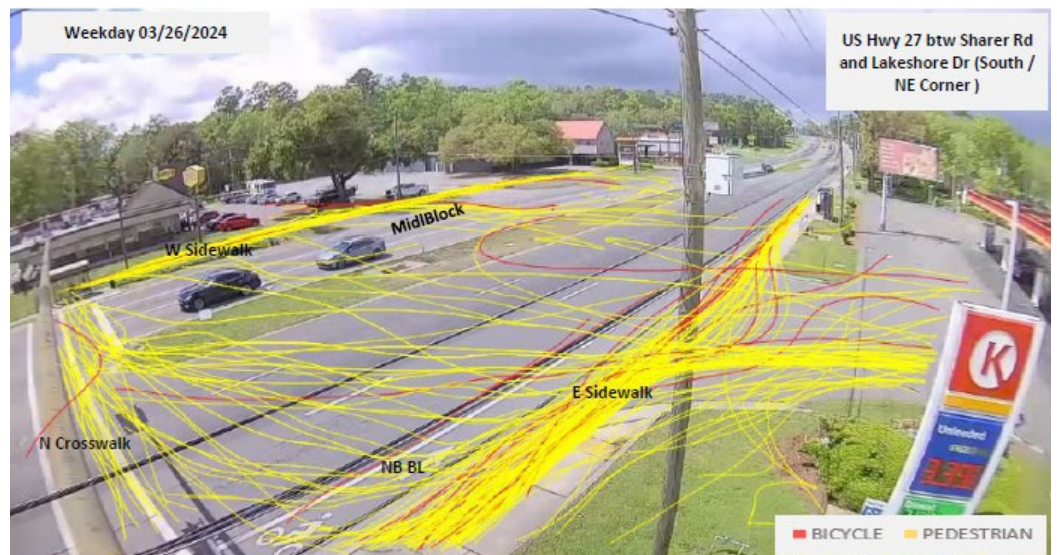
The **photograph to the right** provides an analysis of pedestrian (in yellow) and bicyclist (in red) crossings over a 2-day period looking north along the corridor from Sharer Road. At this location, 237 pedestrians and 29 bicyclists were identified, of which, 21% of bicyclists and 36% of pedestrians chose to jay walk at the midblock location.

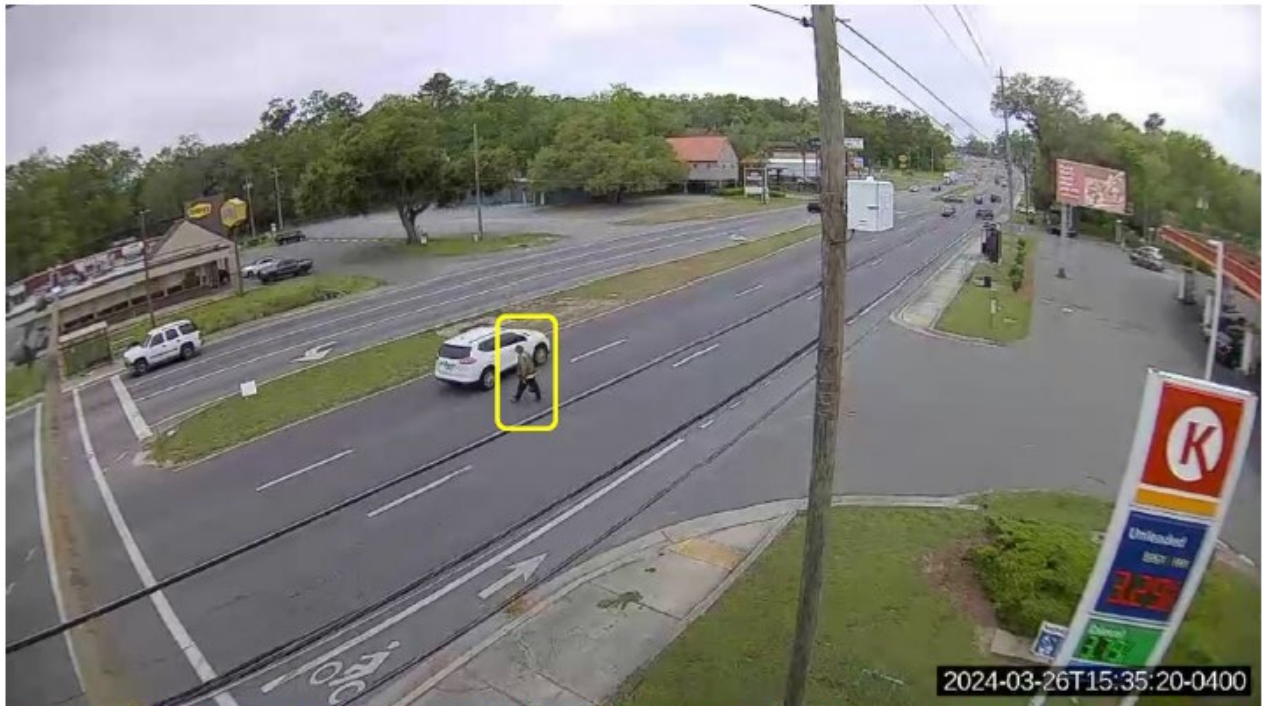
Corridor Location: N. Monroe/Sharer Road

Figure 4: Pedestrian starts crossing westbound near the Gas Station driveway and passes near an incoming vehicle entering US Hwy 27 from the east leg of Sharer Rd. It represents a near-miss case where the driver had to evade the pedestrian. (Date 03/26/2024 at 3:35 PM)

The camera count analysis also included a near miss review between vulnerable users and motorized vehicles. This near miss analysis allowed for development of proactive recommendations (the **photographs below** from the report provide examples of near misses on the corridor).

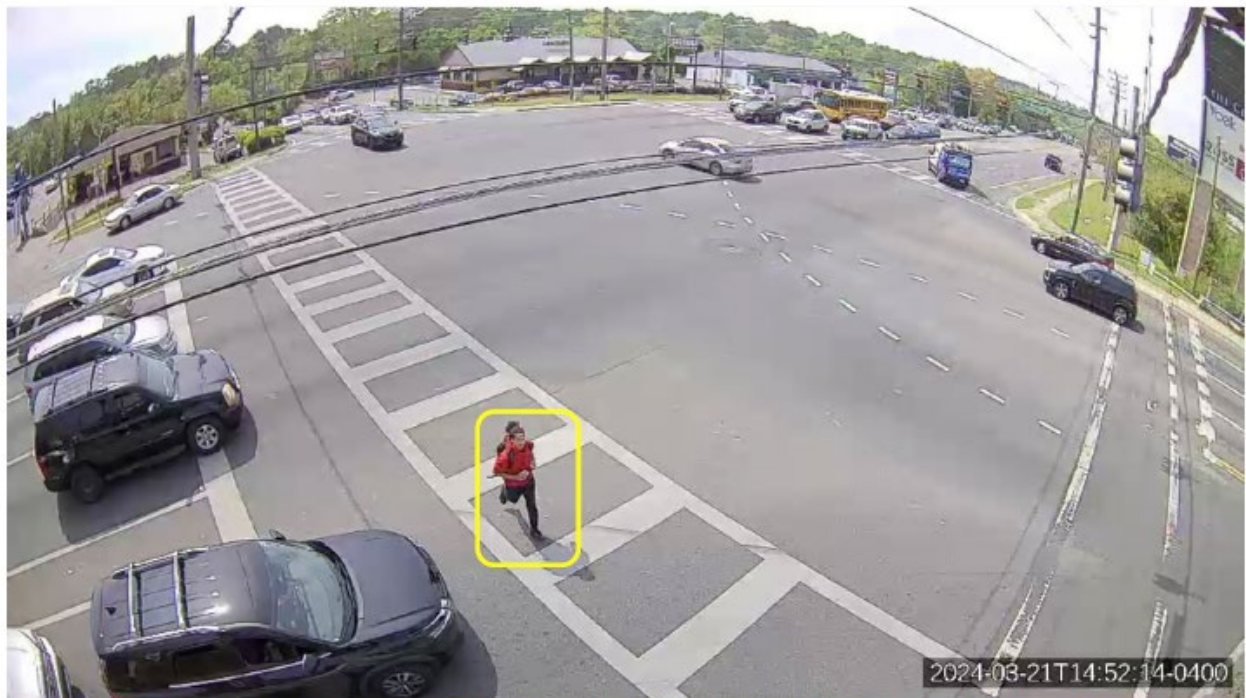
Corridor Location: N. Monroe/John Knox Road

Figure 3: Pedestrian crossing the south approach, vehicle approaching from Northbound Right Turn failed to yield to pedestrian (Date 03/21/2024 at 02:52 PM)
