# FLORIDA DEPARTMENT OF TRANSPORTATION DISTRICT THREE TRAFFIC OPERATIONS TECHNICAL MEMORANDUM

C-9V74 TWO 6 RE: FINAL Qualitative Assessment Location: SR 61 (Thomasville Road) at Savannah Trace – Leon County Section No: 55050000 Mile Post: 3.036 Date: 2/14/2022

# **Speed Zone Study Report**

SR 61 (Thomasville Road)

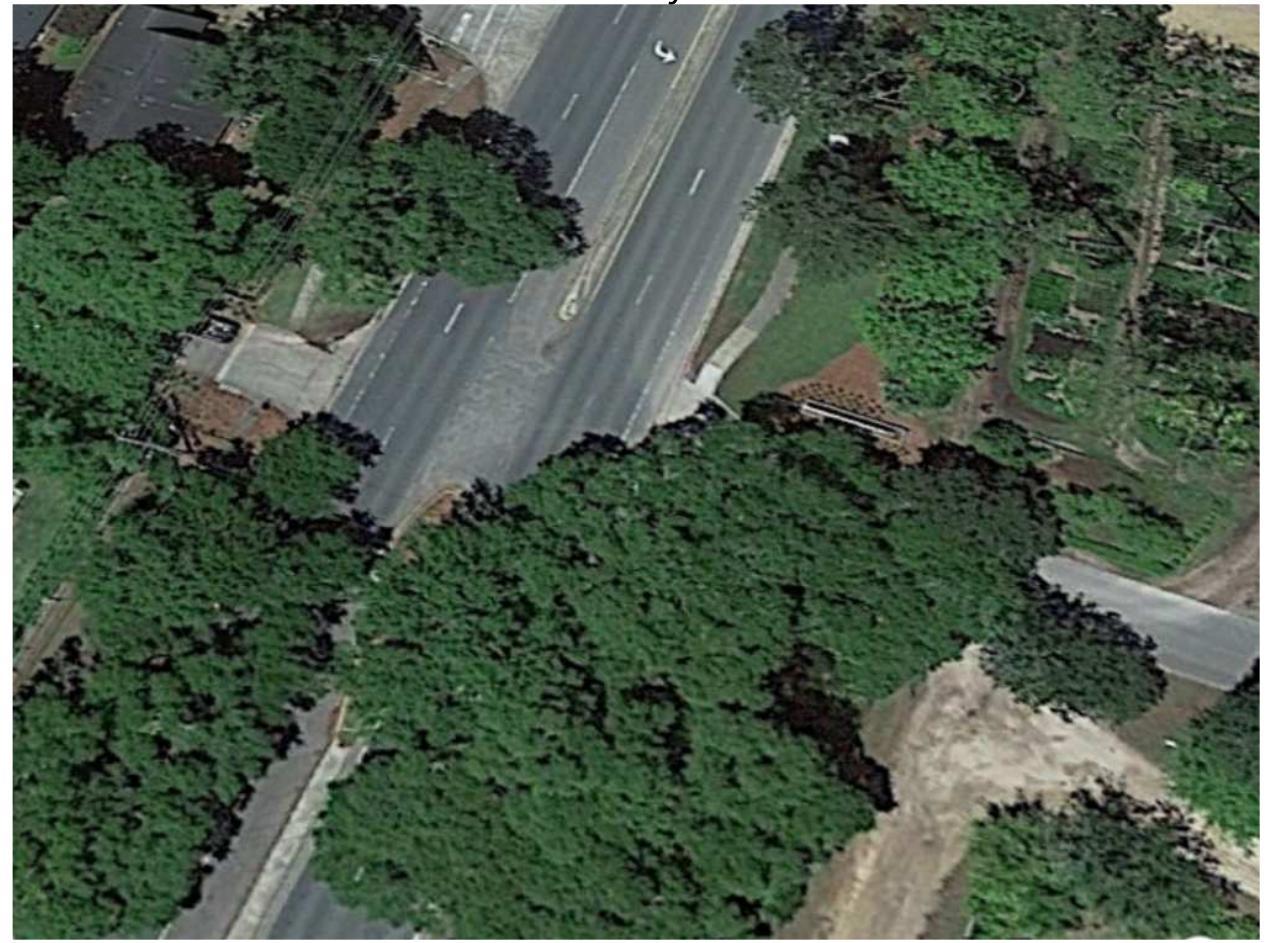
The geometric layout of the intersection along with photographs are shown below: Geometric Layout

SR 61 (Thomasville Road) is a four (4) lane divided roadway with a southbound left-turn lane at Savannah Trace. The posted speed limit along SR 61 (Thomasville Road) is 45 miles per hour (mph). Savannah Trace is a two (2) lane roadway with a single lane approach (shared left and right-turn lane) on the eastbound approach and separate left and right turn lanes on the westbound approach (Tallahassee Nurseries) at SR 61 (Thomasville Road). The speed limit along Savannah Trace is unposted.

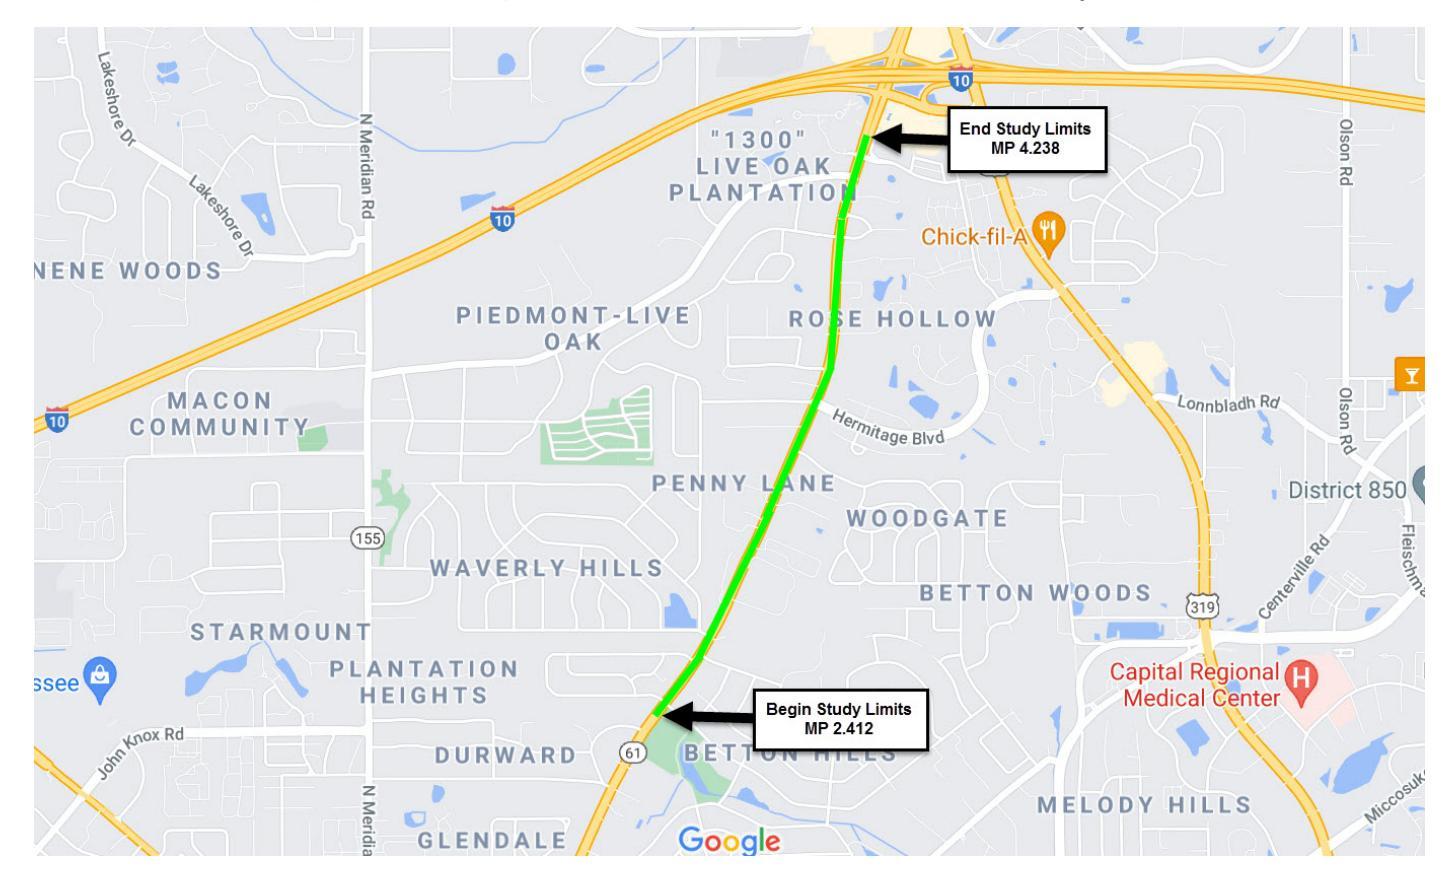
Speed Zone Study Limits

SR 61 (Thomasville Rd) from south of Armistead Rd to north of Metropolitan Blvd

HSA Consulting Group conducted a speed zone study on SR 61 (Thomasville Rd) from south of Armistead Road to north of Metropolitan Boulevard (MP 2.412 - 4.238) measuring 1.826 miles in distance. Data collected for the study included historical traffic volumes, five (5) years of crash data, spot speed studies, and Traffic Operations RCI speed zone data. This information was used to analyze the speed, safety, and operation of this segment of the roadway and determine what, if any, actions should be taken regarding the posted speed limits.
