Existing Conditions

Segment 2: Armistead Road to Woodgate Way

Segment 2: Armistead Road to Woodgate Way Existing Conditions by Segment

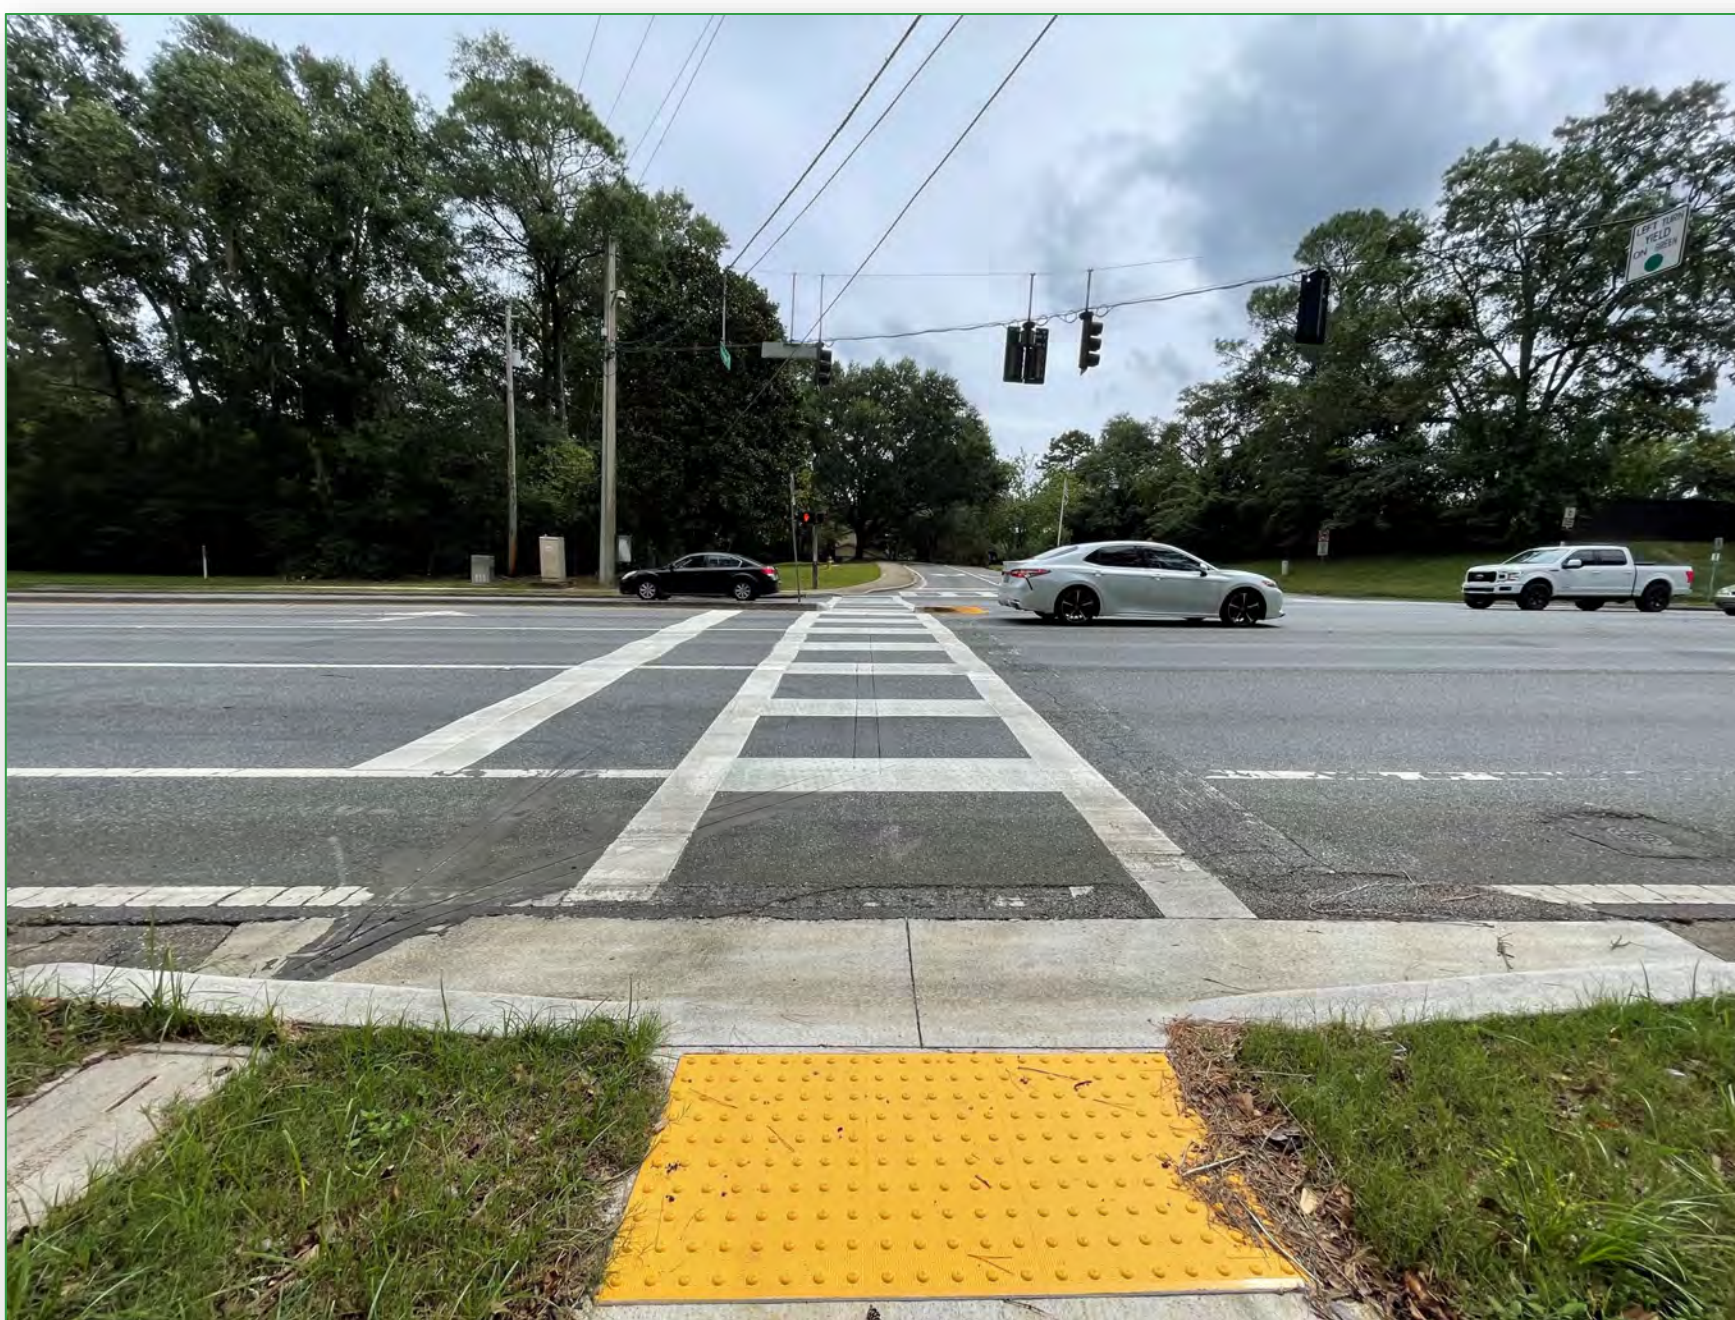
Existing crossing on north side of Woodgate Way and Thomasville Road Intersection
