**CRTPA**  
**TRAFFIC AND OPERATIONS ANALYSIS**  
**THARPE STREET**

January 2019

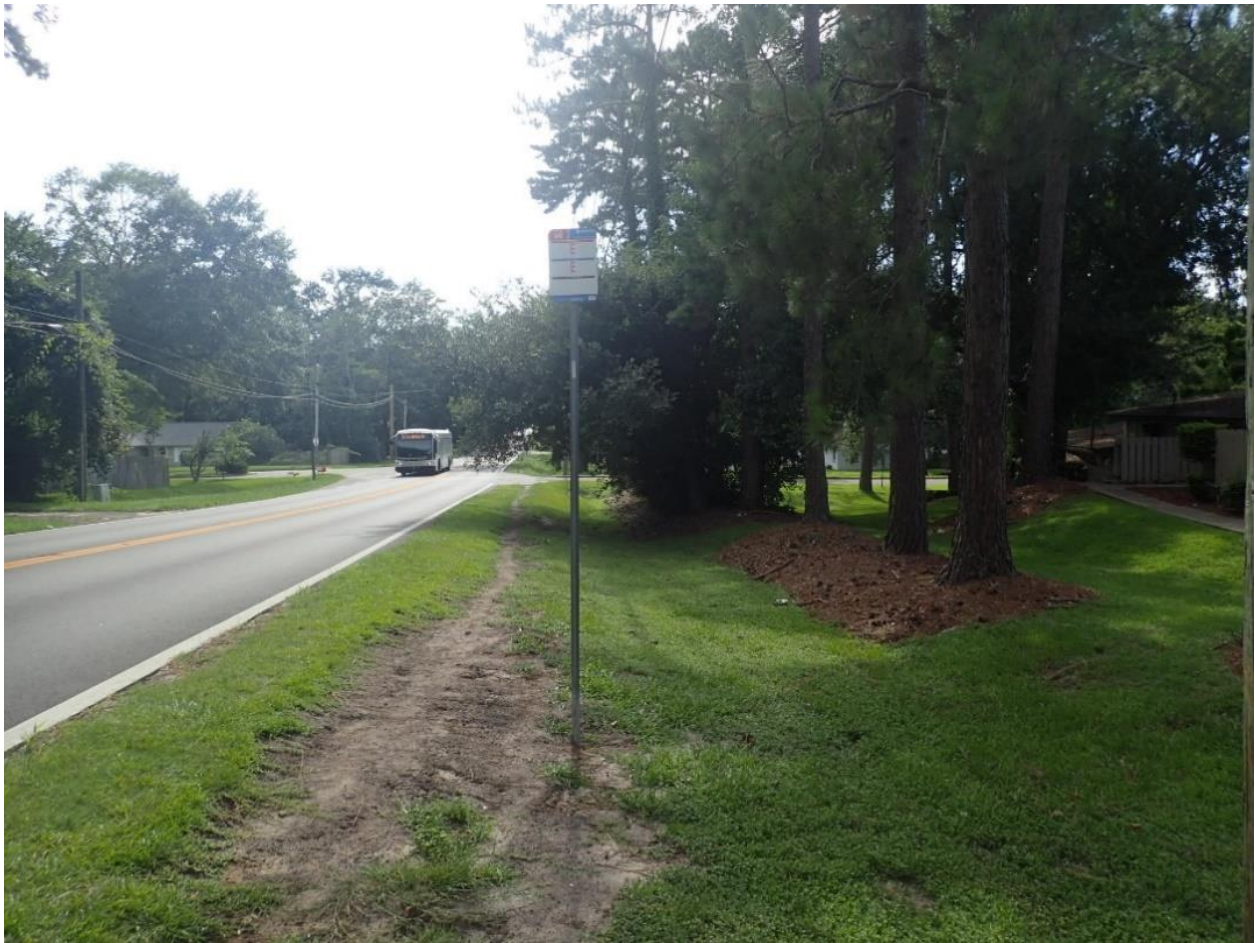
**Figure 2. Typical Bus Stop Along Tharpe Street**

StarMetro serves as the public transit agency for the City of Tallahassee and Florida State University. Currently, bus stops along Tharpe Street are not compliant with the Americans with Disabilities Act (ADA) and offer limited information to passengers (see Figure 2). Current ADA compliance is only required when bus shelters and sidewalks already exist. StarMetro desires to make all public transit links adhere to current ADA standards and to provide schedule and route information, making the system more accessible and safer for all riders.

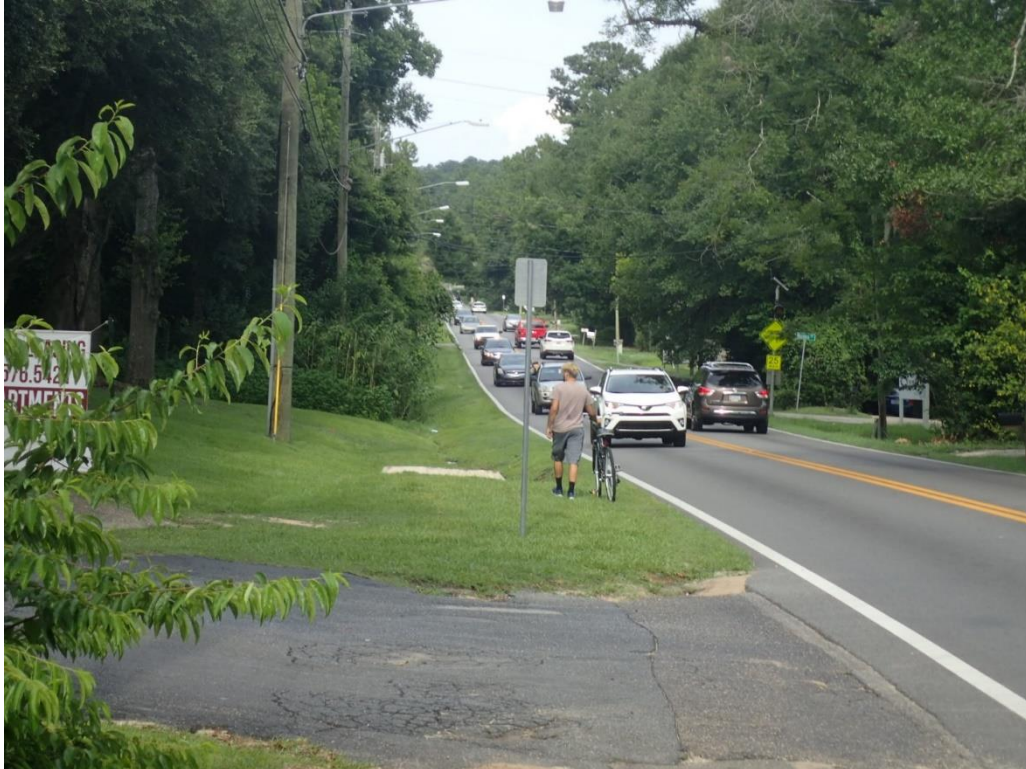
**Figure 5. Pedestrian Travel Pattern**

Presently 90% of the land parcels along Tharpe Street have no access to sidewalks or bicycle facilities. For this reason, cyclists and pedestrians have no choice but to travel along grassed ditches to avoid interaction with motorists (see Figure 5). However, grassed ditches are not always made available. One area in particular, located 500 feet east of Trimble Road, poses a high-risk area for pedestrians as they are given no choice but to travel on the roadway with vehicular traffic (see Figure 6).

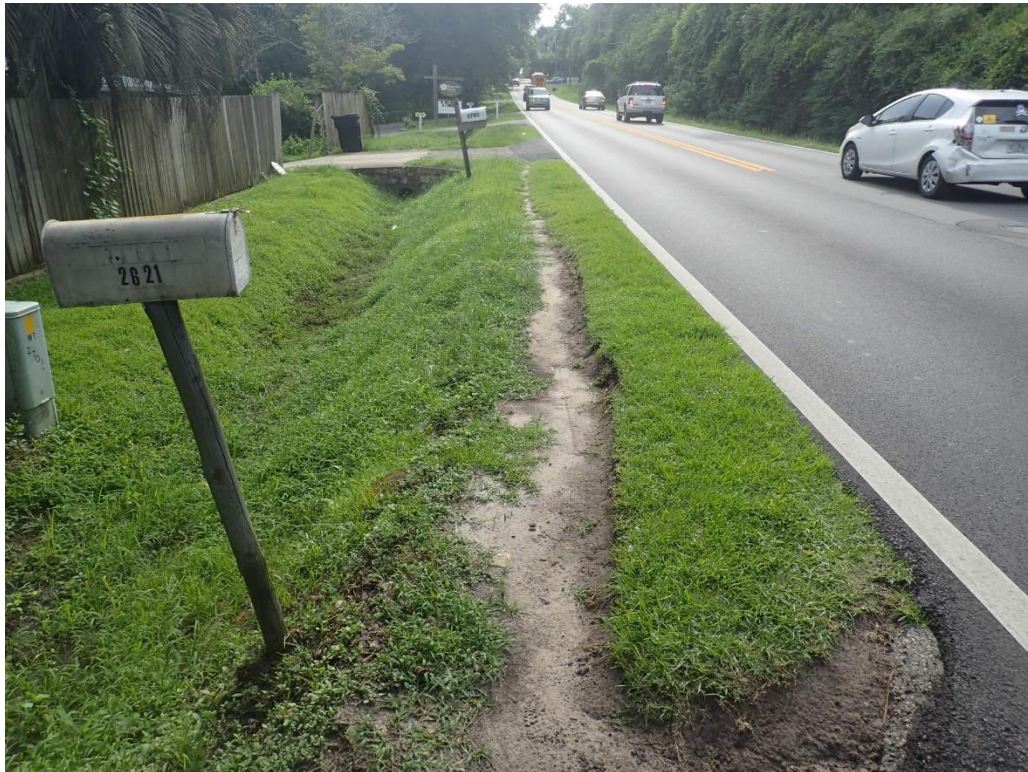
**Figure 7. Desire Lanes along Tharpe Street**

Desire lanes are paths that result from on-going pedestrian foot traffic and can be found at multiple locations along Tharpe Street. This not only lacks pedestrian safety benefits but also uniformity throughout the corridor. Prevalence of desire lanes signify the need for sidewalks (see Figure 7).

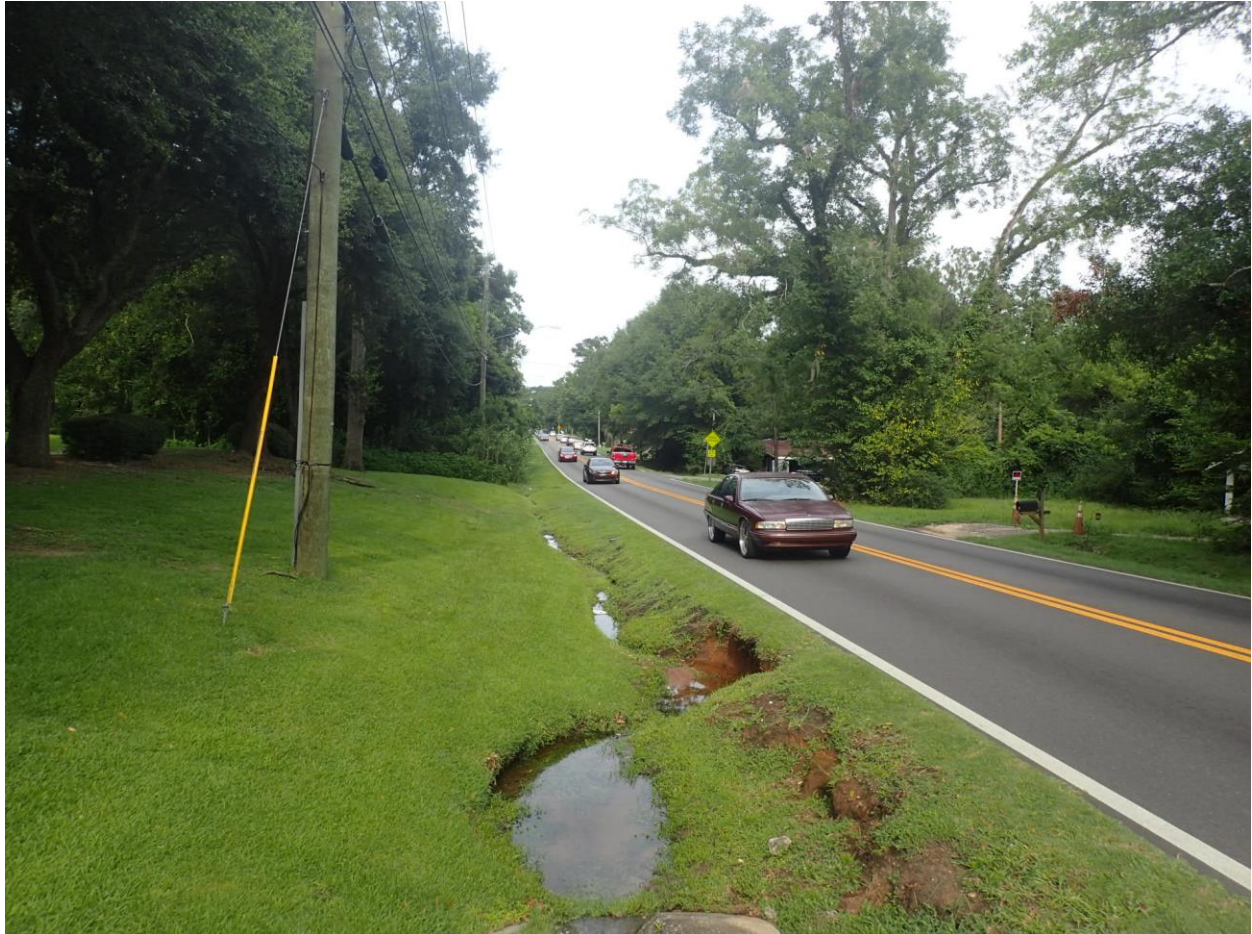
**Figure 8. Slope Erosion Caused by Stormwater Runoff along Tharpe Street**

Evidence of roadside erosion can be observed throughout the corridor. Existing conditions show roadway drainage traveling to nearby roadside ditches that transports water runoff to the nearest outfall point (see Figure 8). Presently, no stormwater treatment is provided for the roadway other than the flow time in grassed ditches.

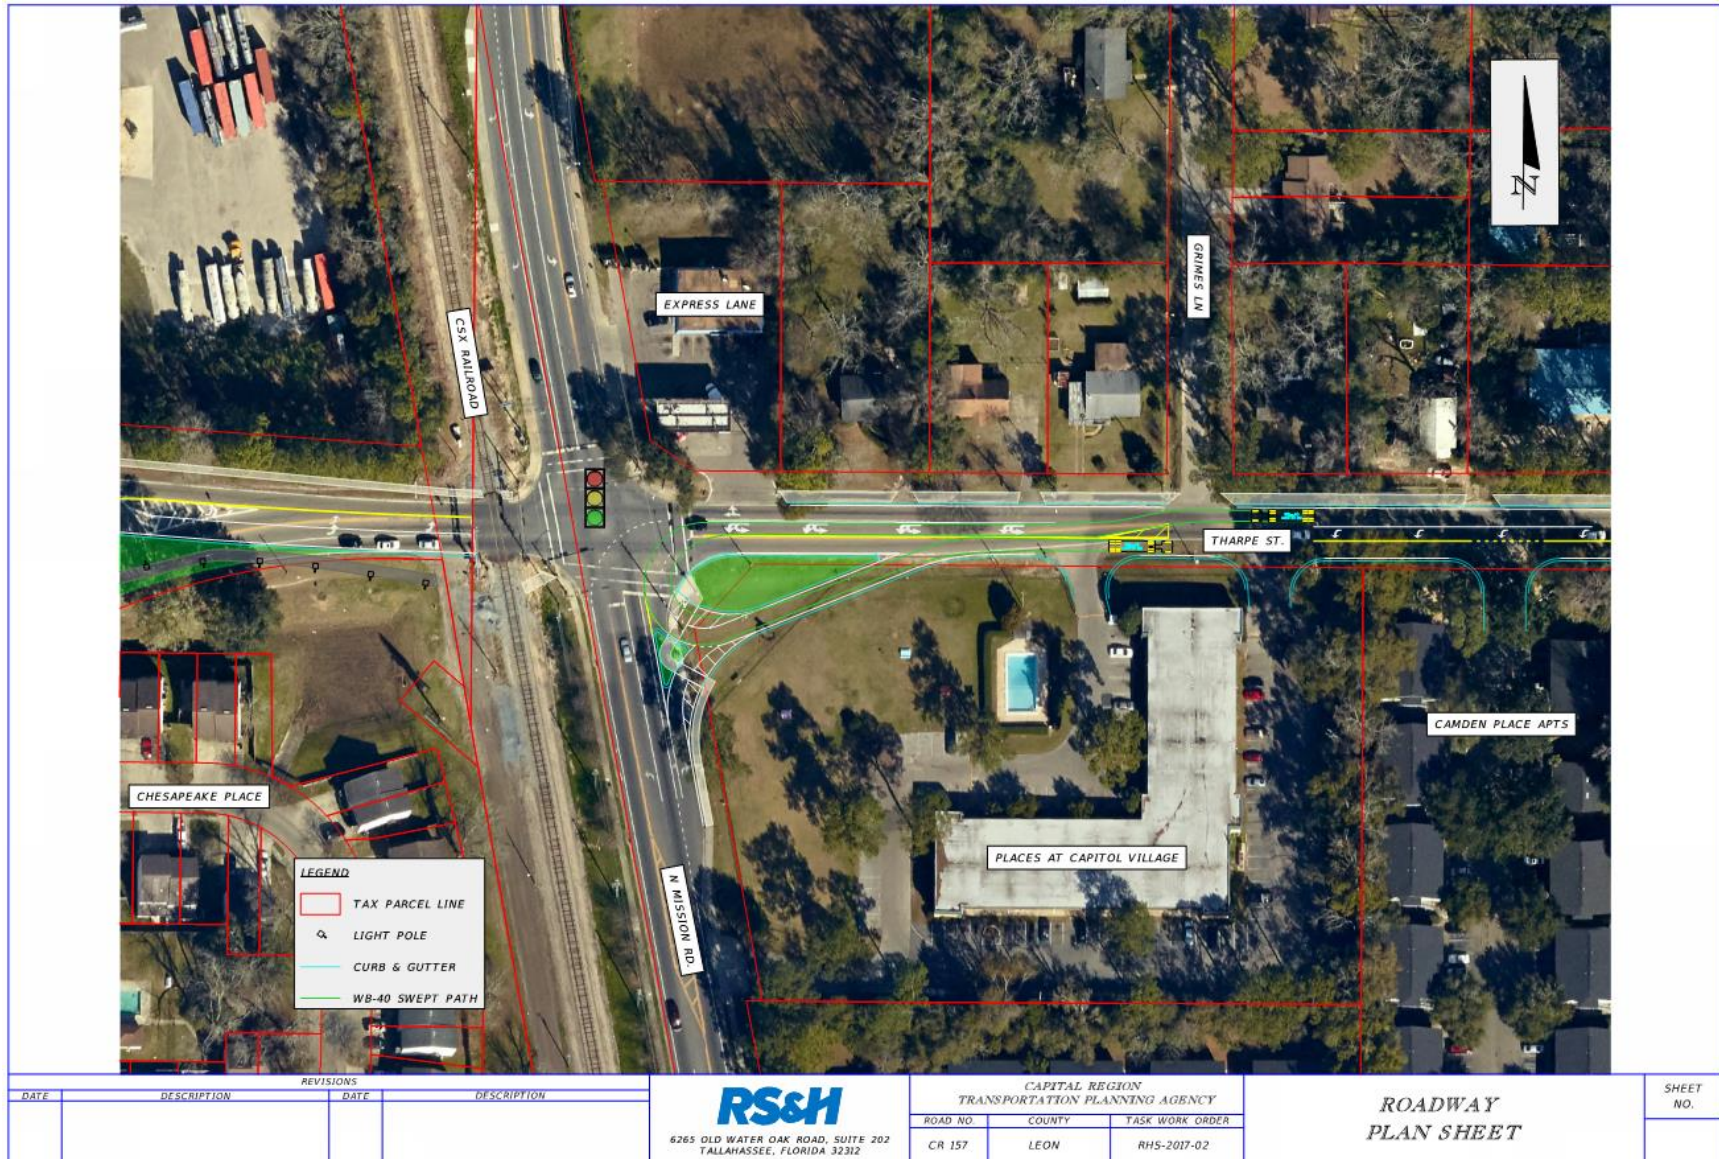
Figure 12. Mission Road at Tharpe Street

- Addition of 8-foot wide concrete sidewalk, culvert system, and curb and gutter along north side of Tharpe Street.
- Addition of 8-foot wide pedestrian bridge over central drainage system.
- Widen 10 feet along the south side of Tharpe Street for addition of medians from Mission Road to Trimble Road.
- Addition of two Jug handle U turns allowing U-turn for vehicles needing left turn access
- Install turnout bays.
- Re-striping east side of Tharpe Street near Ocala Road to include bike lane.

Figures 12 through 16 display the recommendations identified for this section.

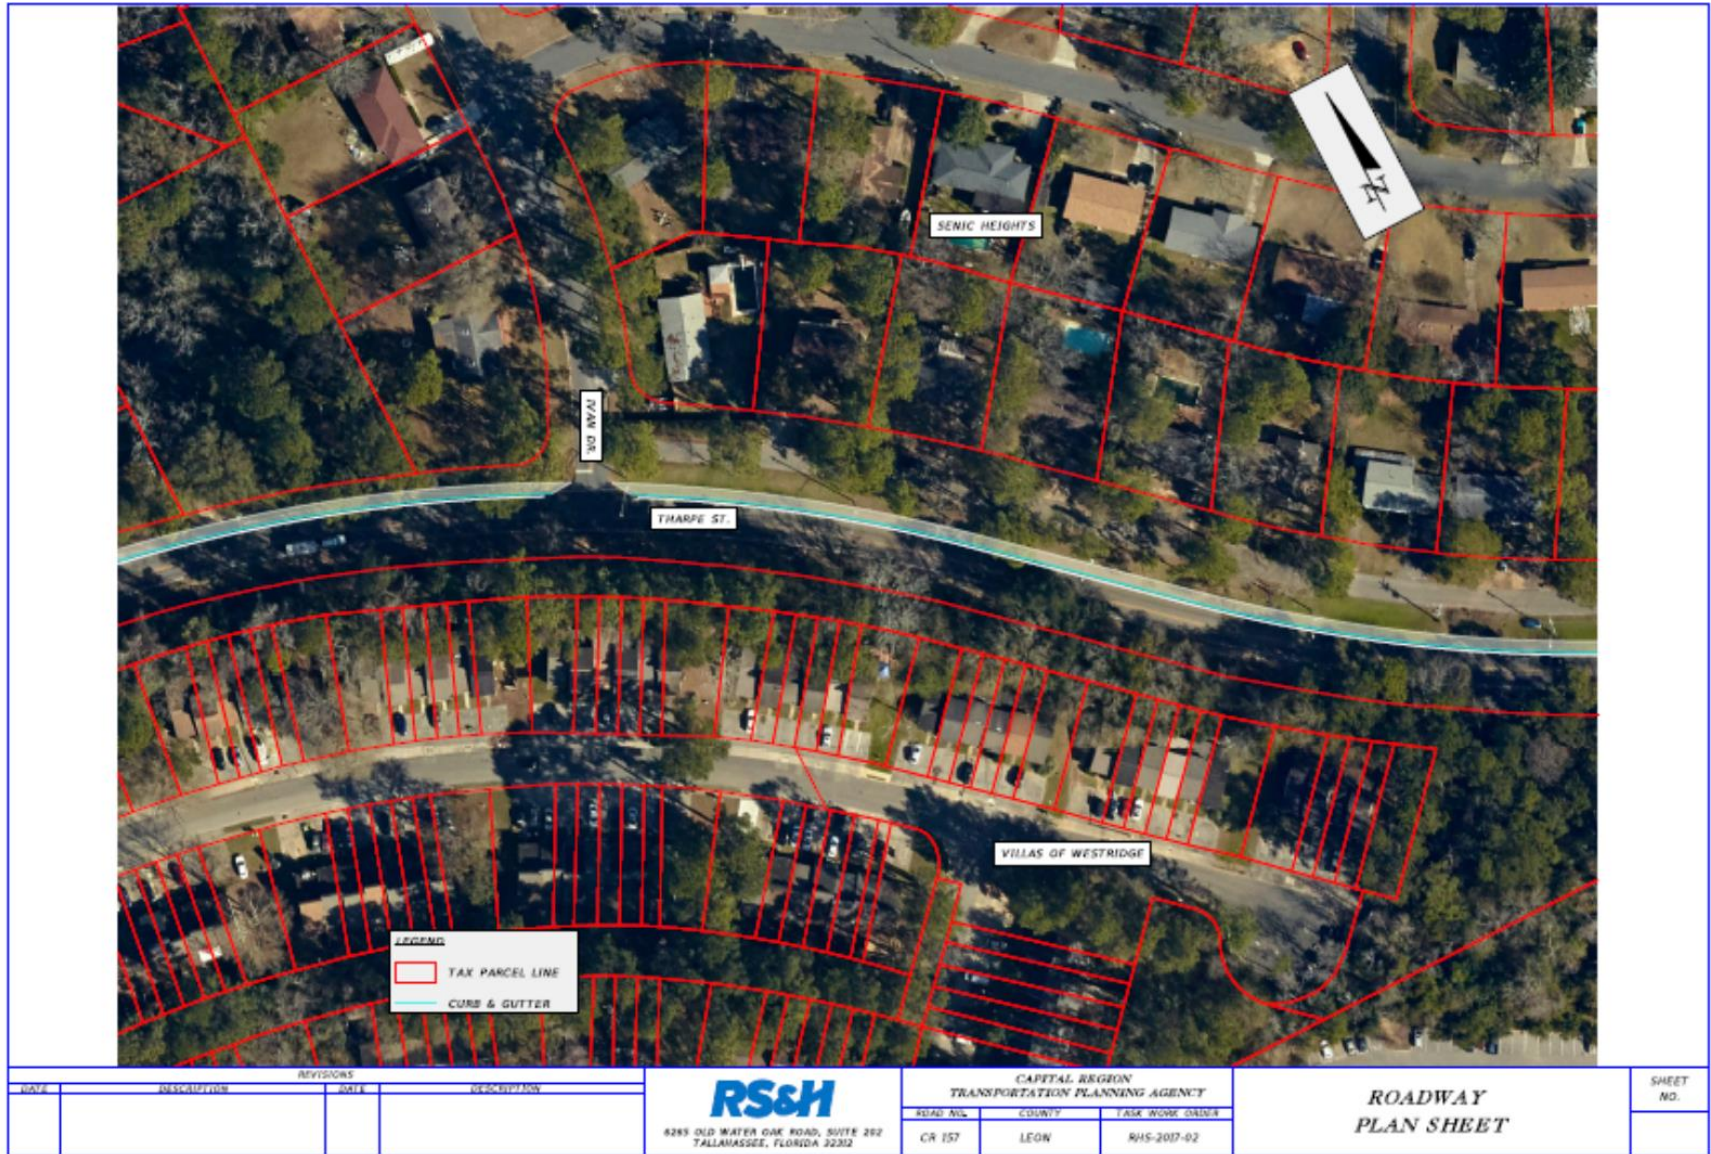
Figure 17. Ivan Drive

- Addition of 8-foot wide concrete sidewalk, culvert system, and curb and gutter along north side of Tharpe Street.

Figures 17 and 18 display the Ivan Drive and Devra Drive areas.
